# STERLING OPERA HOUSE COMPREHENSIVE STUDY

JULY 13, 2026

# STUDY TEAM

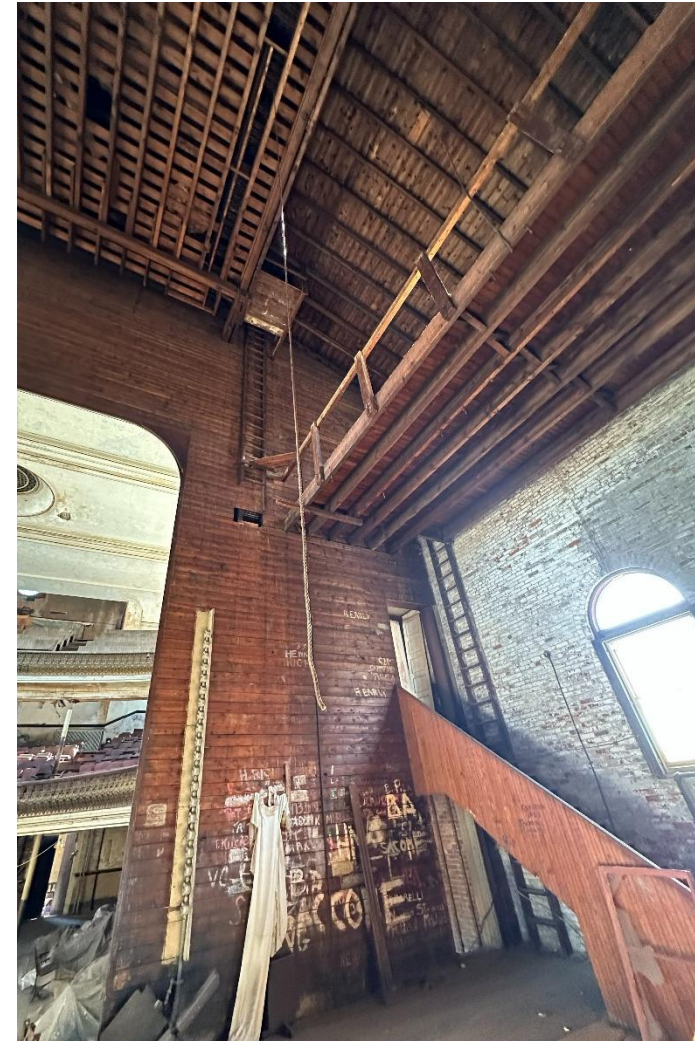
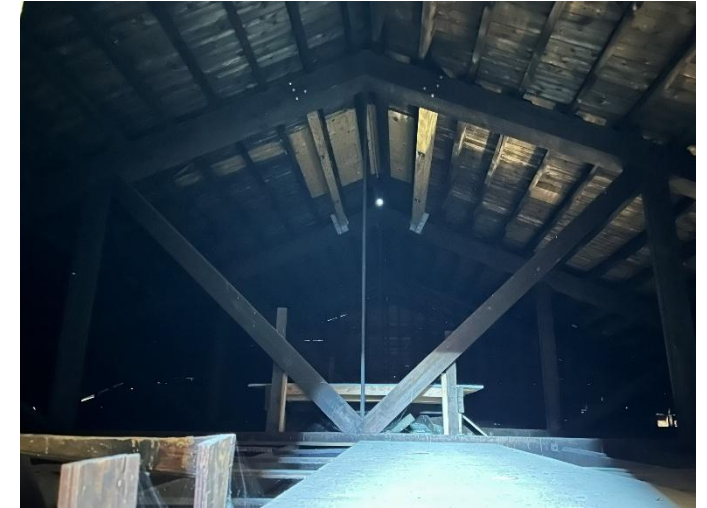
The focus of the structural investigation was to determine primary framing type, location, and representative sizes for major areas, neglecting local details. Bearing walls were identified and viewed in general; these walls did not exhibit obvious deficiencies, noting that they were not thoroughly examined. Much of the wood framing in the building was exposed and was observed to be in generally good condition exhibiting very few checks, splits, twists, corrosion, etc.

Most of the wood was exposed because of prior removals of plaster and similar finished surfaces.

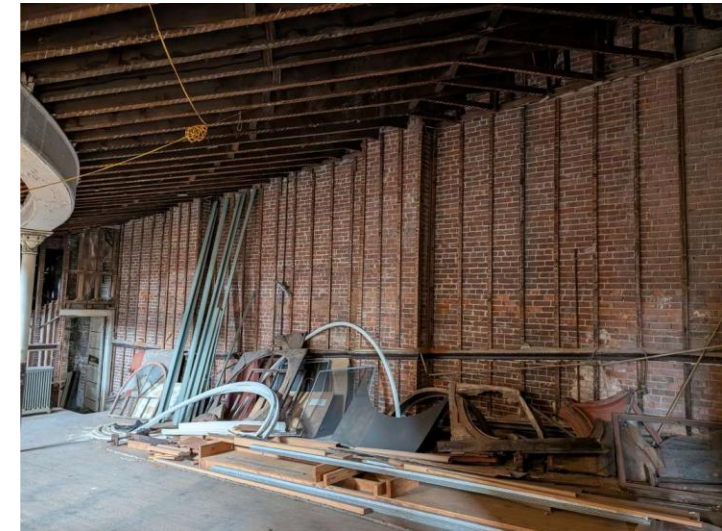
Fig. 1

- The existing conditions of the Sterling Opera House do not reflect its acoustics at its finest moments in the past, nor do they indicate the potential for its use in the future.
- The interior wall finishes are stripped in most locations (Fig. 1) and there are no operable HVAC systems contributing to its background noise conditions. To a large extent, it is a "blank slate" acoustically.
- The basic form of the facility as an intimate proscenium theater (Fig. 2) with a relatively small stagehouse offers an excellent opportunity to develop and utilize the room as a venue hosting natural acoustic performances, amplified performances, or some combination of the two.
- Historically, the theater has a reputation for its excellent natural acoustics, which is not surprising given its intimate volume and good sightlines.

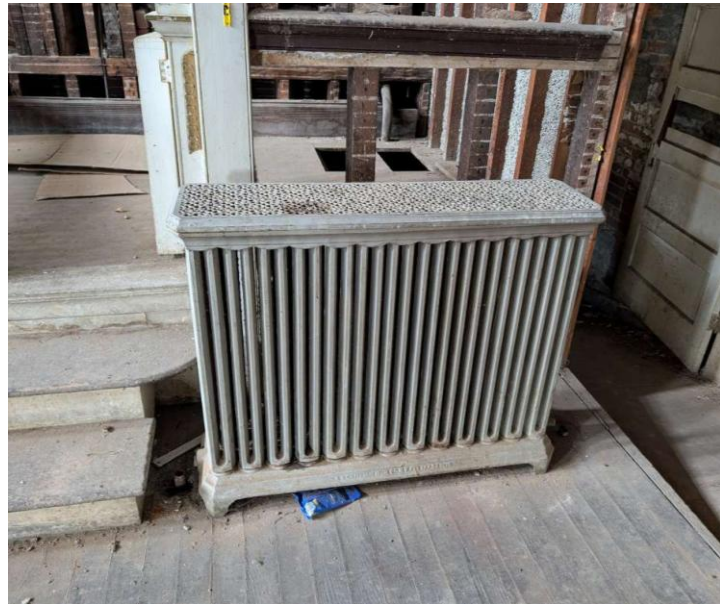
Fig. 5

The building does not appear to have any forced air ventilation. We assume that the heating was provided by steam or hot water, based on the presence of radiators within occupied areas (Fig. 5). Natural ventilation through windows and the attic void (Fig. 6) appears to be the traditional approach for cooling, and was likely satisfactory to audiences of the past century and neighbors who were not subjected to highly amplified performances. Modern comfort standards and the higher sound levels of today's amplified events will most likely lead the team to recommend some form of forced air cooling system with ducted fresh air intake and exhaust. Locating the equipment for these systems - most likely two or more air handlers plus chillers, pumps, and cooling towers - is an acoustical challenge. To the extent possible, these systems are best located in the basement or at grade and mounted on spring and neoprene vibration isolators.

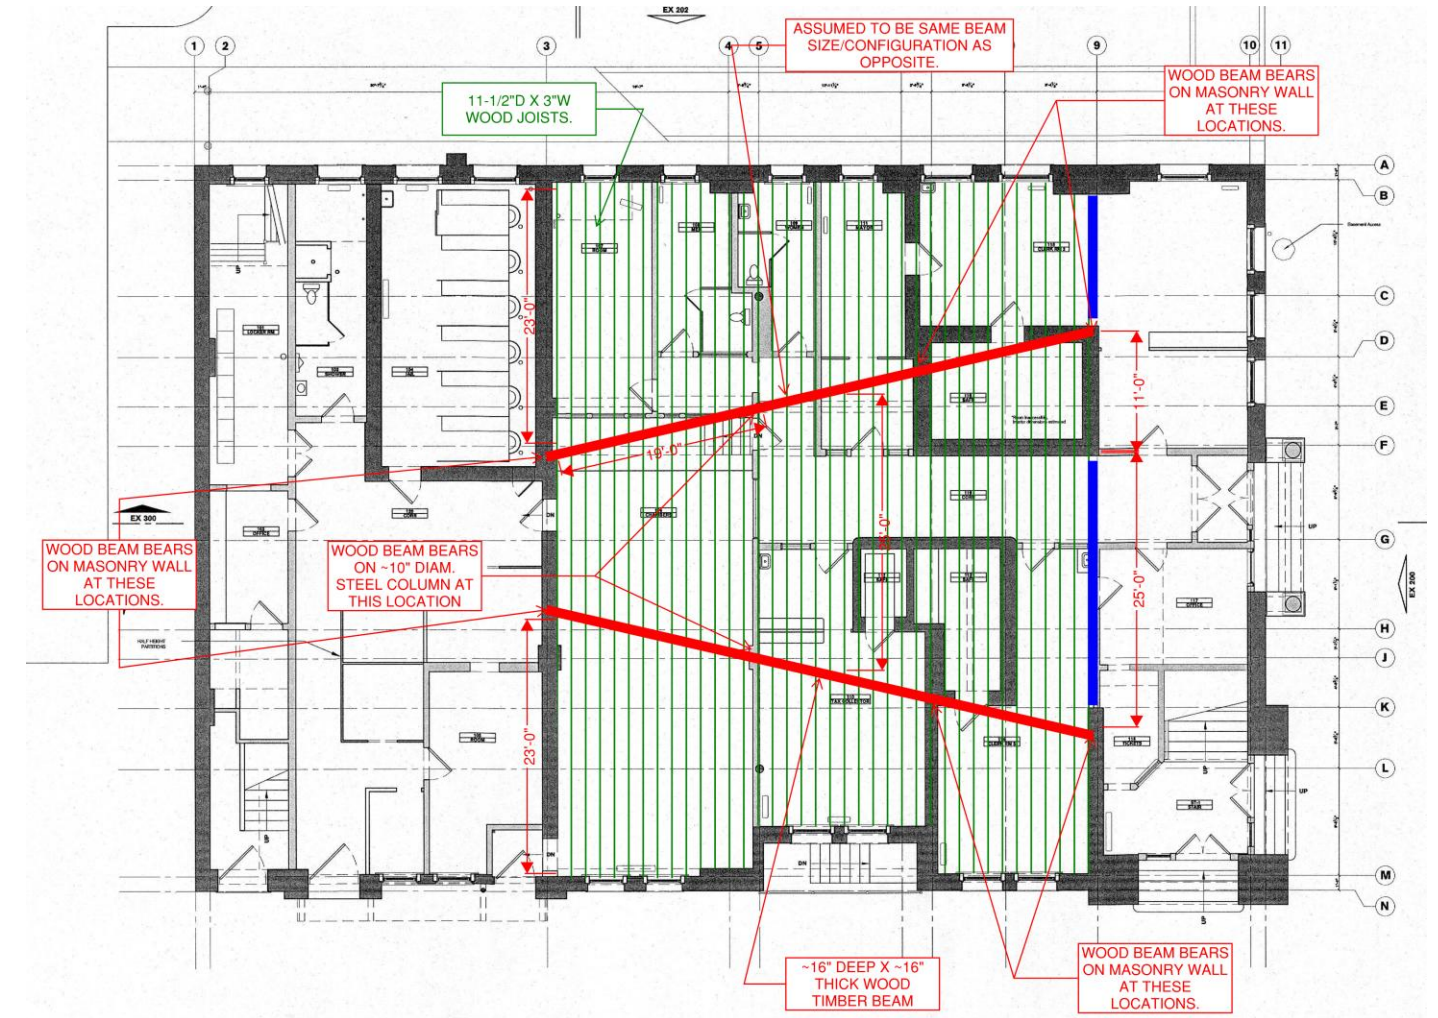
Joists exceeding 19' span are overloaded with public assembly, whereas joist exceeding 21'-6" span are overloaded with fixed seats. This overload pertains to high stresses and excessive deflections. The overloaded joists could be supported by local bearing walls or transfer beams, or they could be reinforced. Reinforcing could consist of side steel flitch plates or LVL wood side plates and through bolts installed along 60% to 70% of the length of each overloaded joist.

The wood girders are notably overloaded under public assembly load, whereas one of the three spans of each girder is overloaded with fixed seats. Like the joists, the girders can be reinforced with steel or LVL side plates along most of the length of the girder.
