- A. FLOOD DAMAGE REDUCTION SEGMENT/SYSTEM INSPECTION REPORT –  
Naugatuck River RB – Southend Ansonia, CT  
Date of Inspection – 4/22/2009 – Provided to Ansonia on February 3, 2010**

February 3, 2010

## Flood Damage Reduction Segment / System Inspection Report

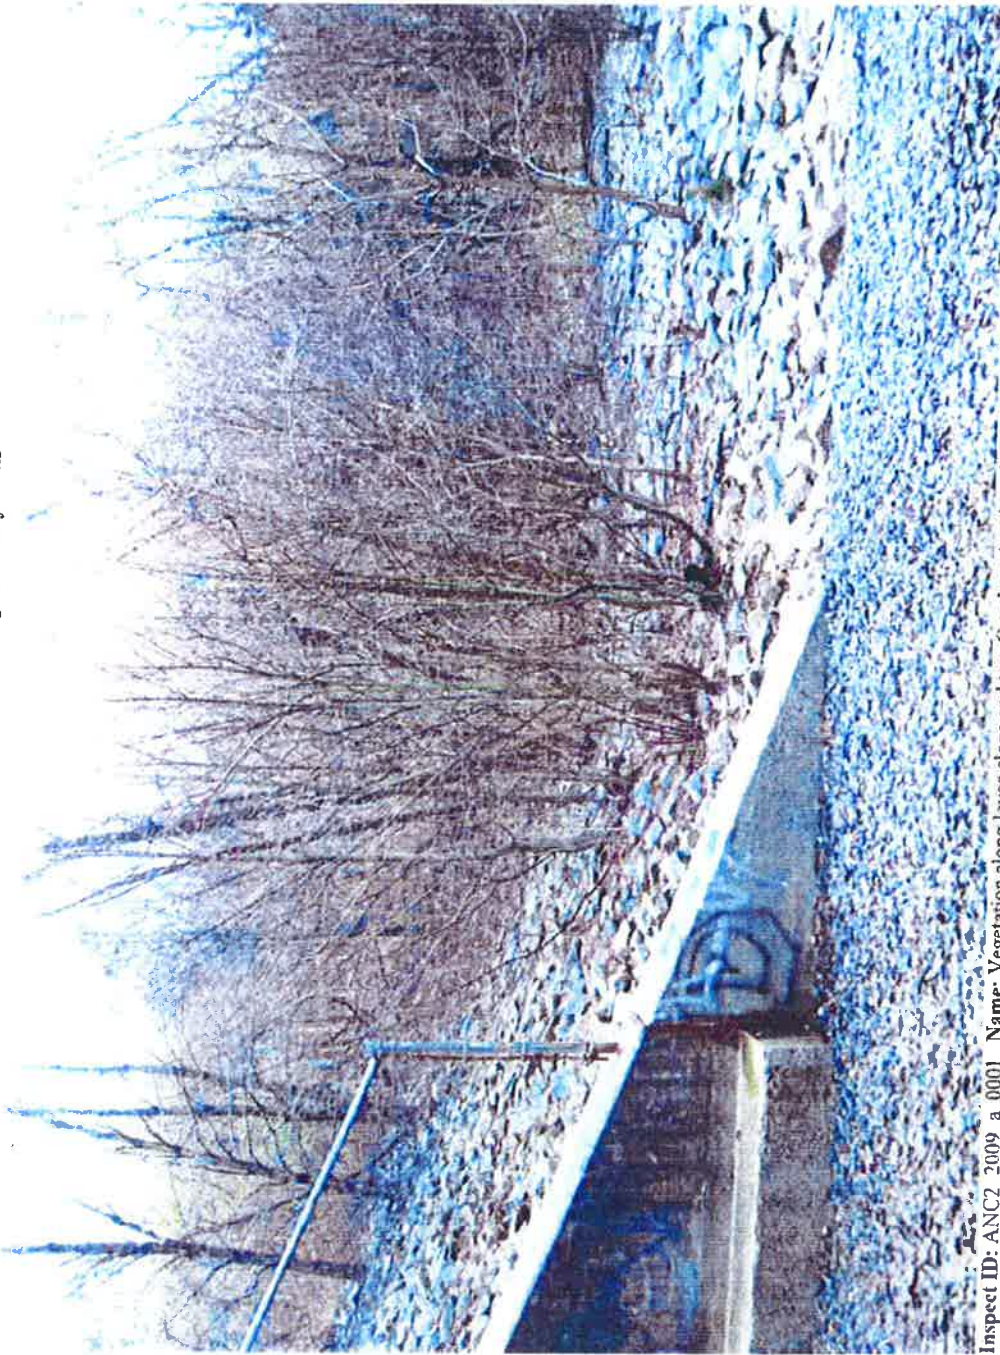
Inspect ID: ANC2\_2009\_a\_0001 Name: Vegetation along levee slope and toe Caption: Another view of vegetation on the river side of the slope.

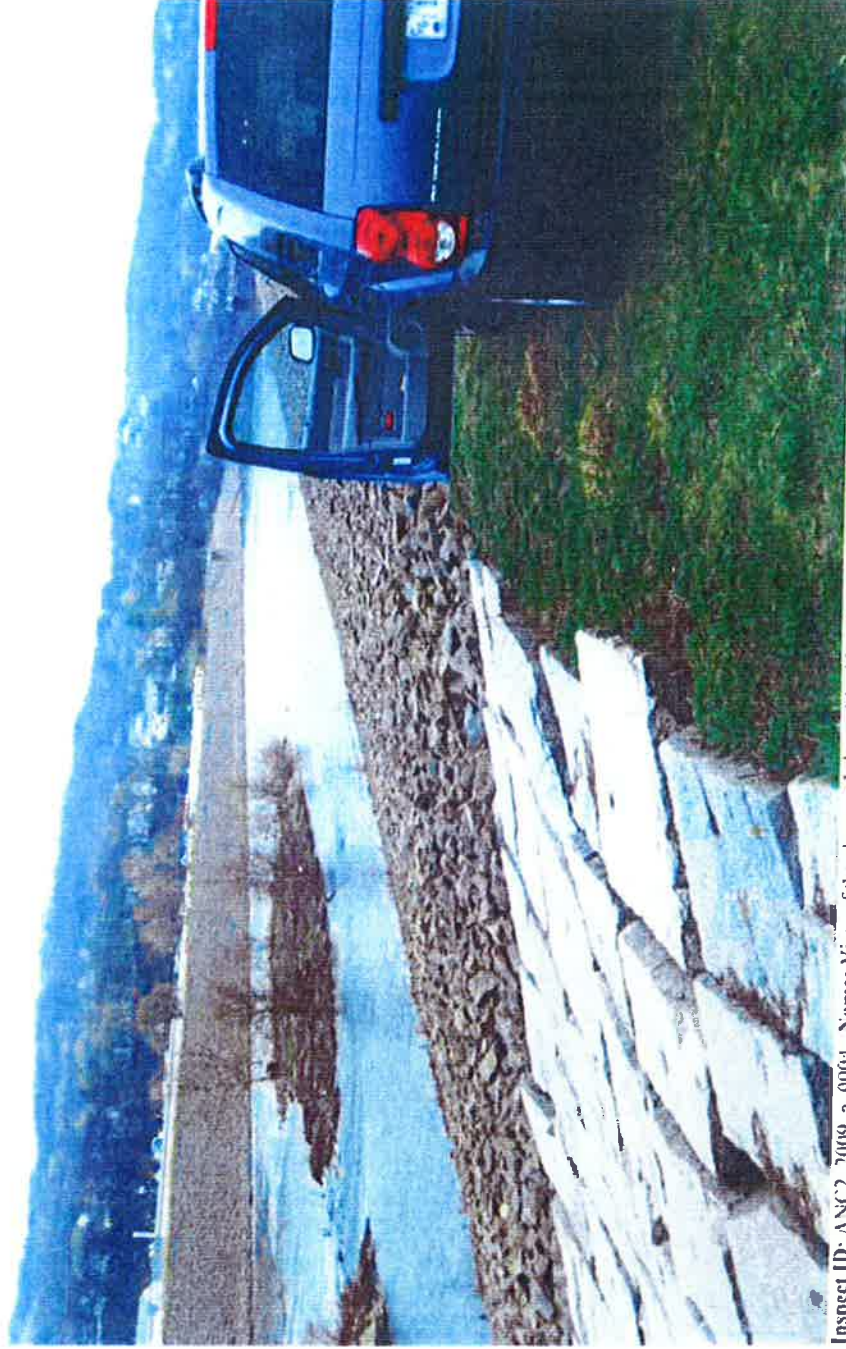
Inspect ID: ANC2\_2009\_a\_0004 Name: View of the slope and channel looking downstream Caption: View looking downstream of the riverside slope. Riprap is in good condition.

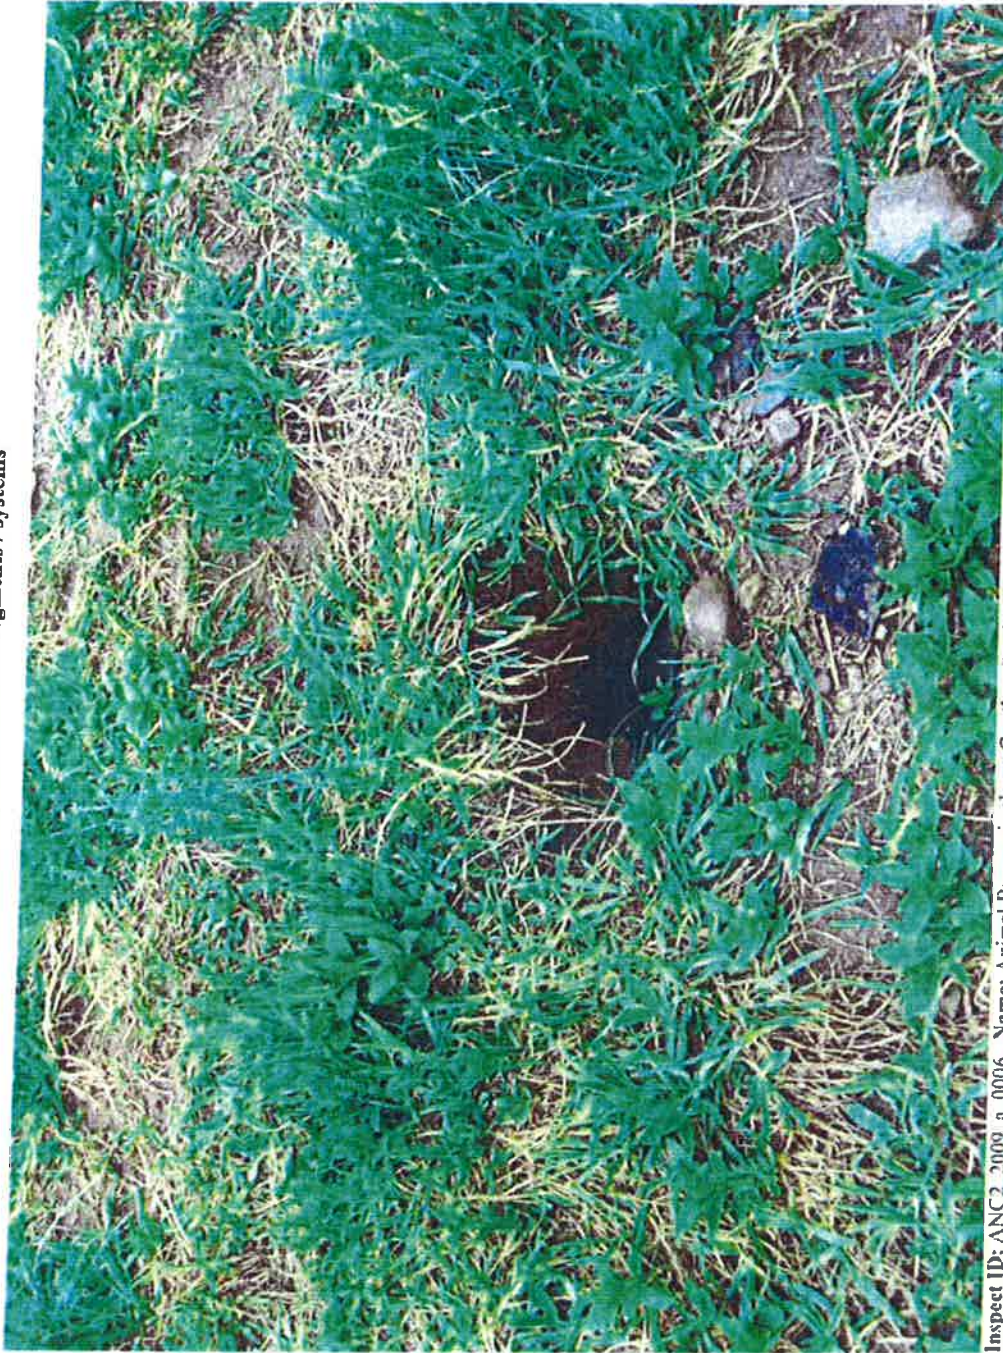
Inspect ID: ANC2\_2009\_a\_0006 Name: Animal Burrow in slope Caption: Typical burrow noted along this segment of levee.

- Numerous animal burrows were noted along the length of the levee. These need to be excavated and backfilled within six months.
- The access cover plates to the gate well of Sluice Gate #7 are missing, posing a significant safety hazard. New cover plates should be installed prior to September 1, 2010.

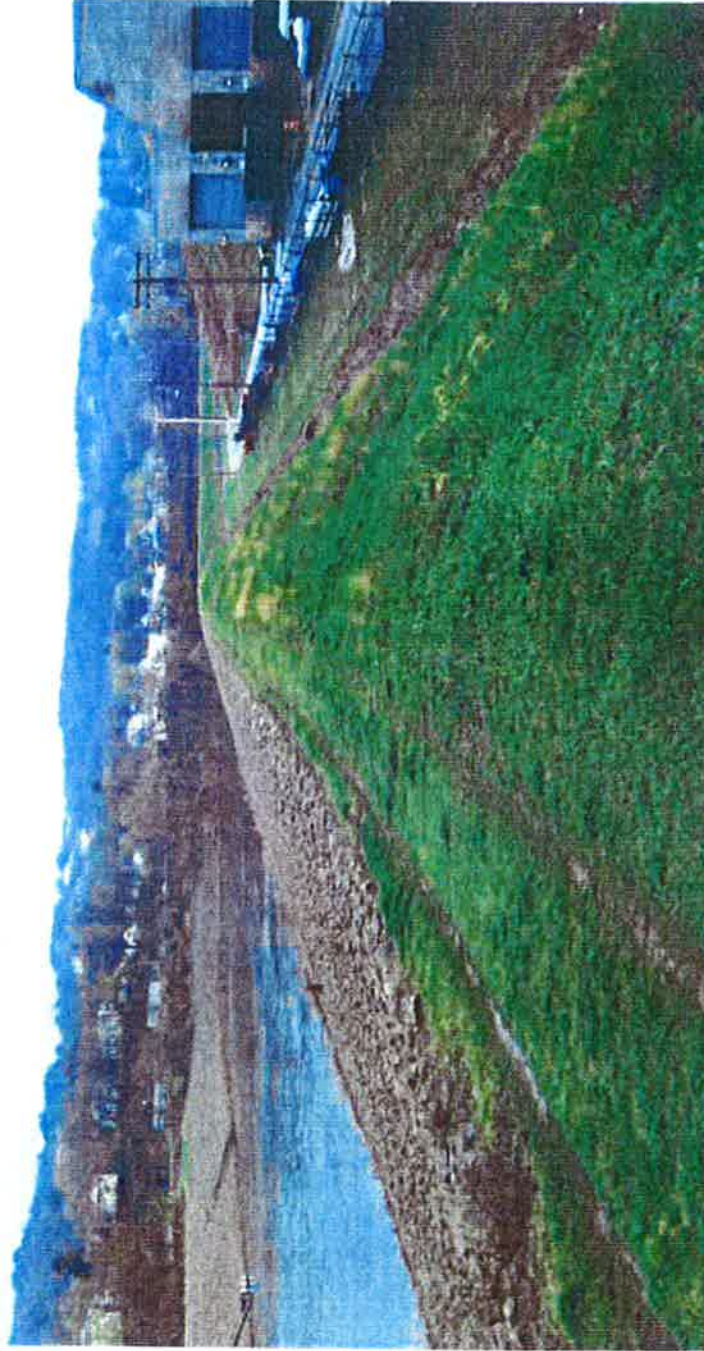
Inspect ID: ANC2\_2009\_a\_0010 Name: Levee looking downstream showing minor rutting from patrol vehicles.

- Minor rutting from patrol vehicles was noted along the levee crown. This should be monitored and repaired if the condition degrades.

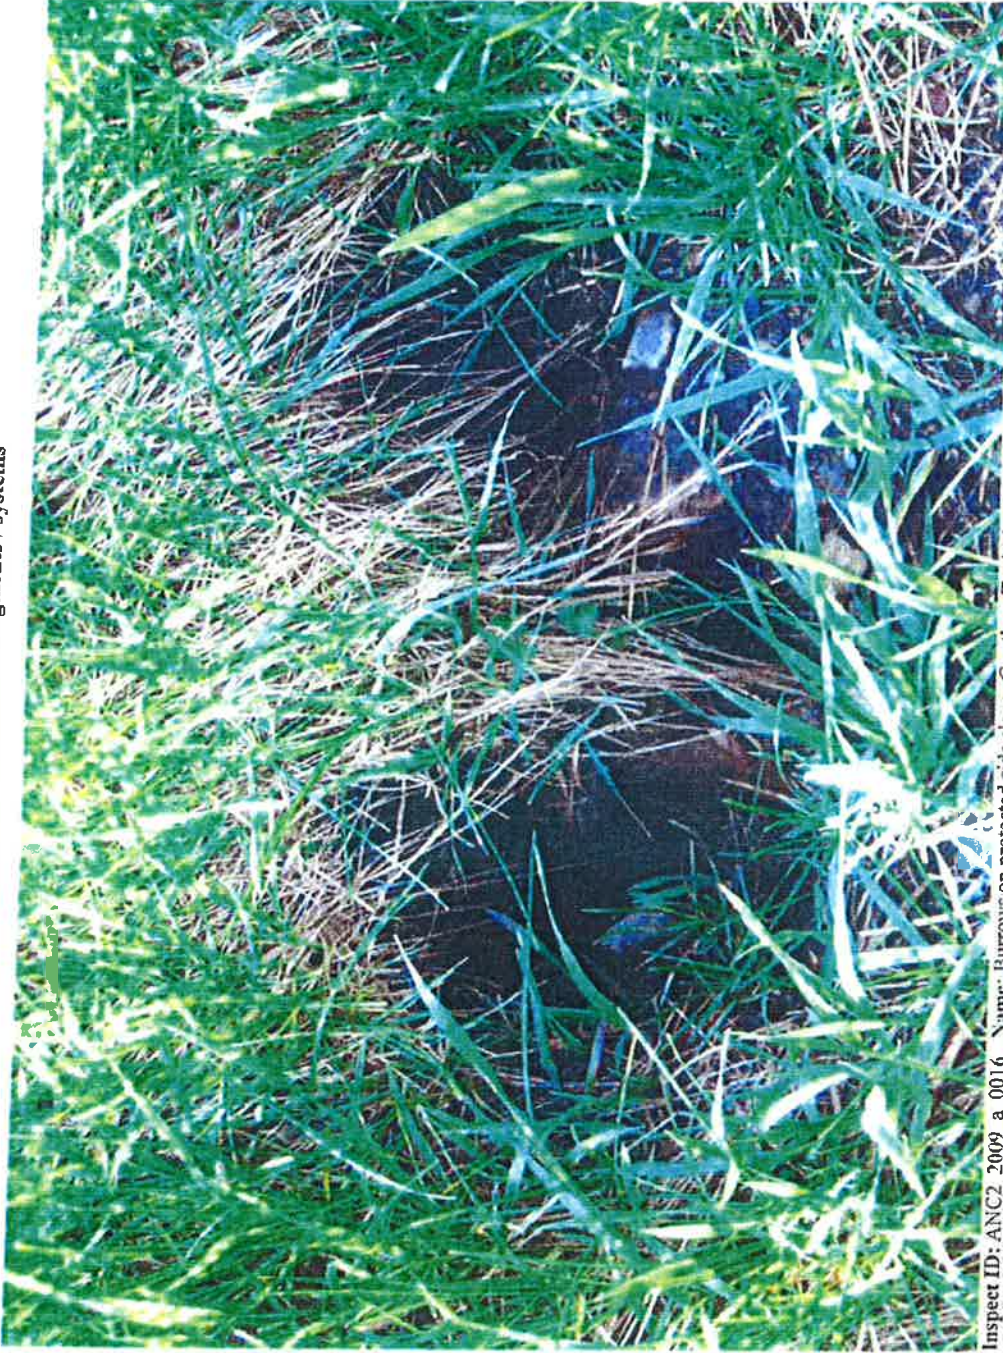
Inspect ID: ANC2\_2009\_a\_0016 Name: Burrows on protected side slope Caption: Typical animal burrows found along this segment of the levee.

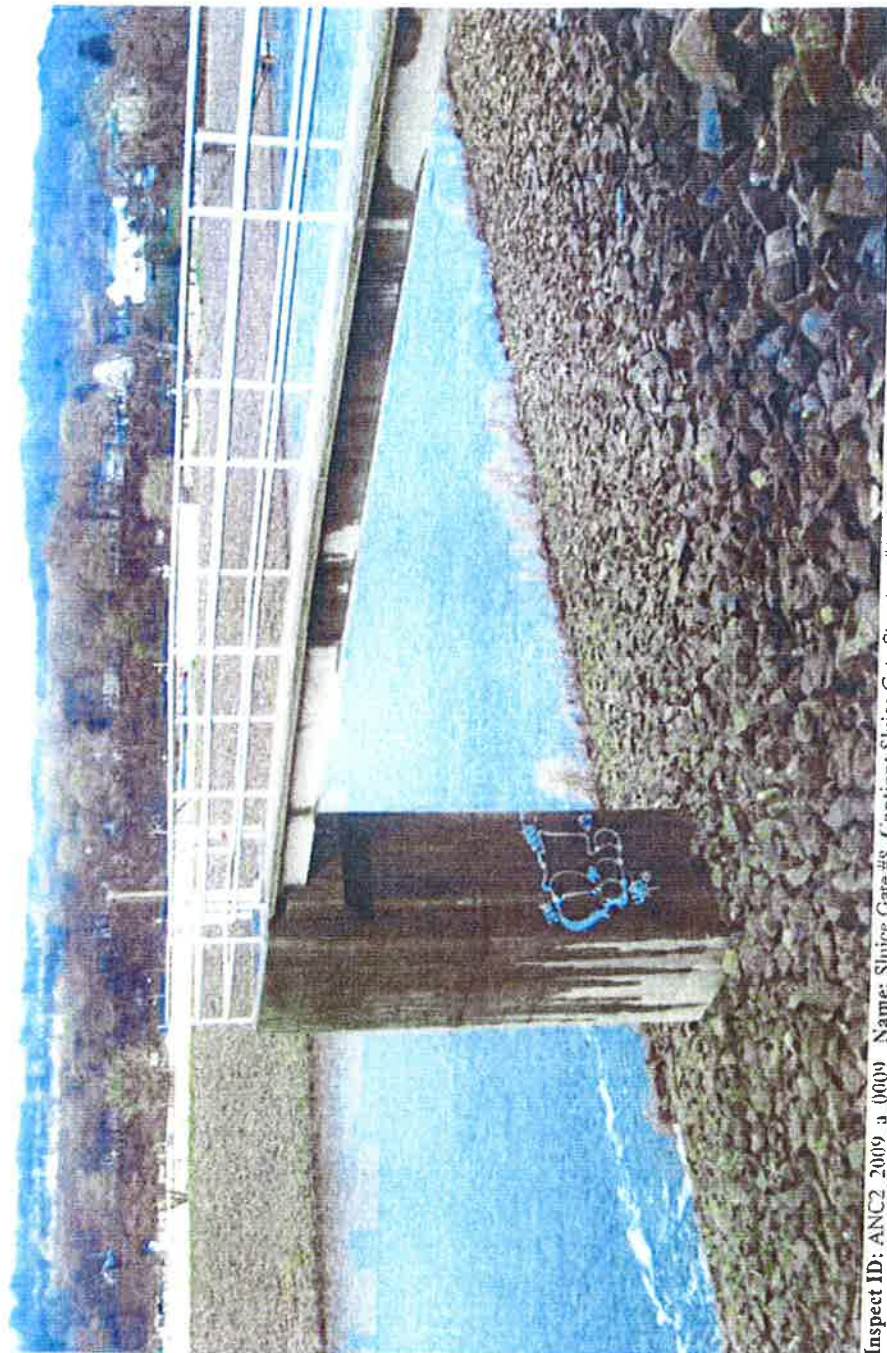
Inspect ID: ANC2\_2009\_a\_0009 Name: Sluice Gate #8 Caption: Sluice Gate Structure #8. Gate structure is in good condition.

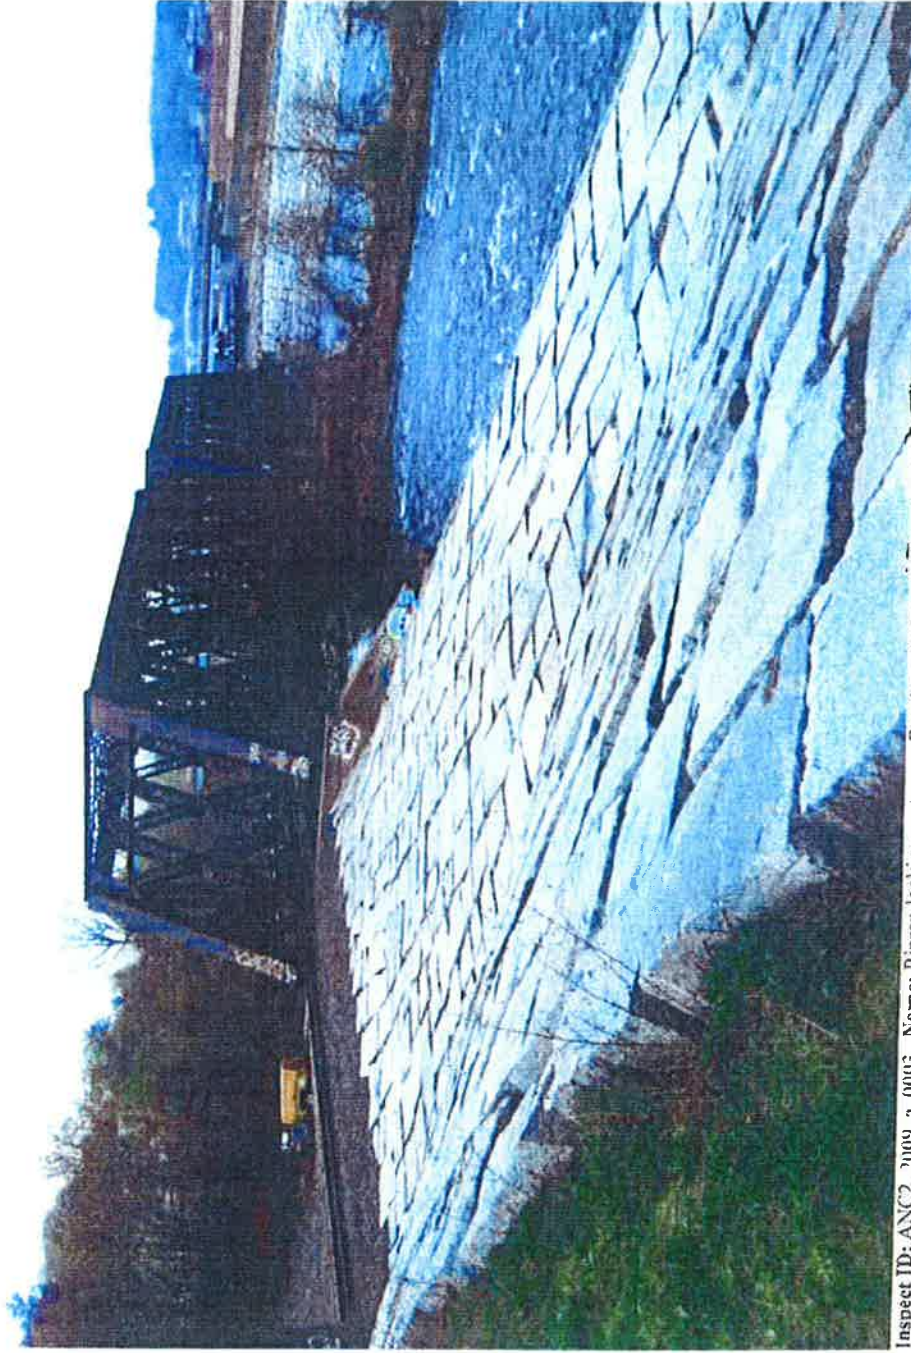
Inspect ID: ANC2\_2009\_a\_0003 Name: Riprap looking upstream Caption: A view showing the placed riprap adjacent to the rail bridge. Riprap is in good condition.

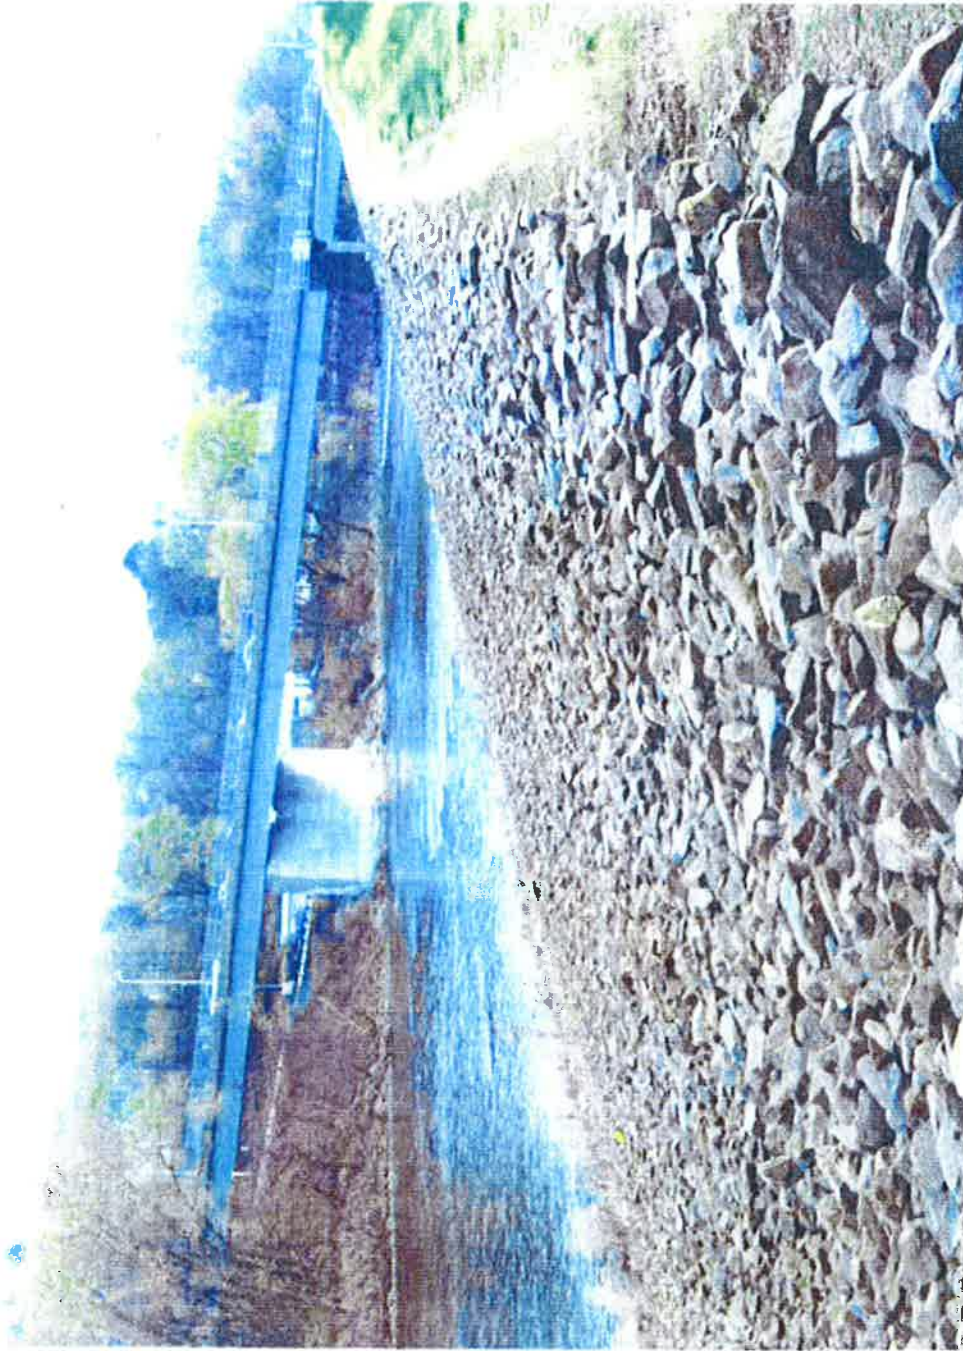
Inspect ID: ANC2\_2009\_a\_0012 Name: View of Riverside looking downstream Caption: View showing the riverside riprap. Riprap is in good condition.

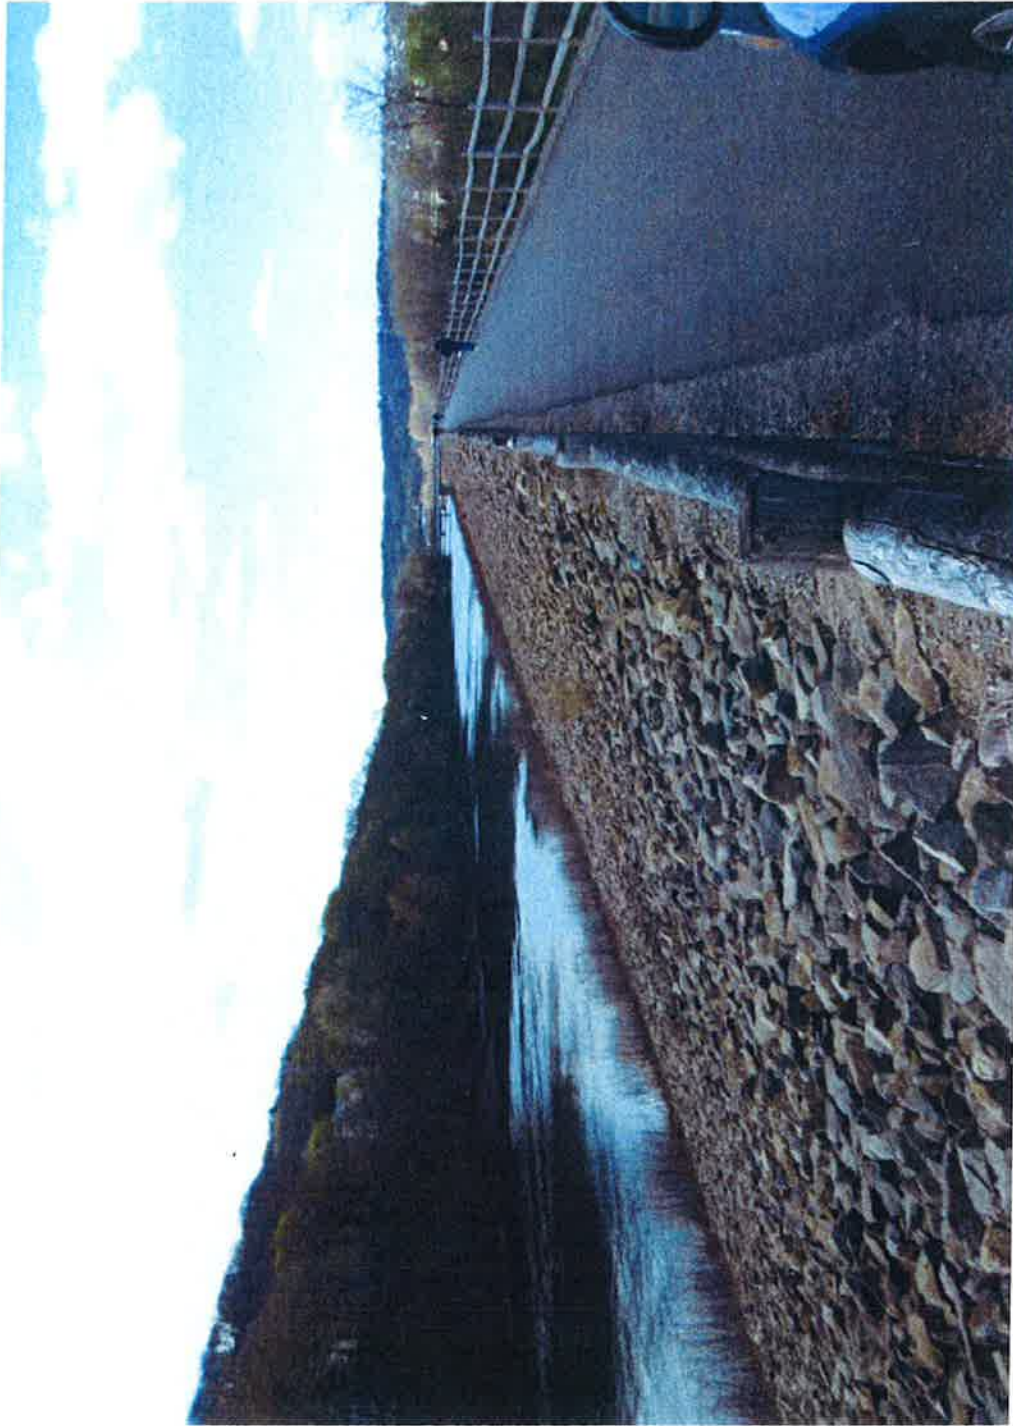
Inspect ID: NRDB\_2009\_a\_0001 Name: Start of Derby Segment Caption: View looking downstream at the start of the Derby segment showing the paved trail along the crest of the levee.

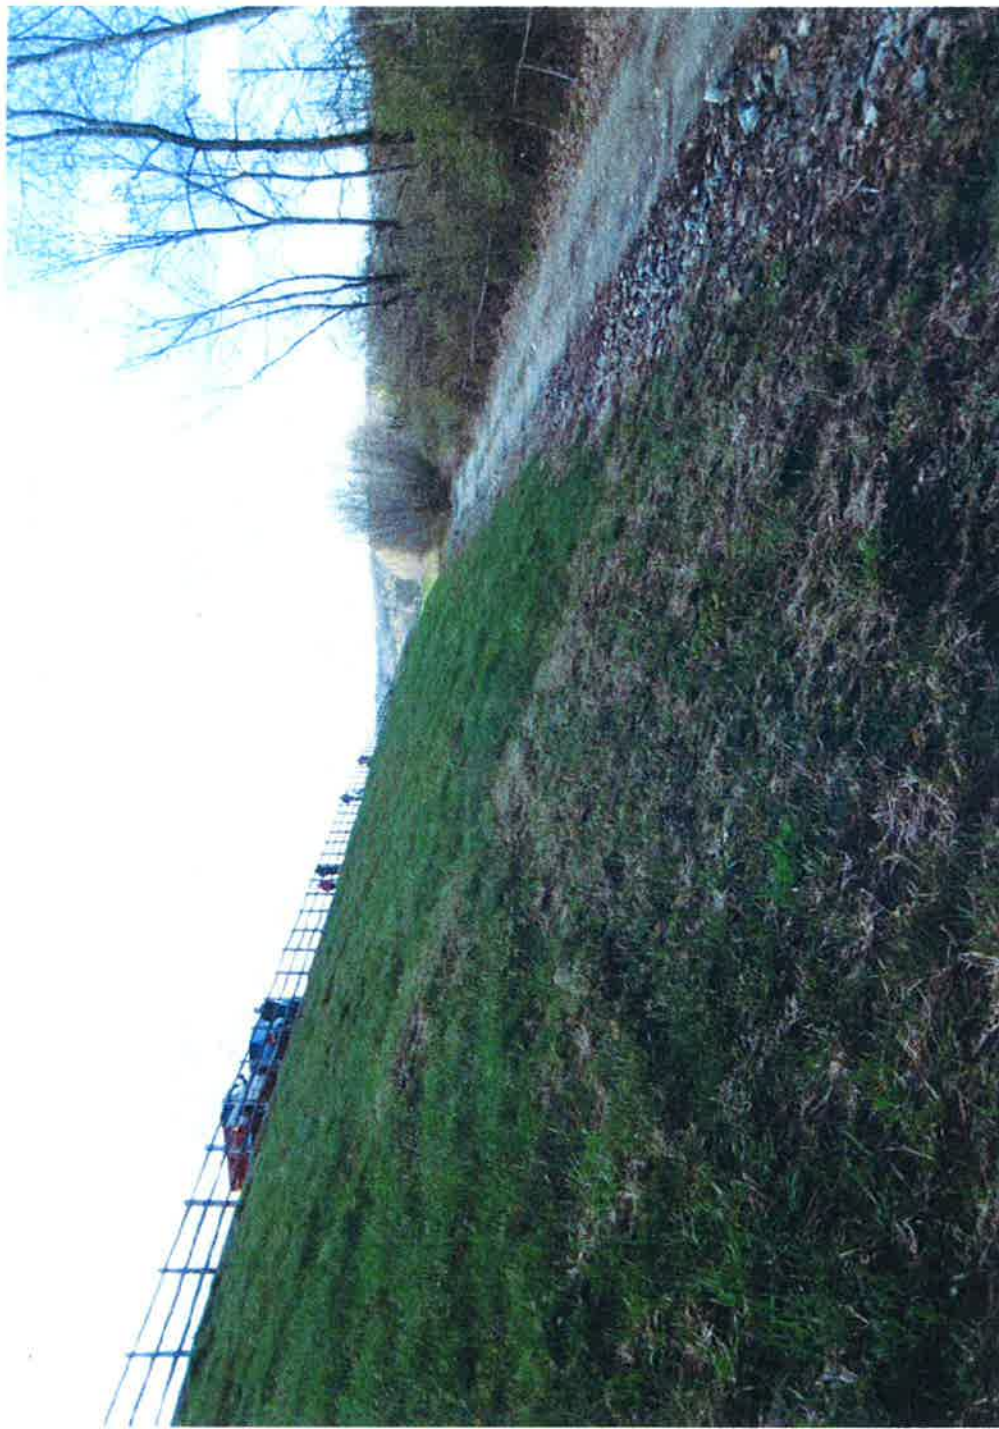
Inspect ID: NRDB\_2009\_a\_0002 Name: Protected Side Slope Caption: View showing the protected side slope. Slope is well maintained and in good condition.

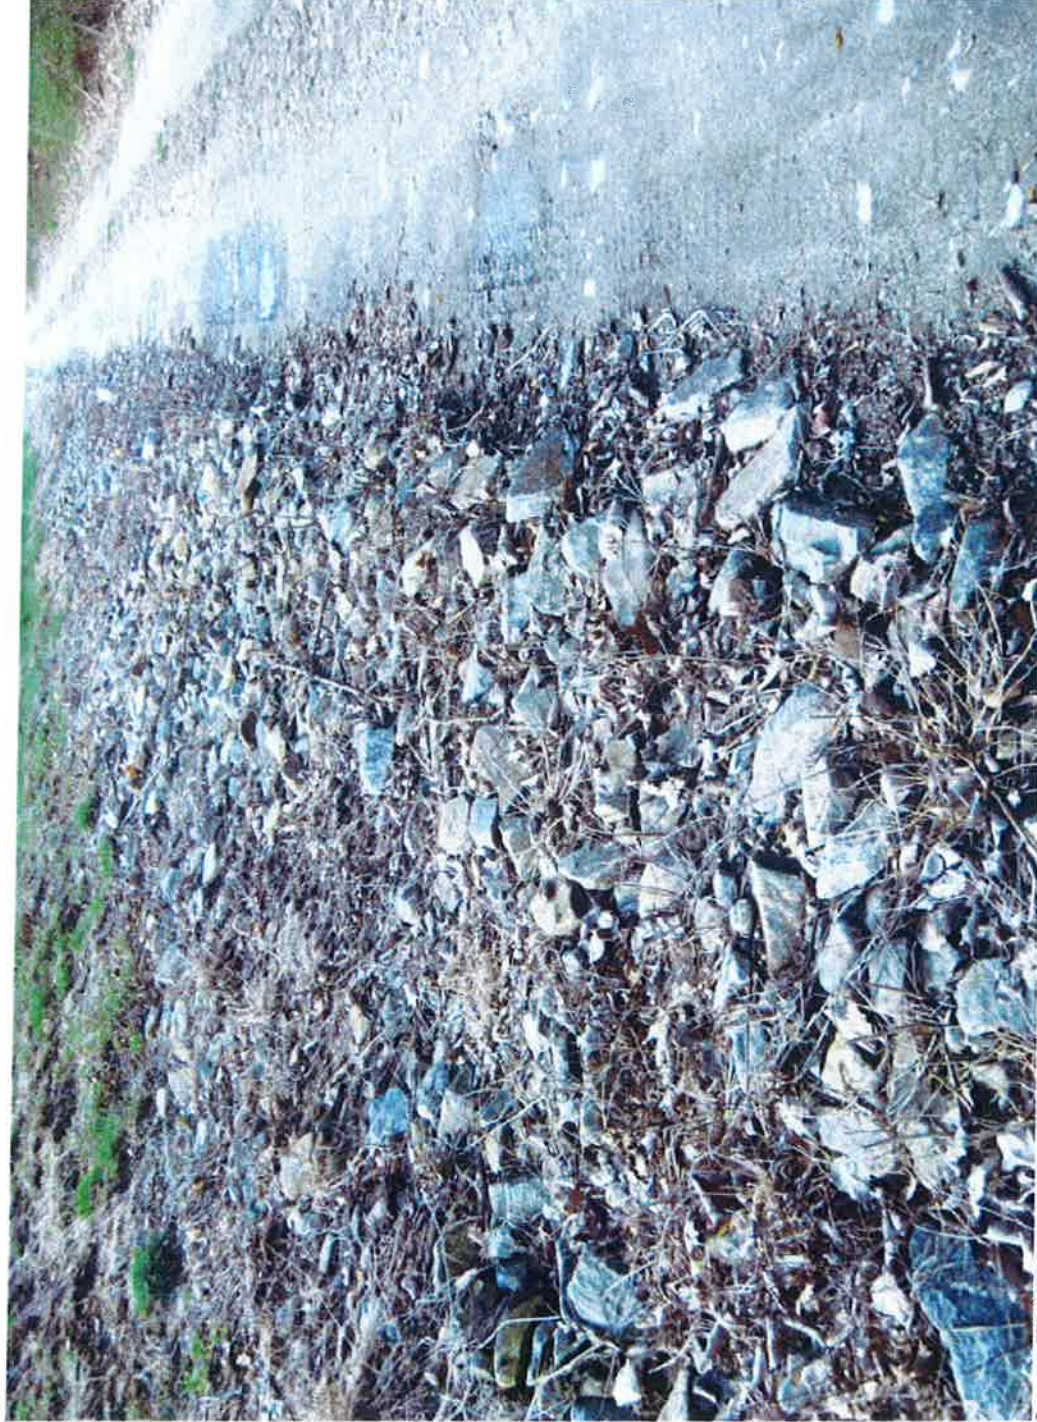
Inspect ID: NRDB\_2009\_a\_0003 Name: Toe Drain Caption: Closeup of the toe drain showing vegetation and debris build up.

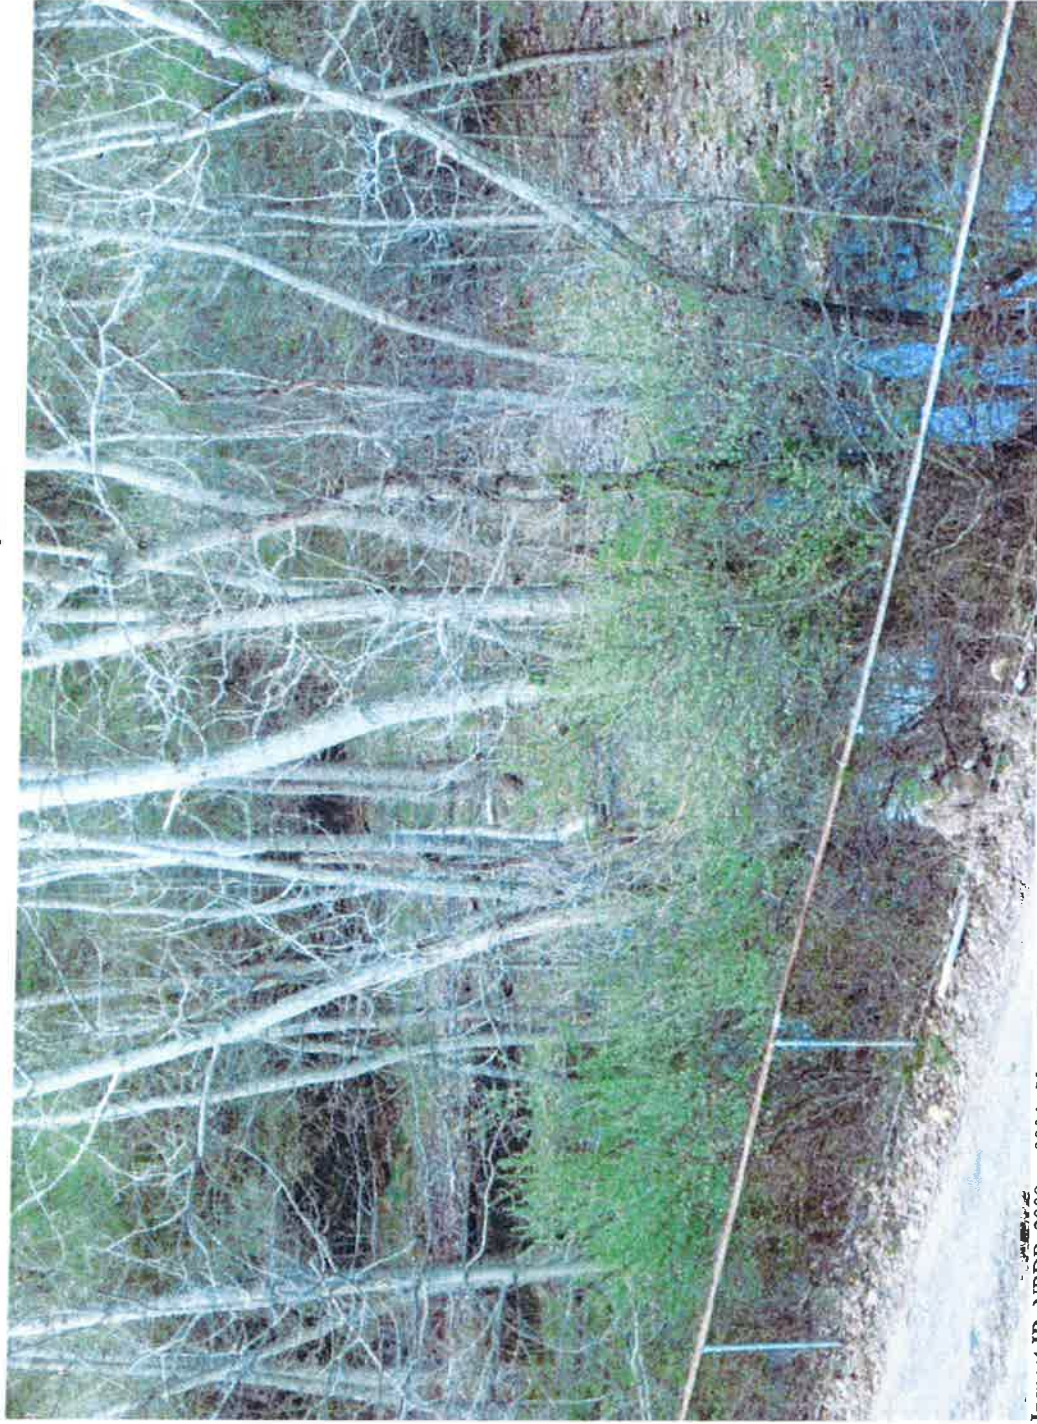
Inspect ID: NRDB\_2009\_a\_0004 Name: EXisting pond, protected side Caption: View of an existing pond adjacent to the levee. Note the significant vegetation. Vegetation should be cleared to allow pond to be observed during periods of high water.

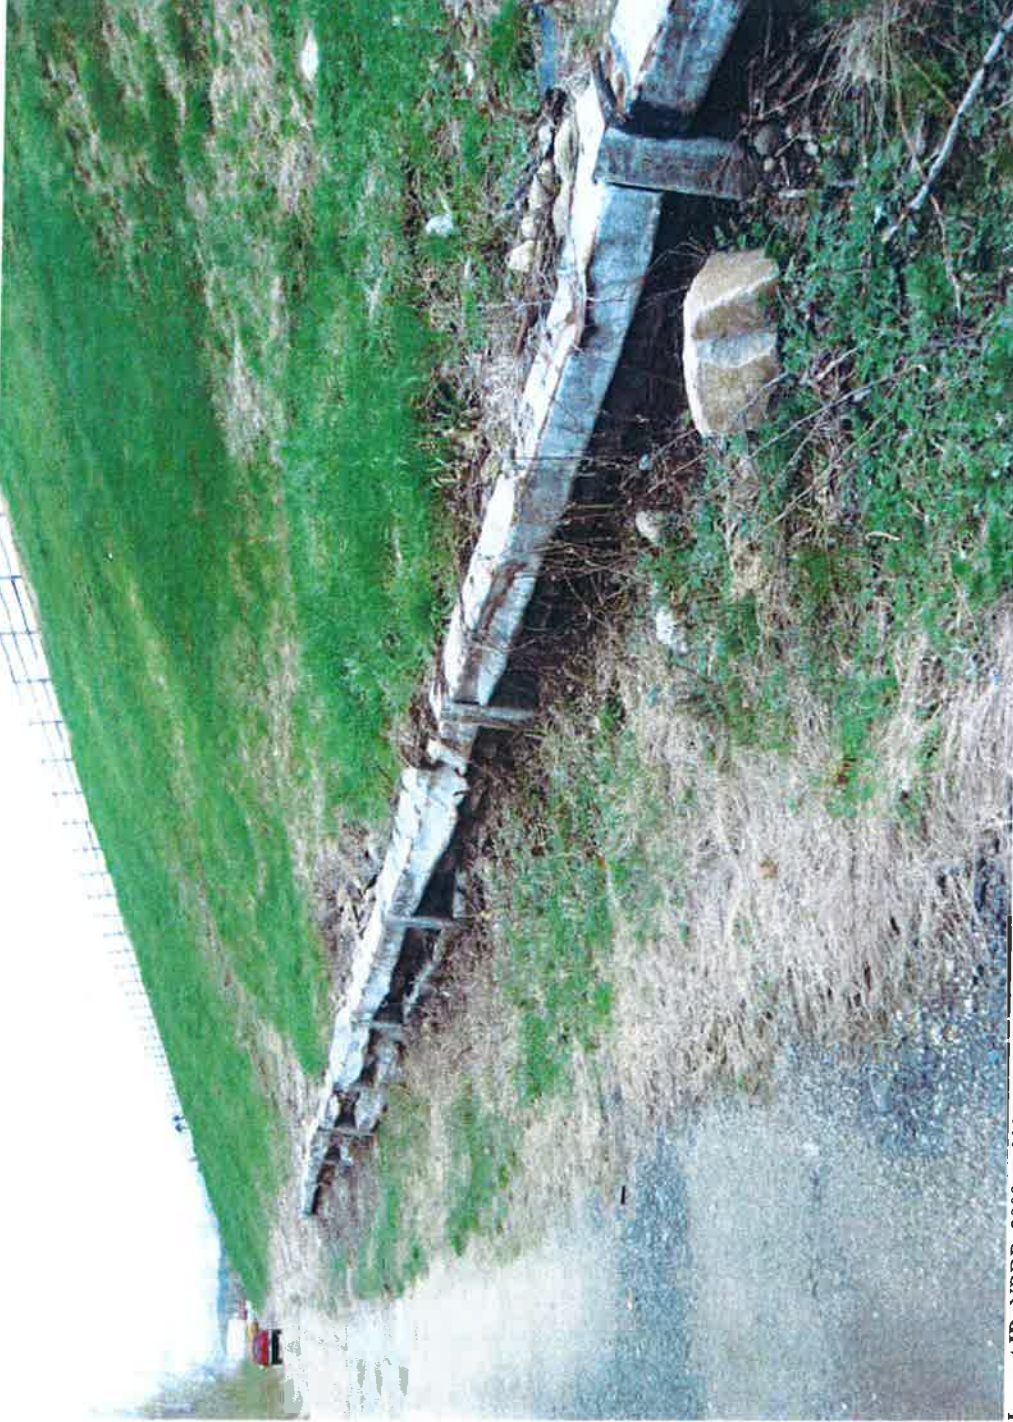
**Inspect ID:** NRDB\_2009\_a\_0005 **Name:** Retaining wall **Caption:** Metal bin retaining wall. Wall is in fair to poor condition. It appears to have suffered numerous collisions from vehicular traffic, possibly from plows or mowers.

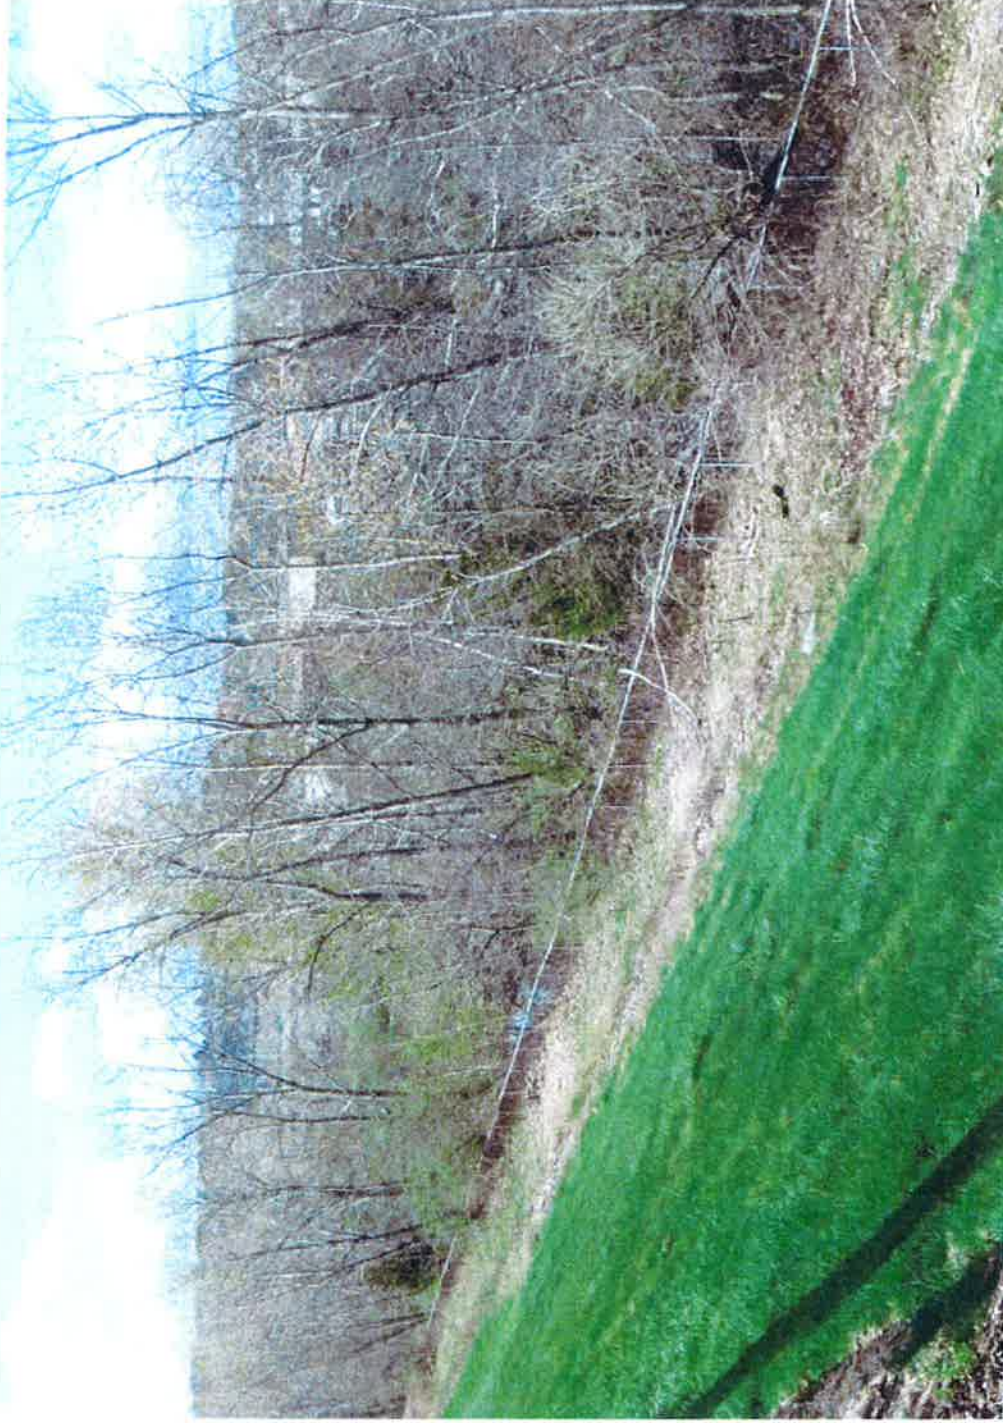
**Inspect ID:** NRDB\_2009\_a\_0009 **Name:** View of the slope looking downstream **Caption:** View showing the heavy vegetation adjacent to the toe blocking view of the wet areas adjacent to the toe.

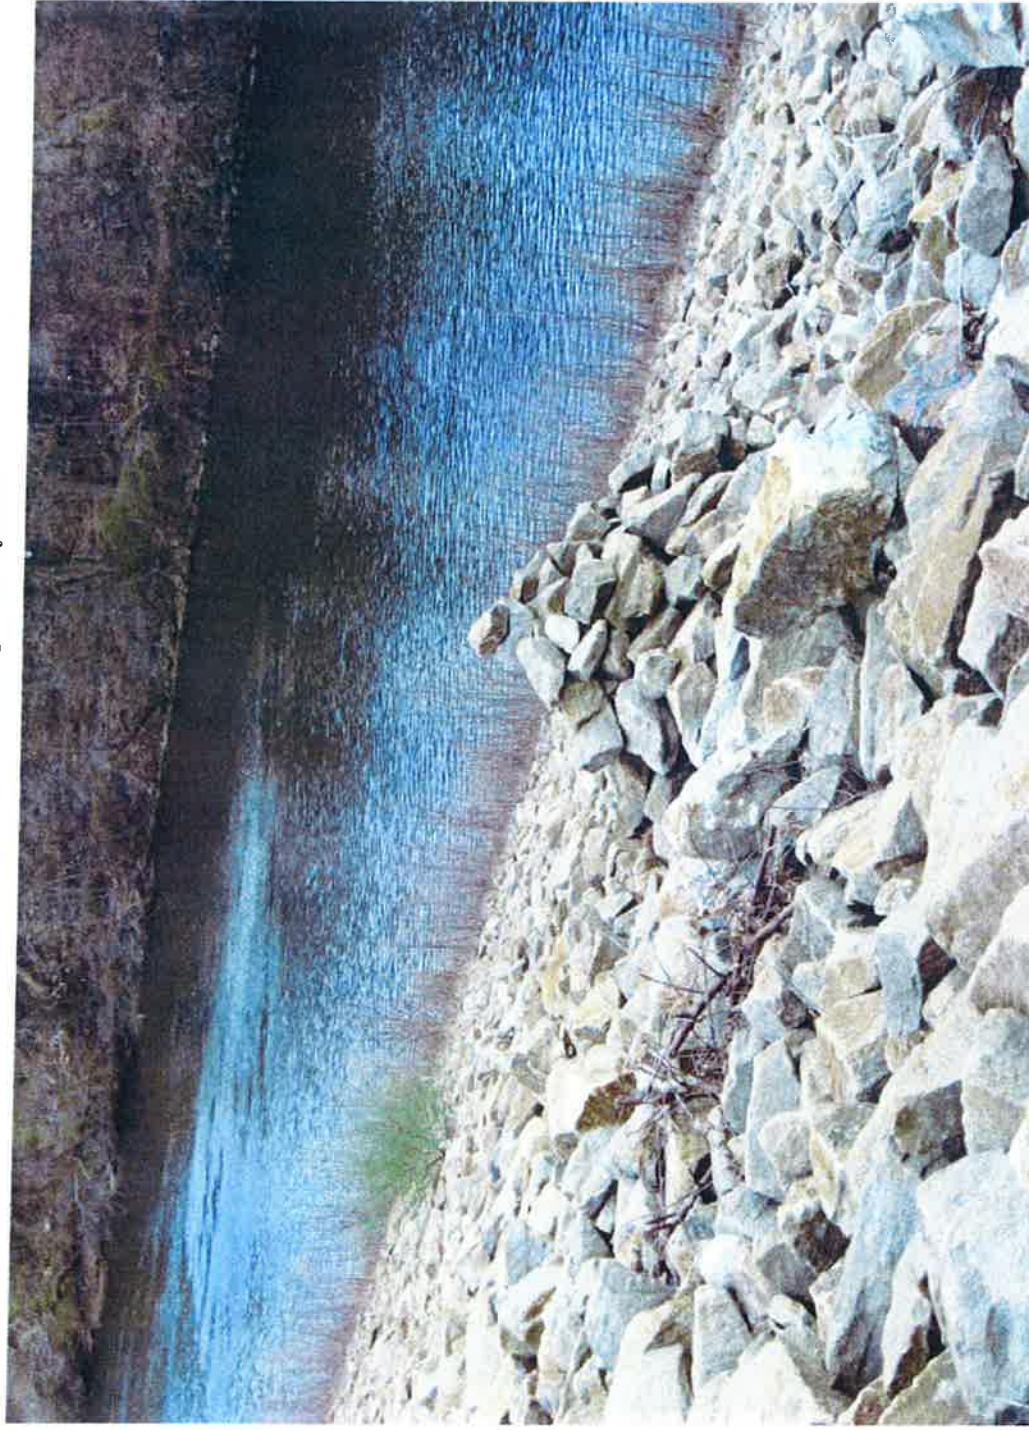
**Inspect ID:** NRDB\_2009\_a\_0010 **Name:** Displaced Riprap **Caption:** View of one of the cairns built out of displaced riprap. These should be removed and the riprap replaced along the slope.

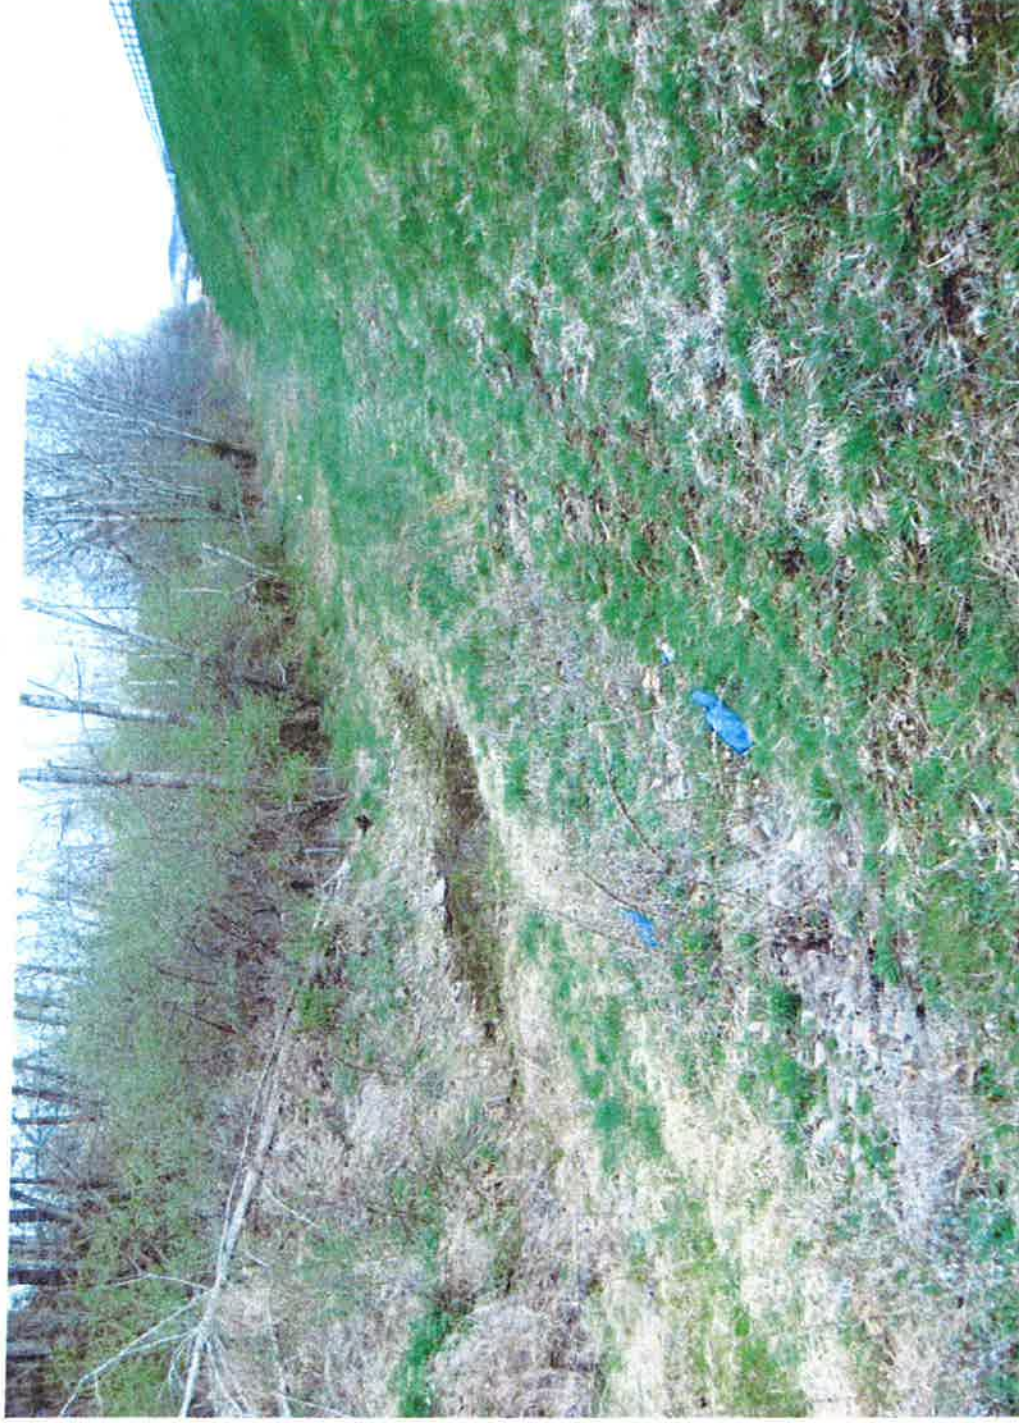
**Inspect ID:** NRDB\_2009\_a\_0011 **Name:** Ponding areas at levee toe **Caption:** View of the wet areas along this section of the toe. These need to be further investigated to determine if these are caused by failure of the toe drain and relief wells, or if they are possibly due to seepage.
