- A. FLOOD DAMAGE REDUCTION SEGMENT/SYSTEM INSPECTION REPORT –  
Naugatuck River RB – Southend Ansonia, CT  
Date of Inspection – 4/22/2009 – Provided to Ansonia on February 3, 2010**

February 3, 2010

## Flood Damage Reduction Segment / System Inspection Report

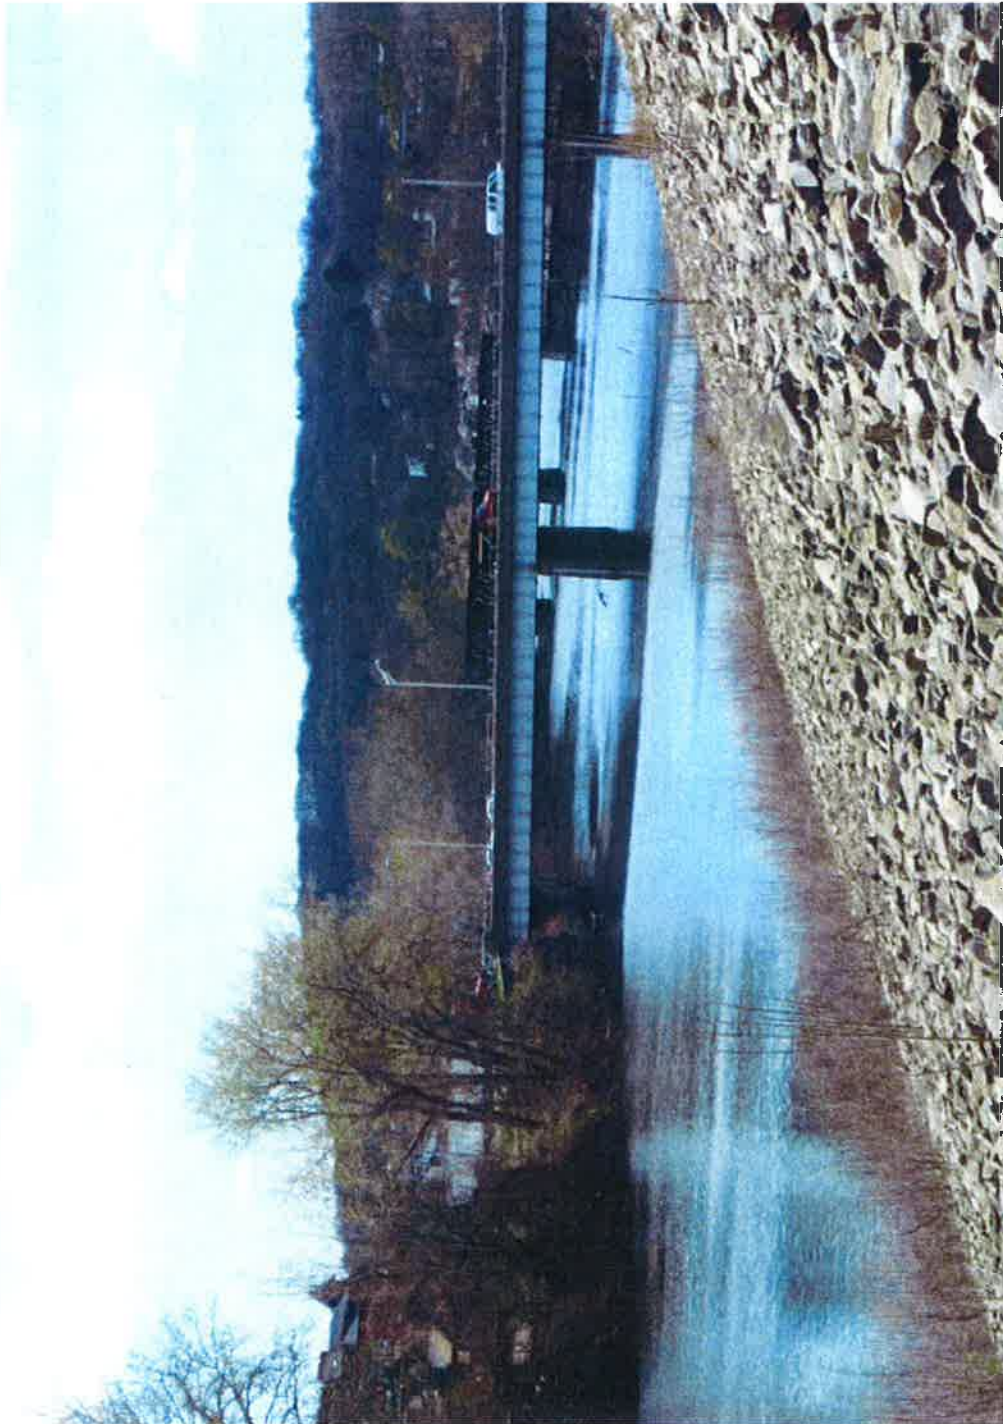
Inspect ID: NRDB\_2009\_a\_0012 Name: River side looking downstream Caption: View of the riprap looking downstream. Note the minor vegetation along the channel bank.

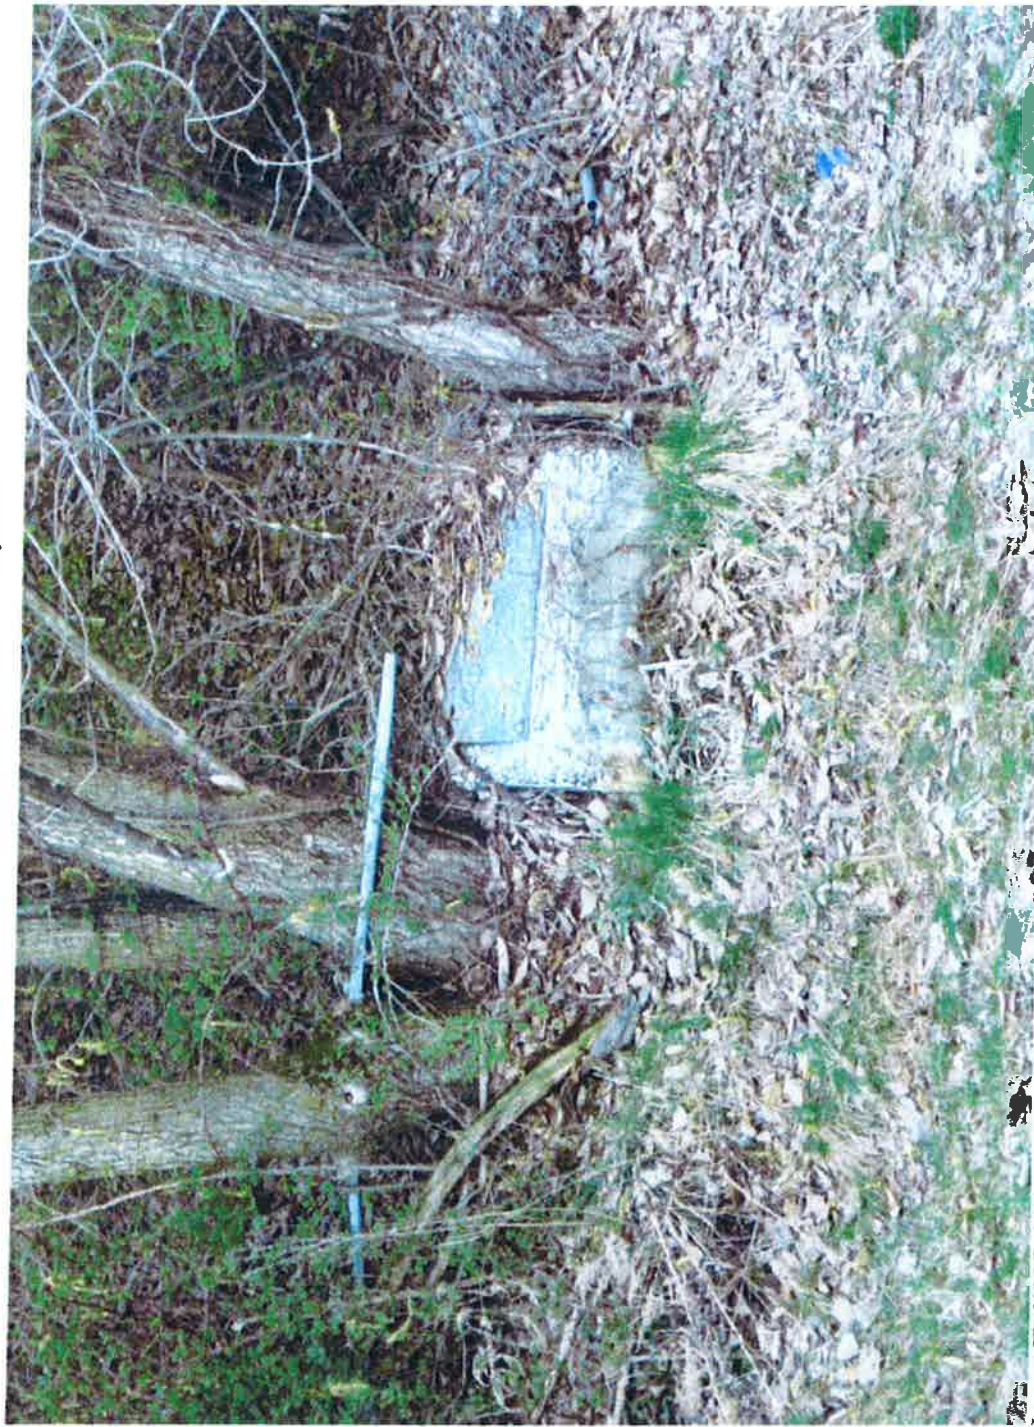
Inspect ID: NRDB\_2009\_a\_0013 Name: Relief Well # 4 Caption: View of what appears to be Relief Well # 4. The trees growing next to it need to be cleared and the well inspected to determine if it is still functioning properly.

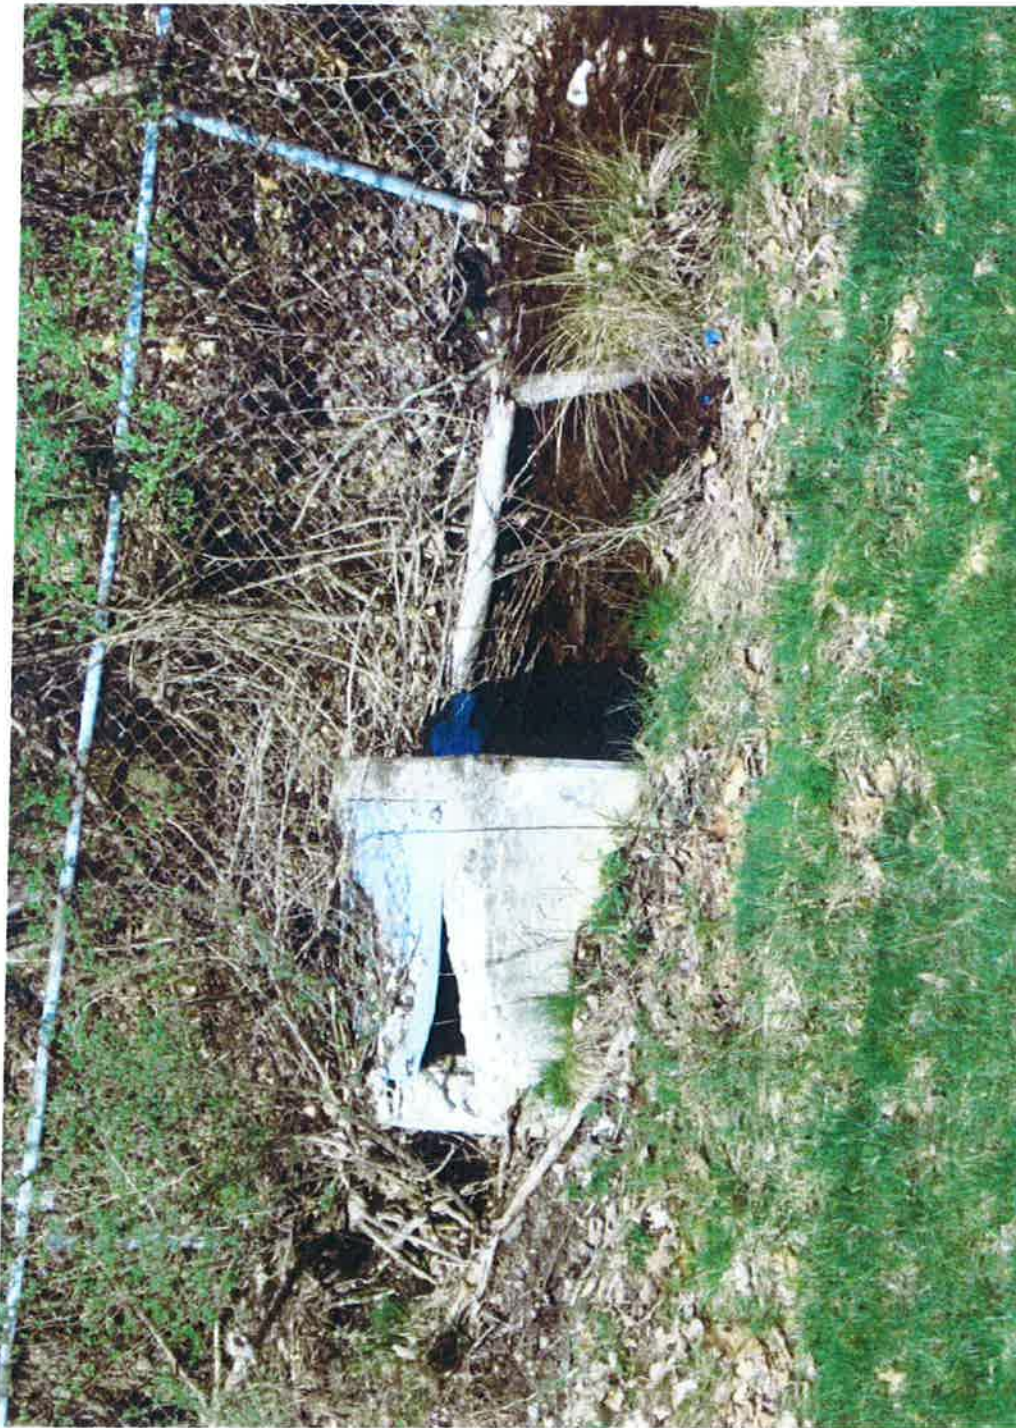
**Inspect ID:** NRDB\_2009\_a\_0013 **Name:** Relief Well # 1 **Caption:** View of what is believed to be Relief Well # 1. Structure is in poor condition and there is significant water ponding around the base of the structure. Structure needs to be repaired and the well inspected to determine if it is still functioning properly.

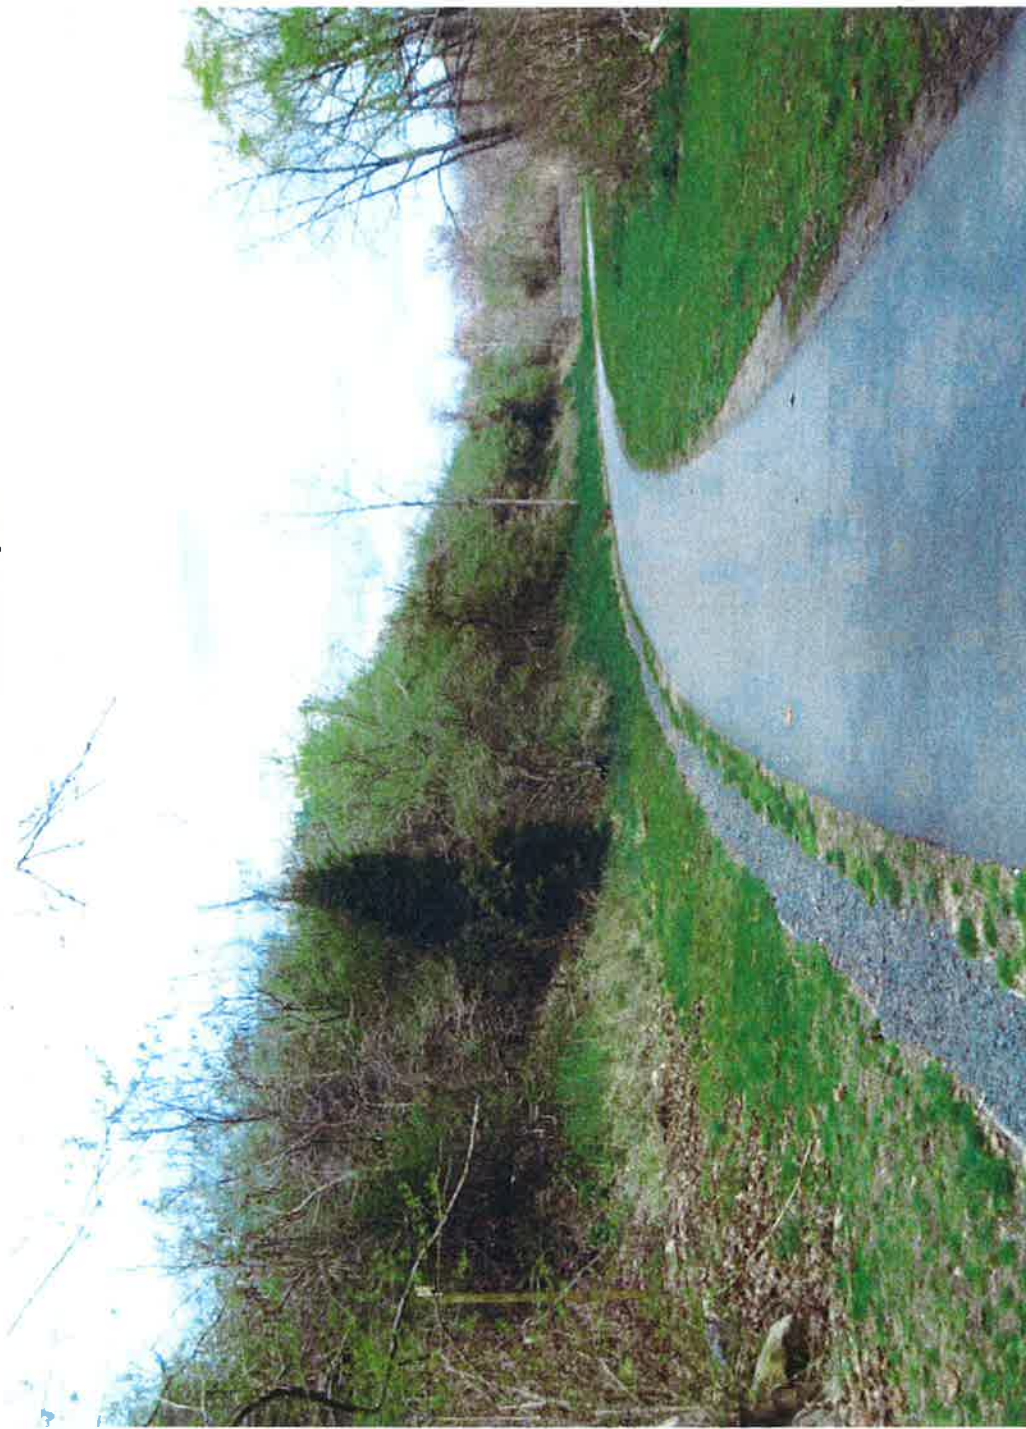
**Inspect ID:** NRDB\_2009\_a\_0033 **Name:** RT 8 Embankment **Caption:** View of the RT 8 Embankment looking upstream. Note the heavy vegetation growing on the slope, potentially compromising the impervious layer.

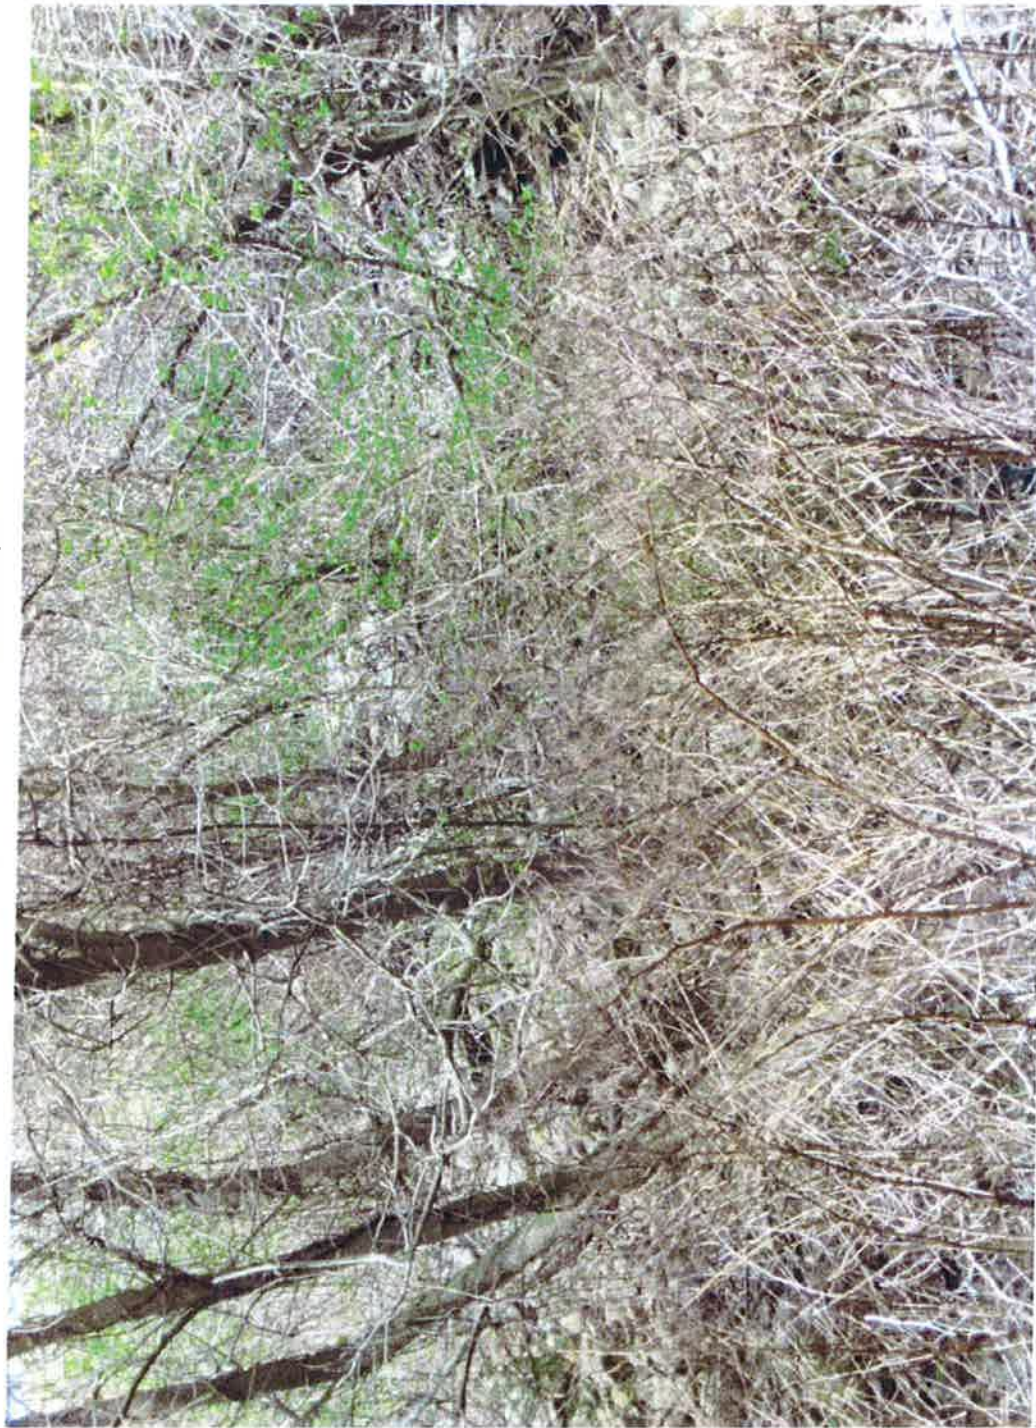
Inspect ID: NRDB\_2009\_a\_0034 Name: RT 8 Embankment Caption: Closeup showing the dense vegetation growing on the embankment slope.

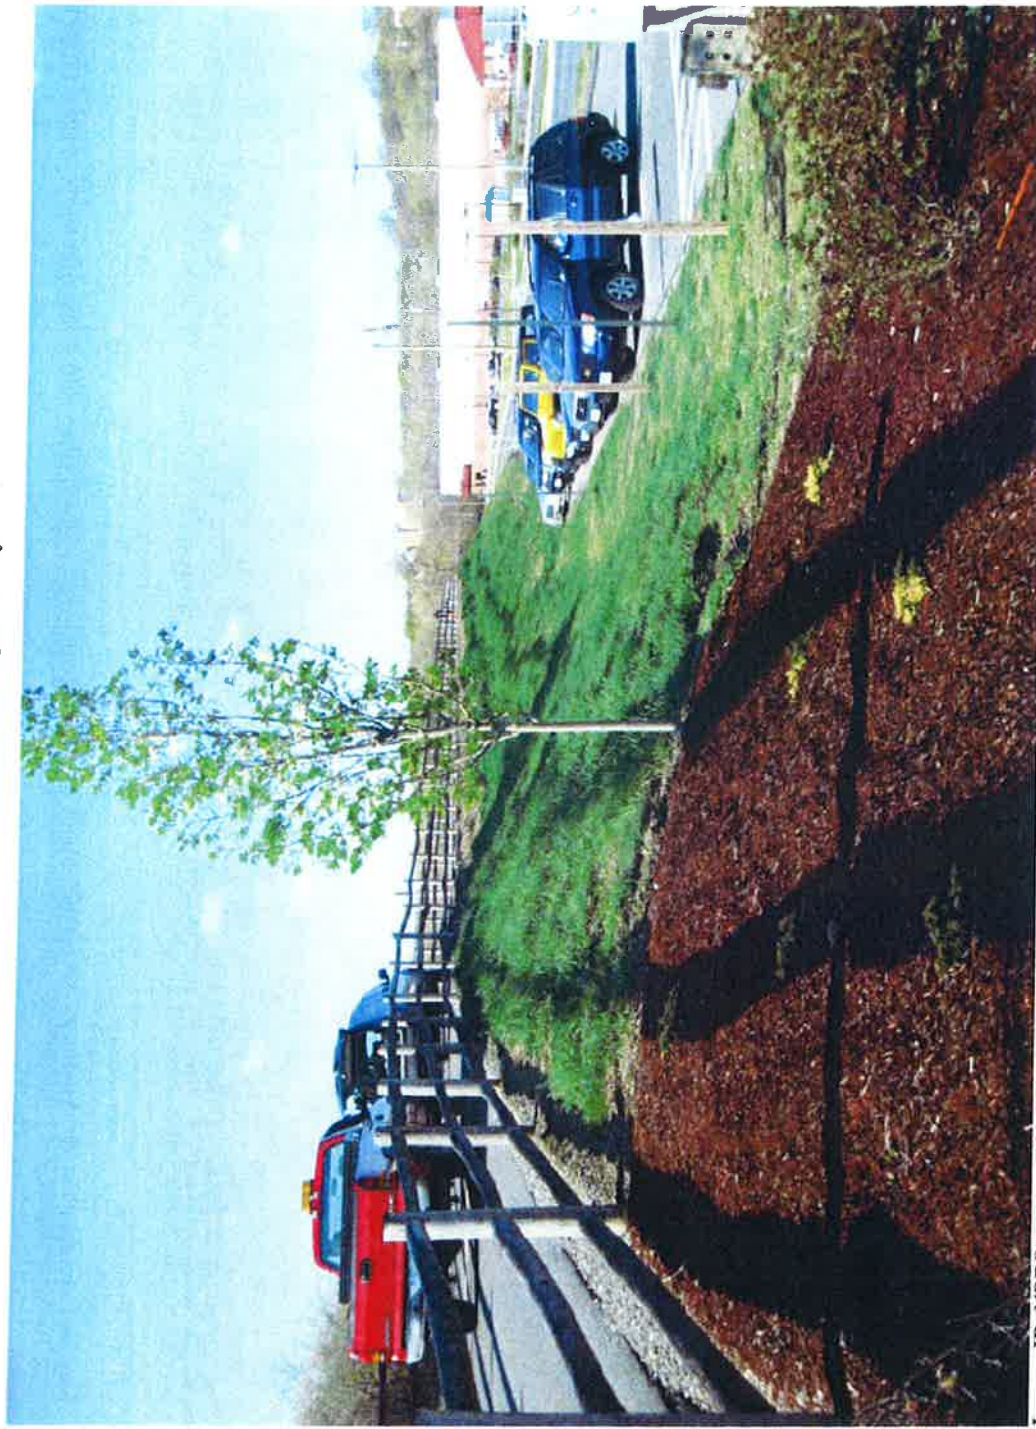
Inspect ID: NRDB\_2009\_a\_0035 Name: Landscaping at north end of Derby segment Caption: Tree planted adjacent to the levee. The tree needs to be removed.

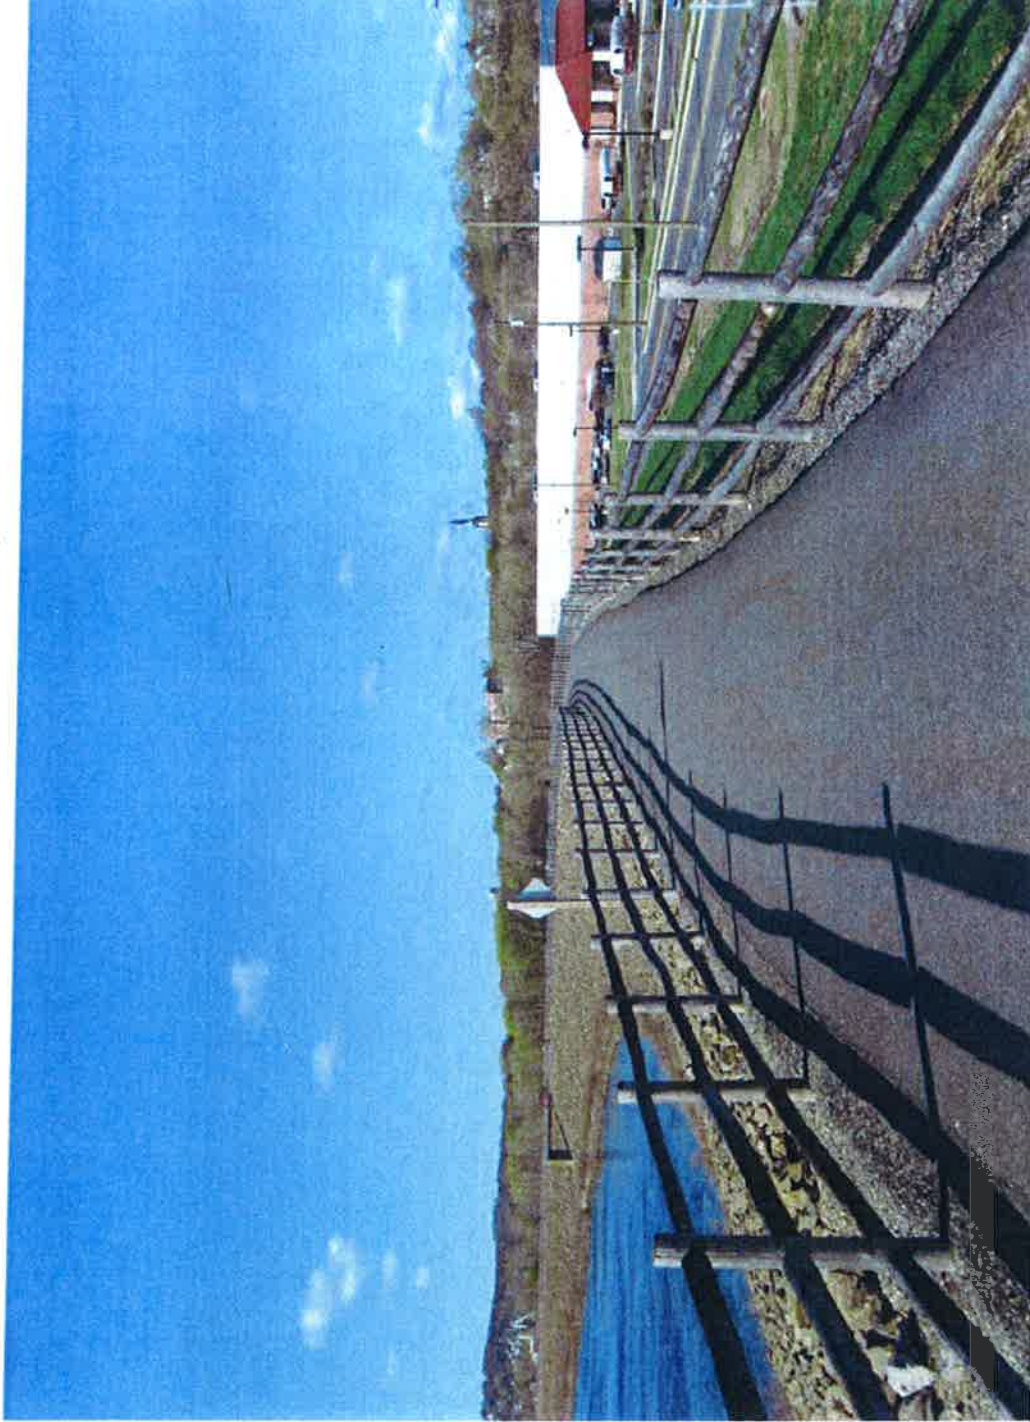
**Inspect ID:** NRDB\_2009\_a\_0036 **Name:** North end of Derby segment **Caption:** View of the crest looking downstream showing the paved path installed on the crest. Path is well maintained and in good condition.

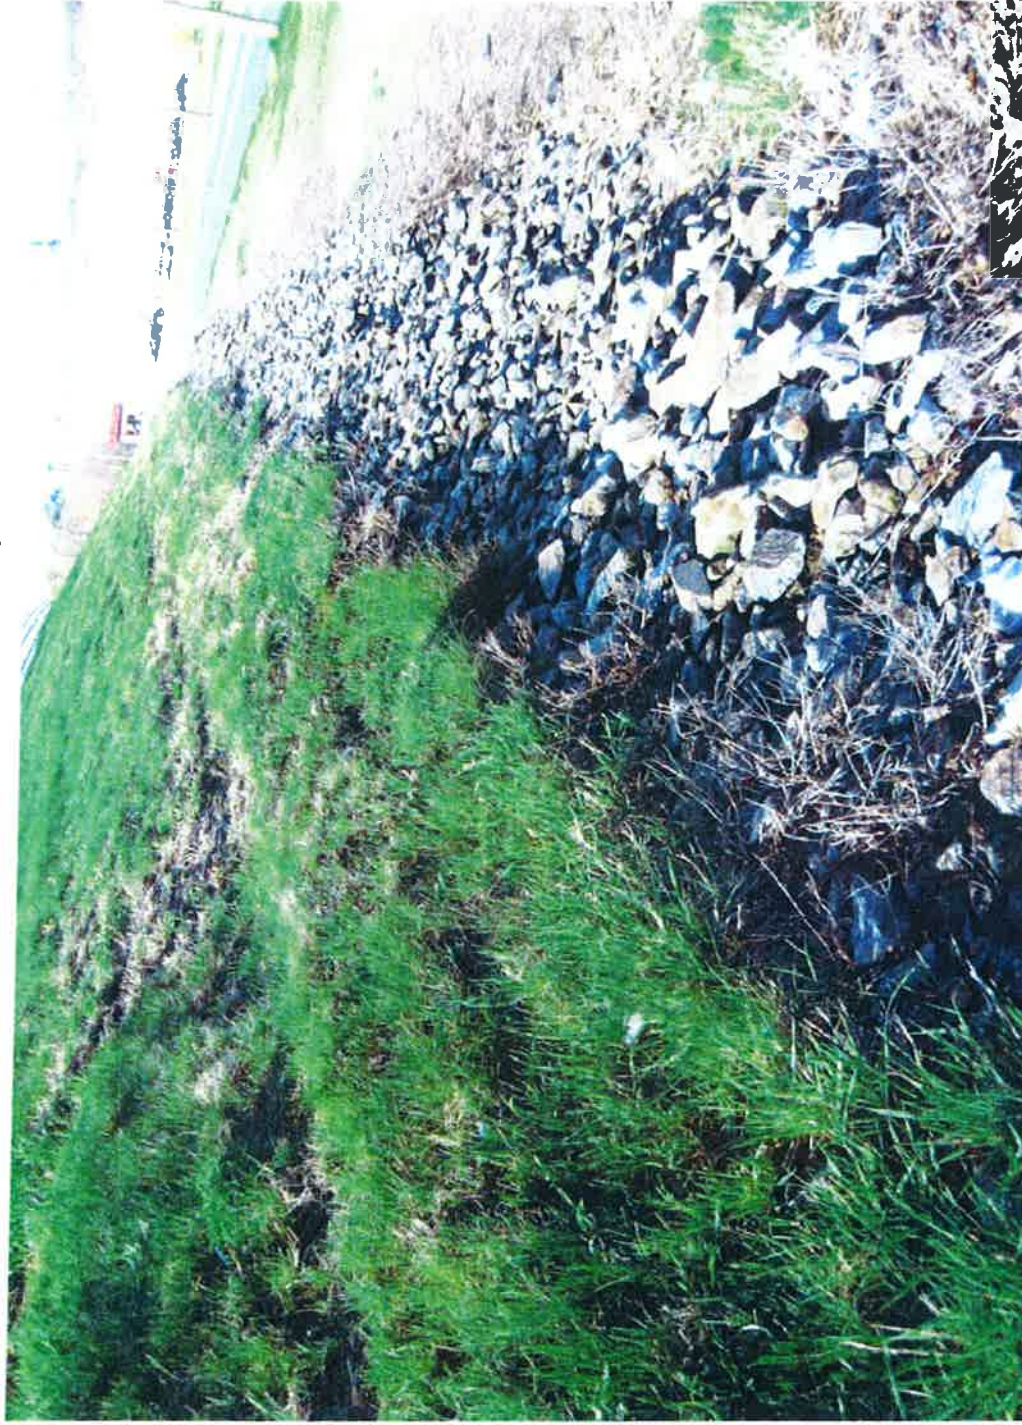
Inspect ID: NRDB\_2009\_a\_0037 Name: Toe drain Caption: View of the toe drain riprap. Some sections of the riprap have minor vegetation growing.

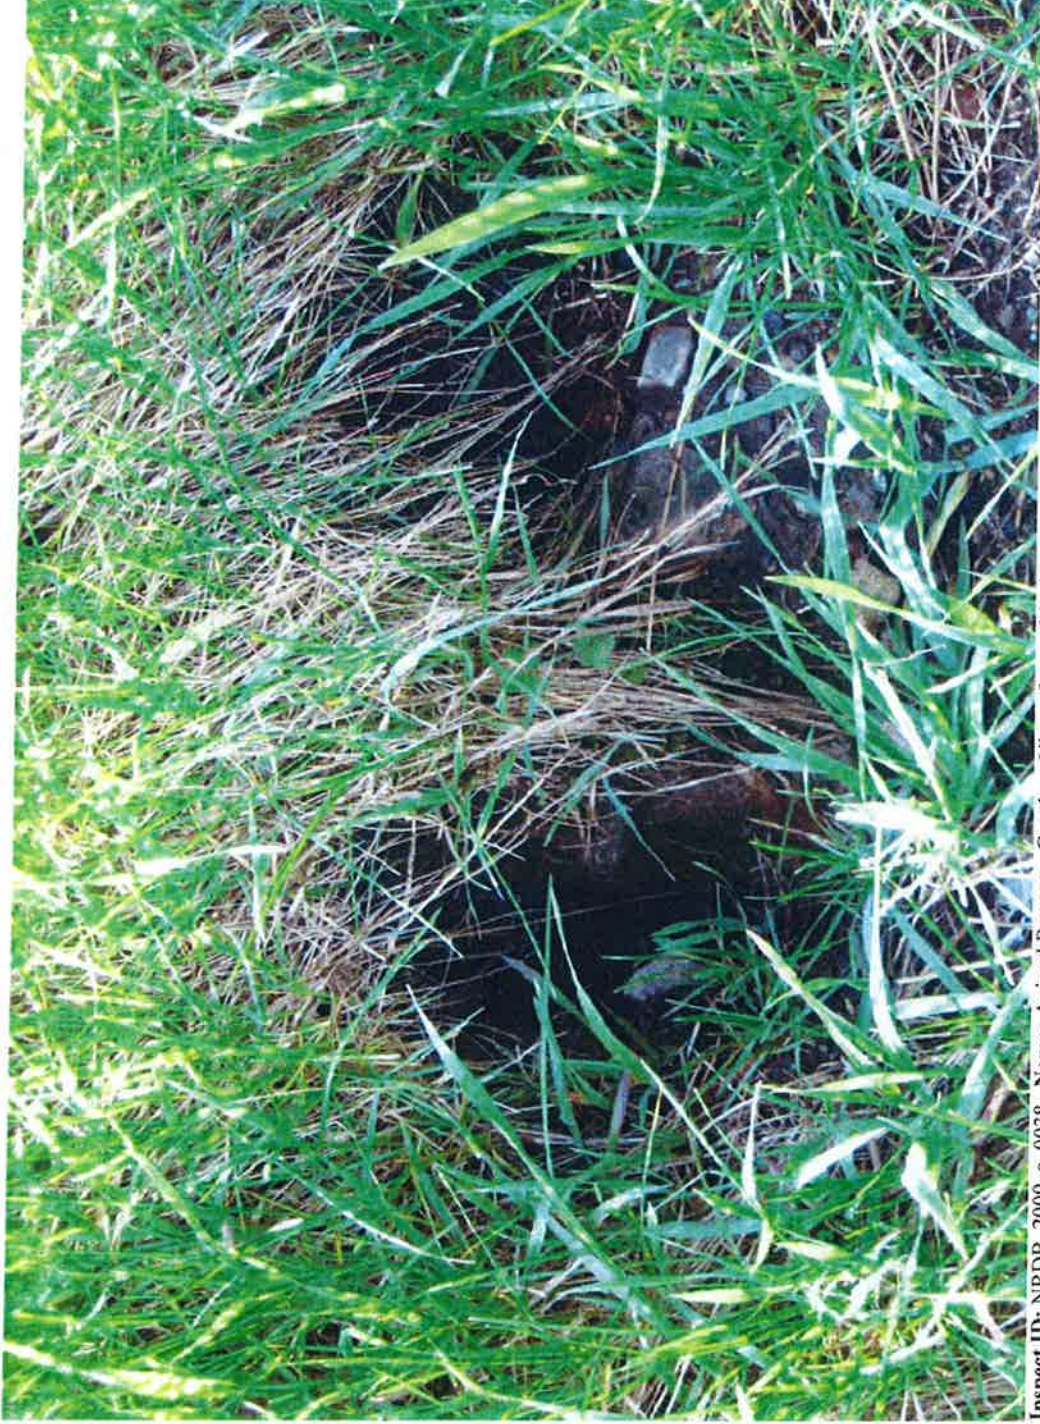
Inspect ID: NRDB\_2009\_a\_0038 Name: Animal Burrows Caption: View of one of the burrows noted along this segment.

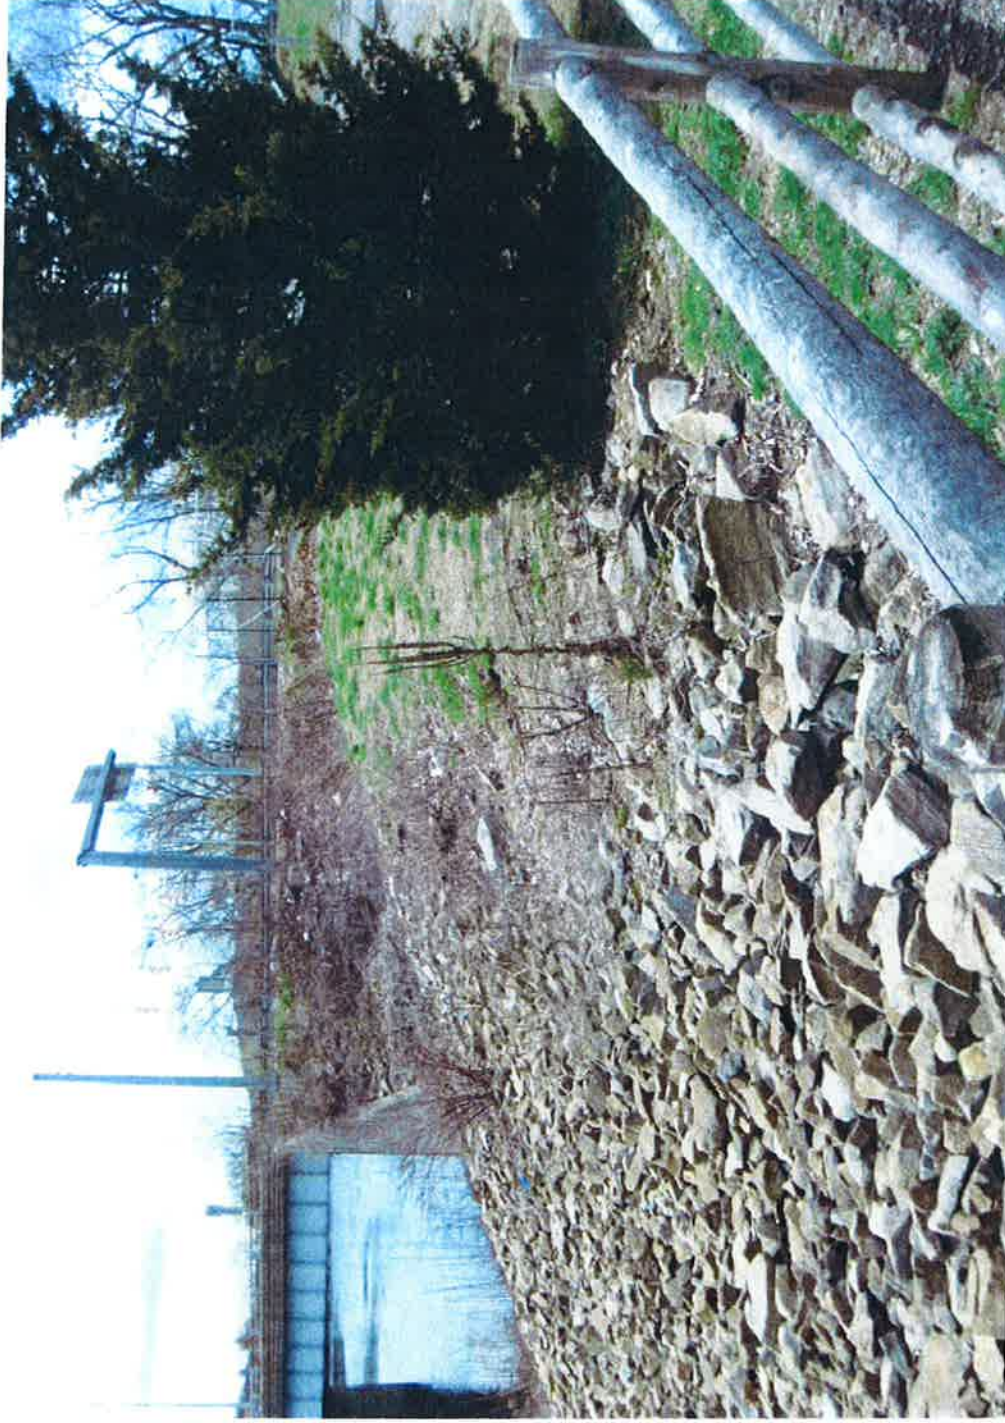
Inspect ID: NRDB\_2009\_a\_0014 Name: Tree on levee slope Caption: View of an ornamental tree planted on the levee slope. Tree needs to be removed.

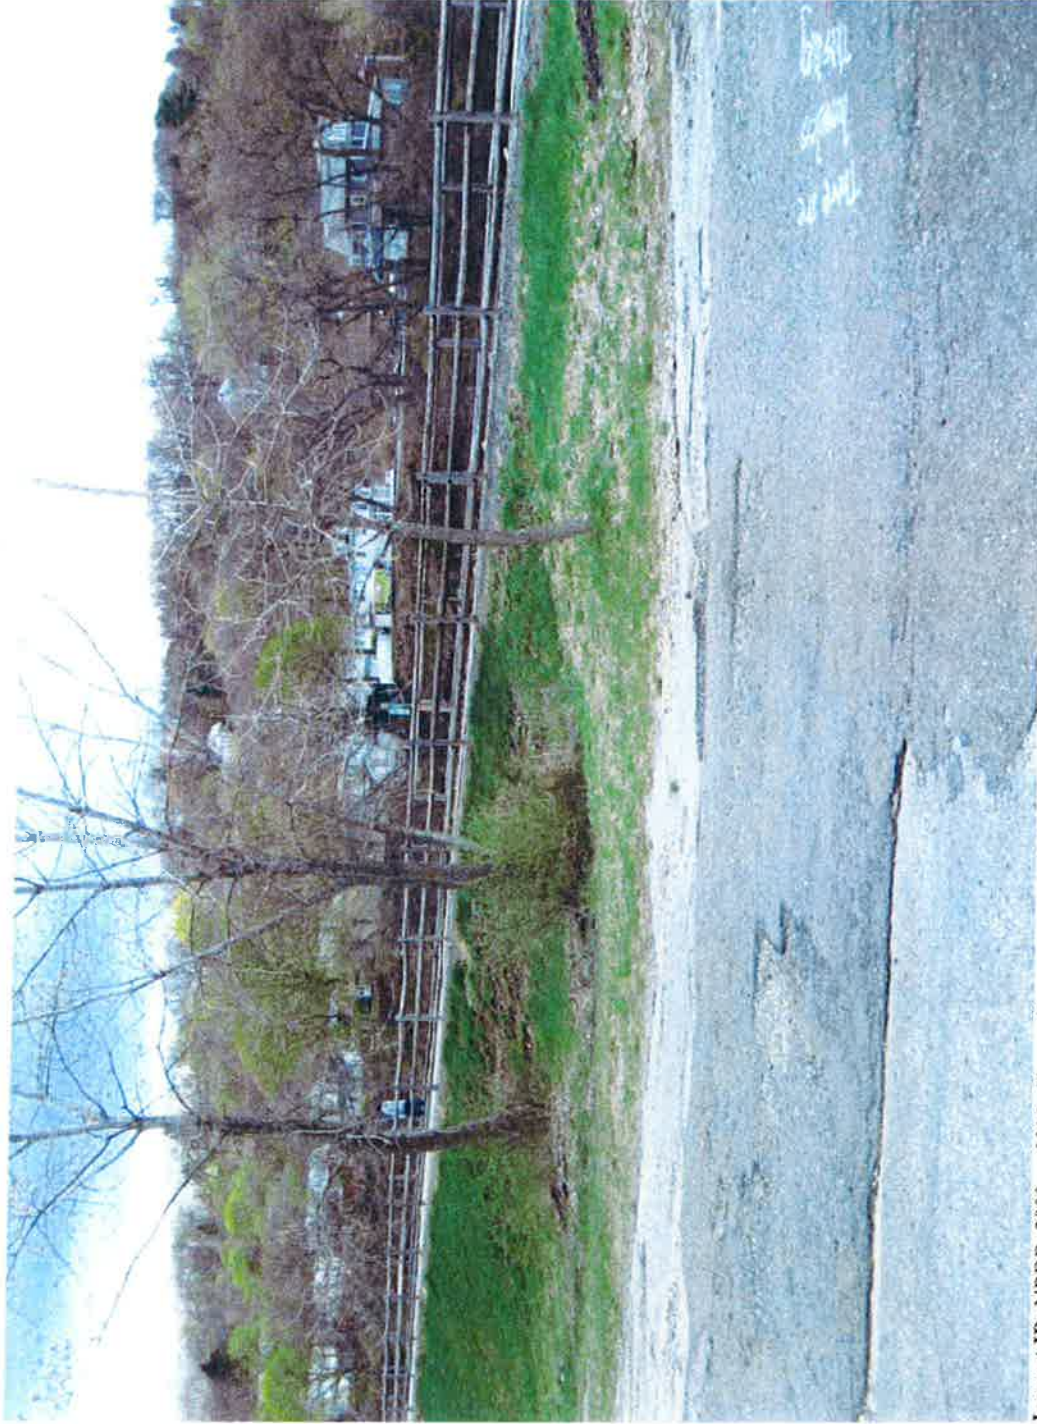
Inspect ID: NRDB\_2009\_a\_0015 Name: Trees on protected side slope Caption: View of two trees growing on the protected side of the levee slope. Trees need to be removed.

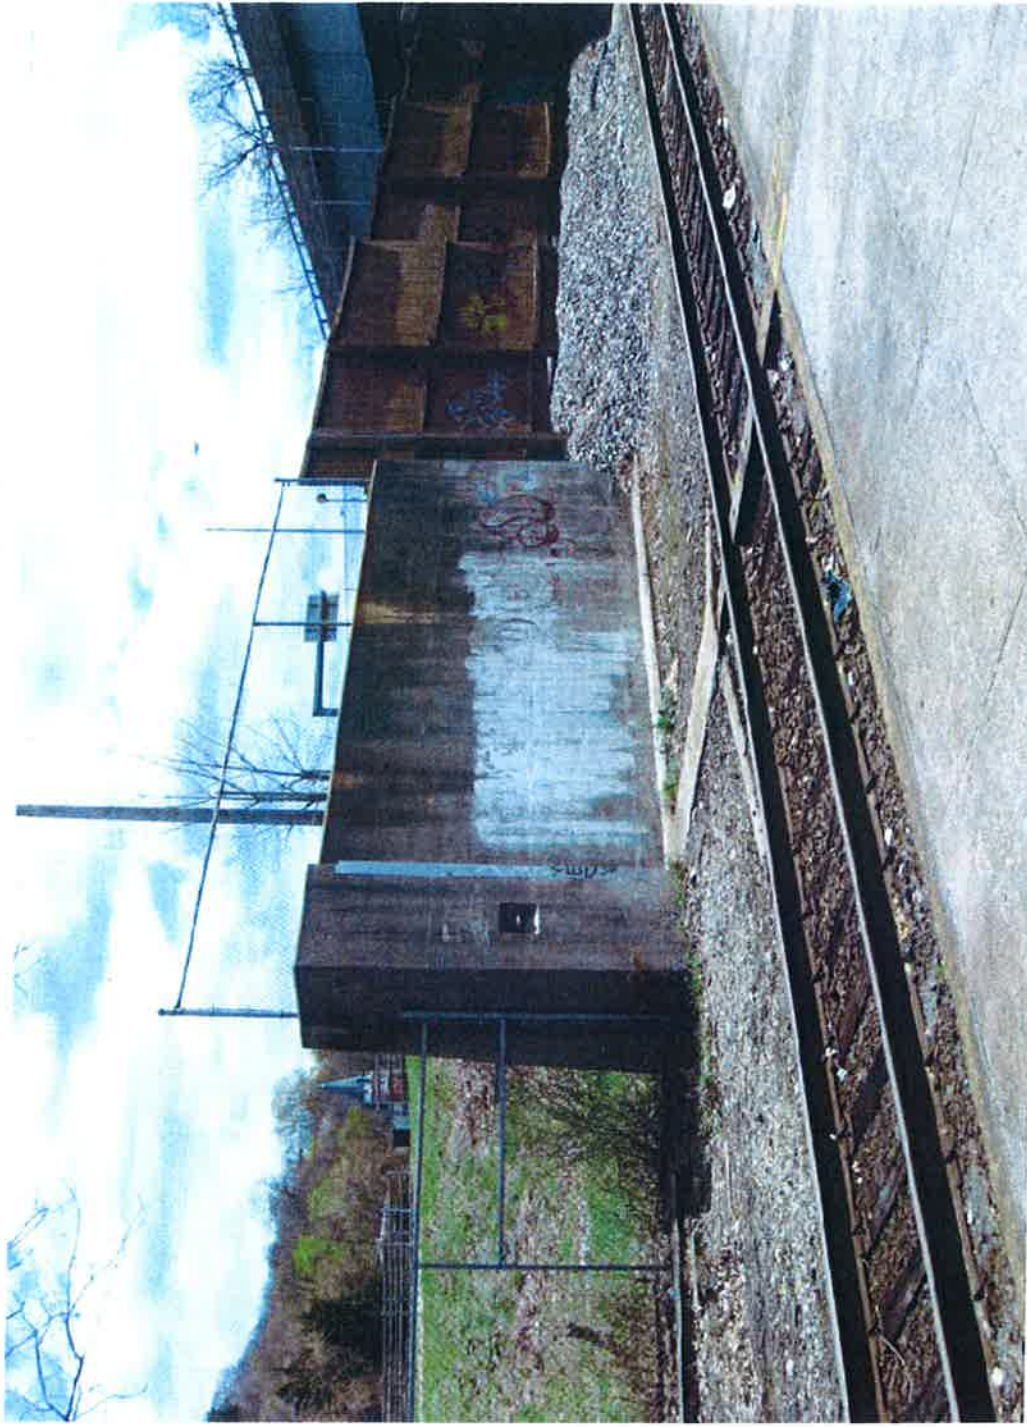
**Inspect ID:** NRDB\_2009\_a\_0016 **Name:** Railroad Gate # 1 **Caption:** Railroad Gate # 1. Gate is in good condition. Access to the gate is sometimes blocked by the rail line. this is unacceptable, especially during inspections and potential flood conditions.

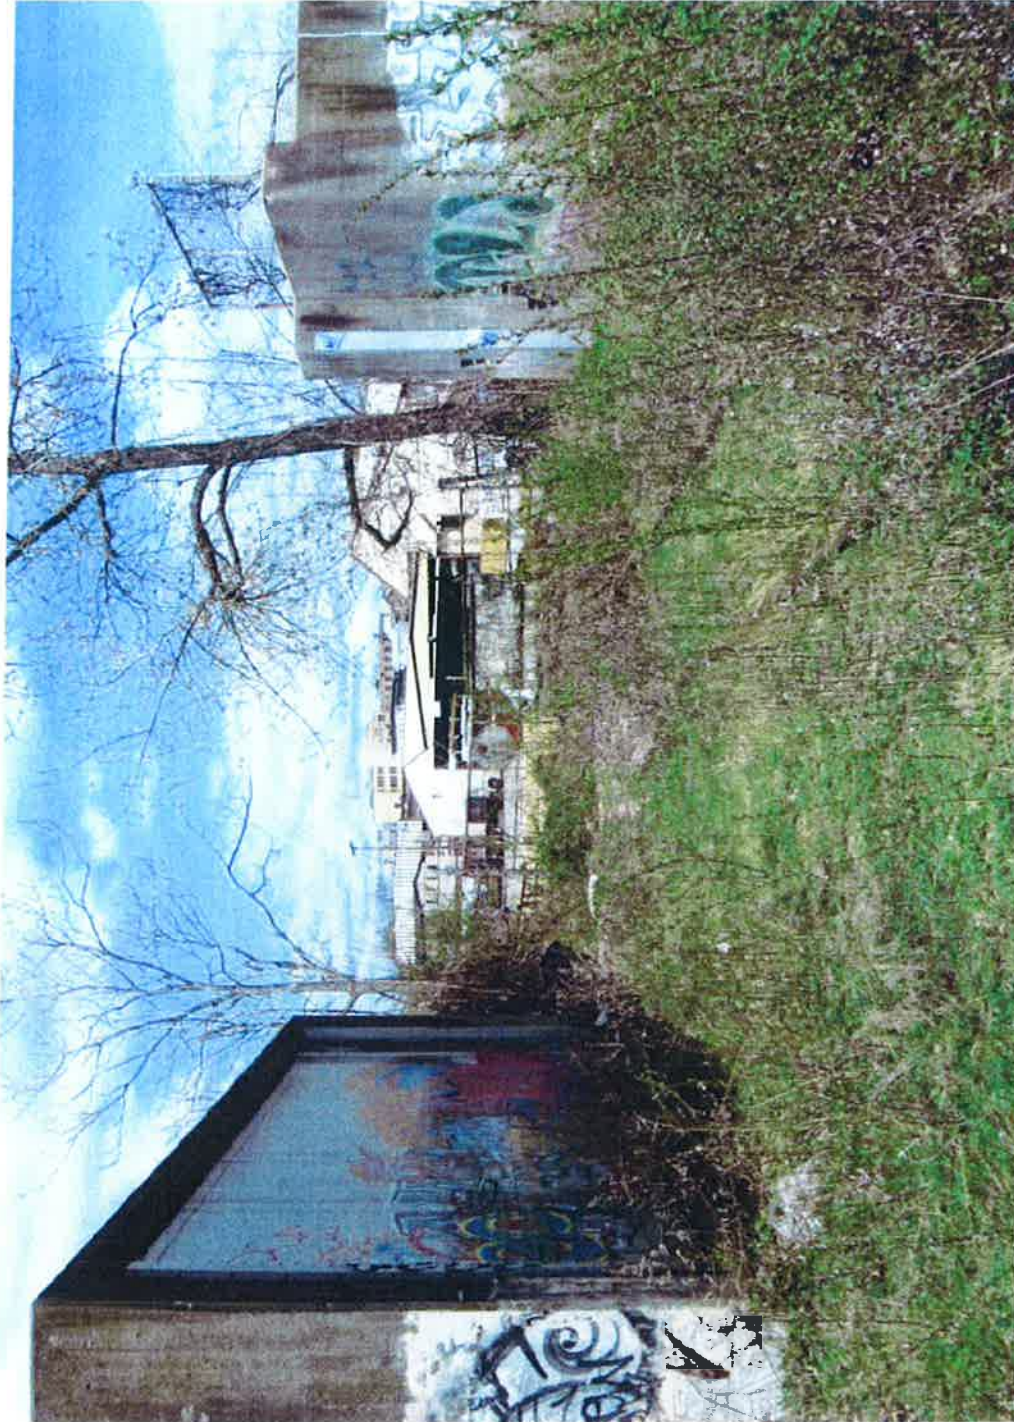
**Inspect ID:** NRDB\_2009\_a\_0019 **Name:** Railroad Gate # 2A **Caption:** Railroad Gate # 2A. Note the significant vegetation growing along the walls and in the closure area. The gate and walls are in fair condition. The vegetation needs to be cleared.

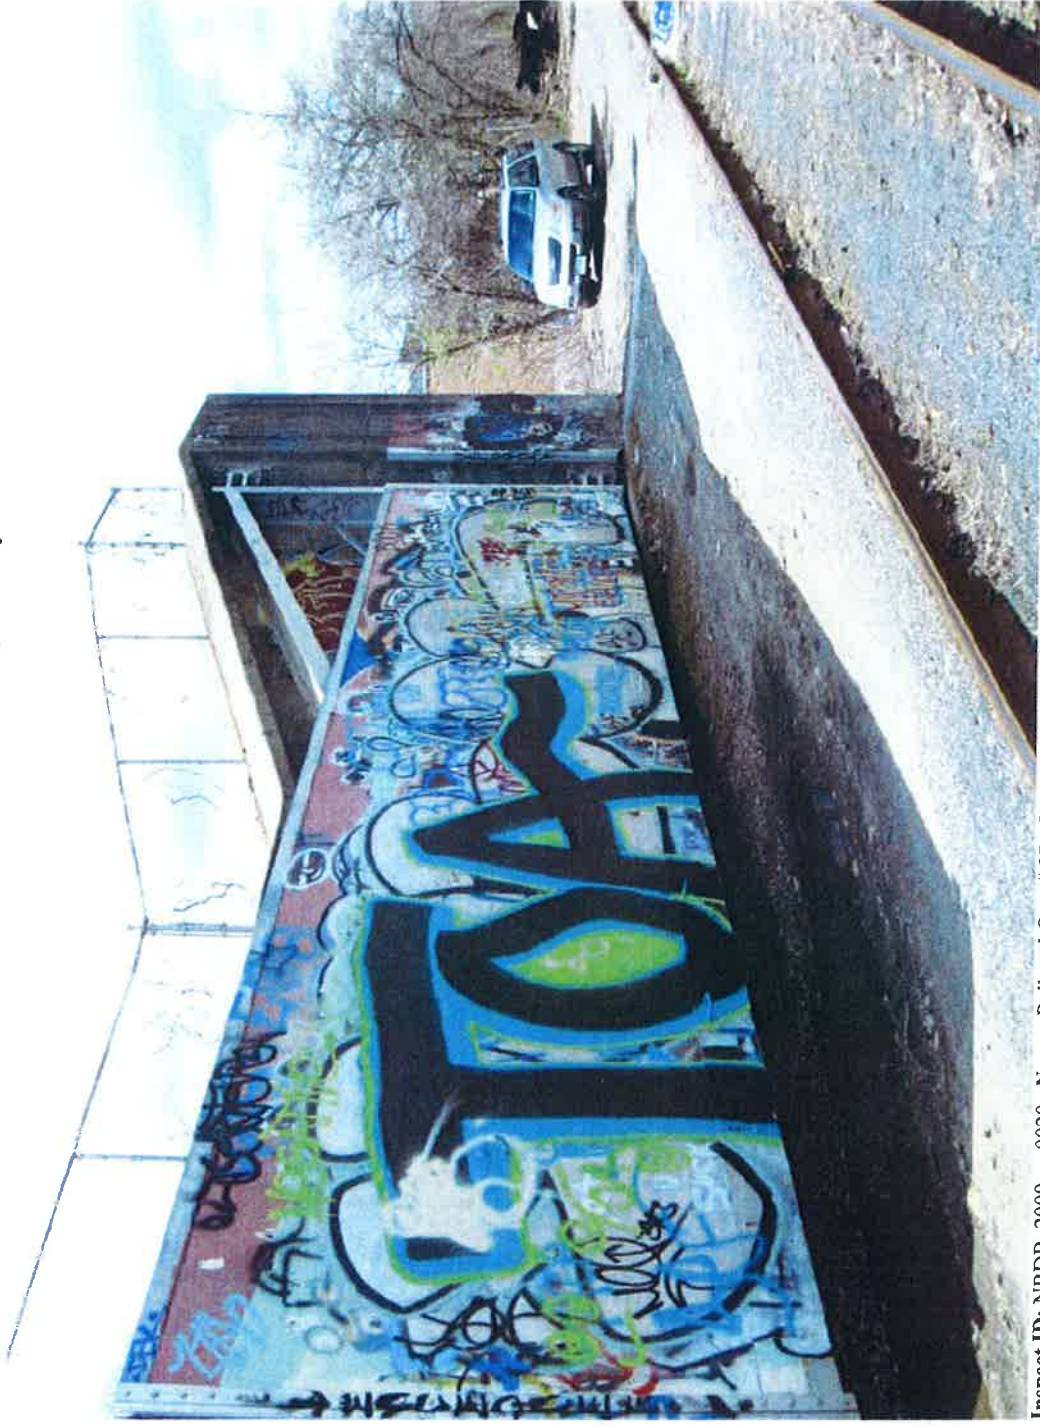
Inspect ID: NRDB\_2009\_a\_0020 Name: Railroad Gate # 2B Caption: Railroad Gate # 2B. This structure is in good condition. Moderate to significant vegetation is present, which needs to be cleared.

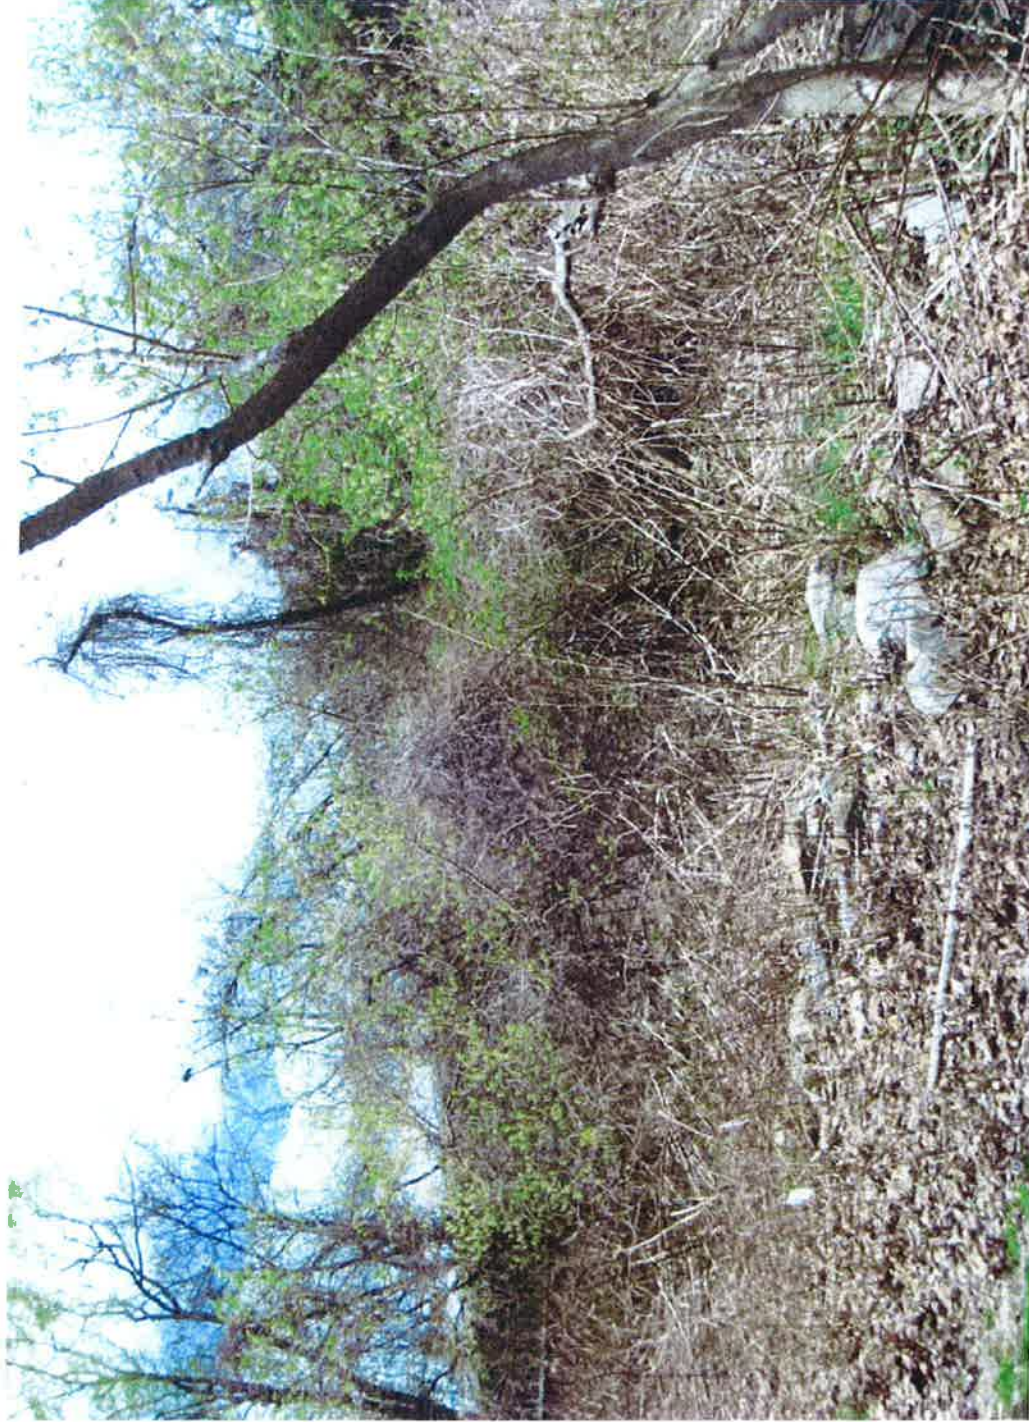
Inspect ID: NRDB\_2009\_a\_0021 Name: Heavy vegetation along slope Caption: This section on the levee has heavy vegetation which needs to be cleared.
