- A. FLOOD DAMAGE REDUCTION SEGMENT/SYSTEM INSPECTION REPORT –  
Naugatuck River RB – Southend Ansonia, CT  
Date of Inspection – 4/22/2009 – Provided to Ansonia on February 3, 2010**

February 3, 2010

## Flood Damage Reduction Segment / System Inspection Report

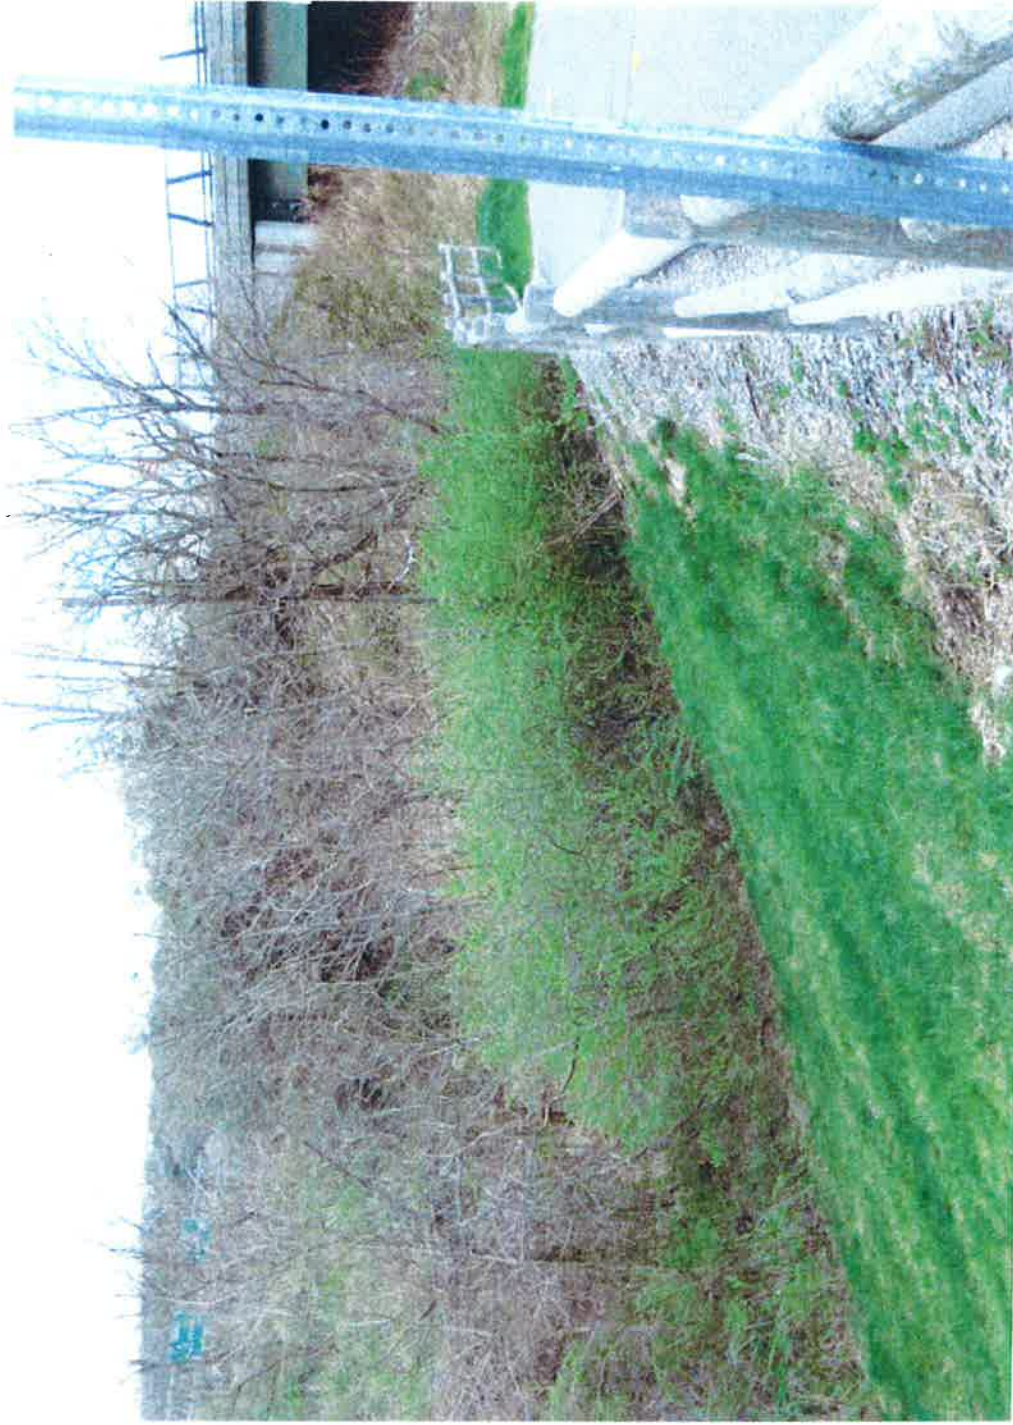
**Inspect ID:** NRDB\_2009\_a\_0023 **Name:** Vegetation along tie in to RT 8 overpass **Caption:** View of the vegetation growing adjacent to the levee next to the Rt. 8 overpass. This vegetation needs to be cleared back at least 15 feet from the toe.

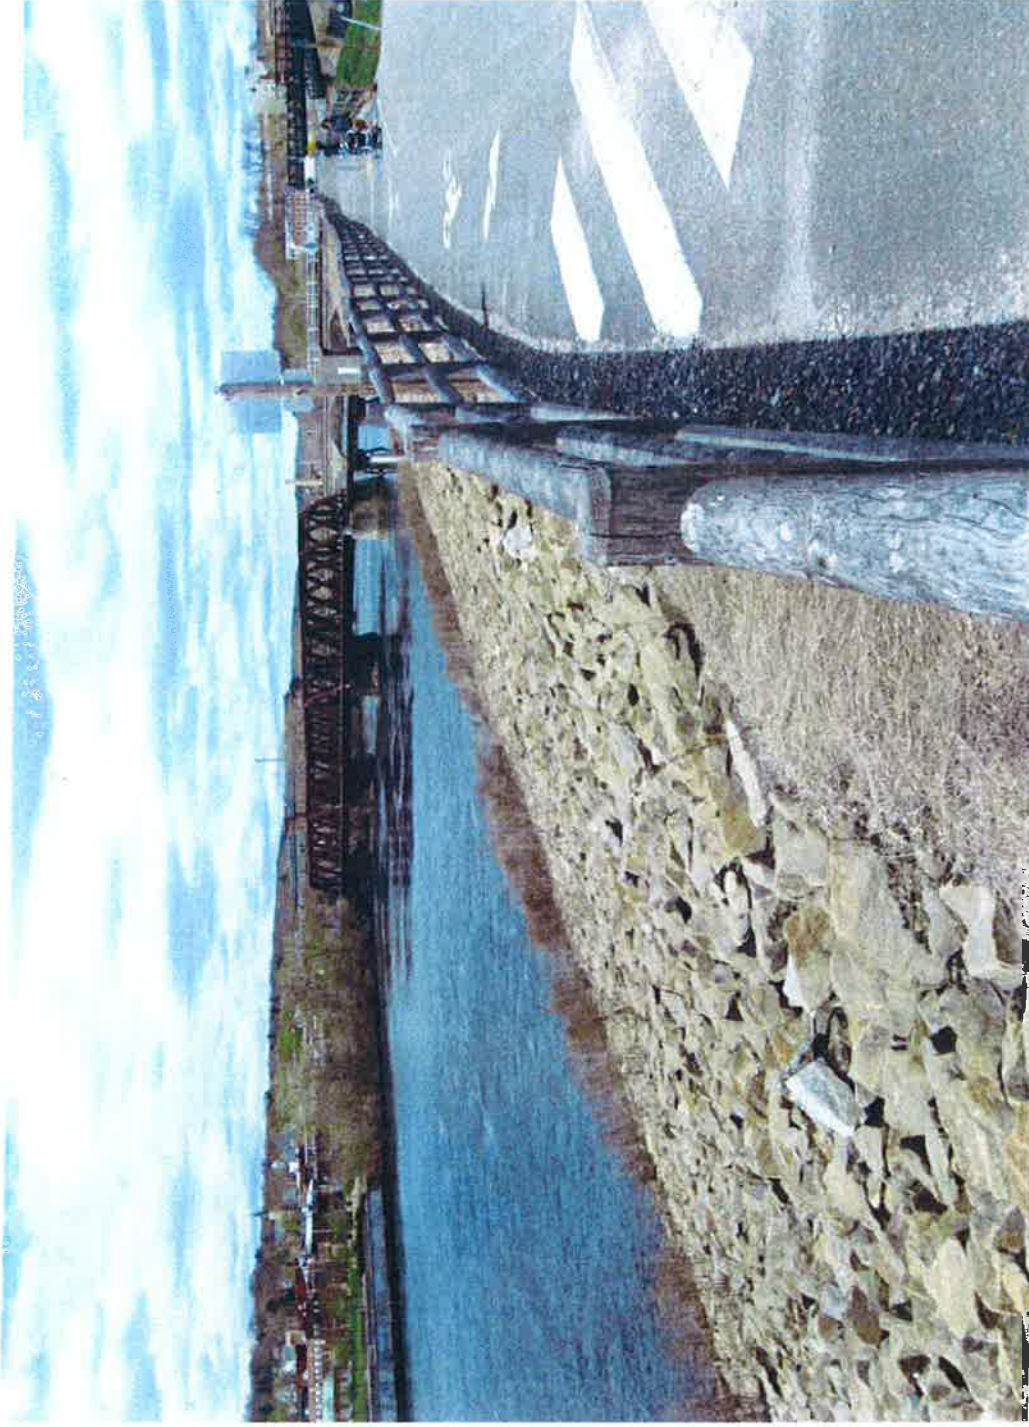
**Inspect ID:** NRDB\_2009\_a\_0024 **Name:** Housatonic Side looking upstream **Caption:** View of the riprap slope along the Housatonic River. Riprap is in good condition. Minor vegetation along the river bank.

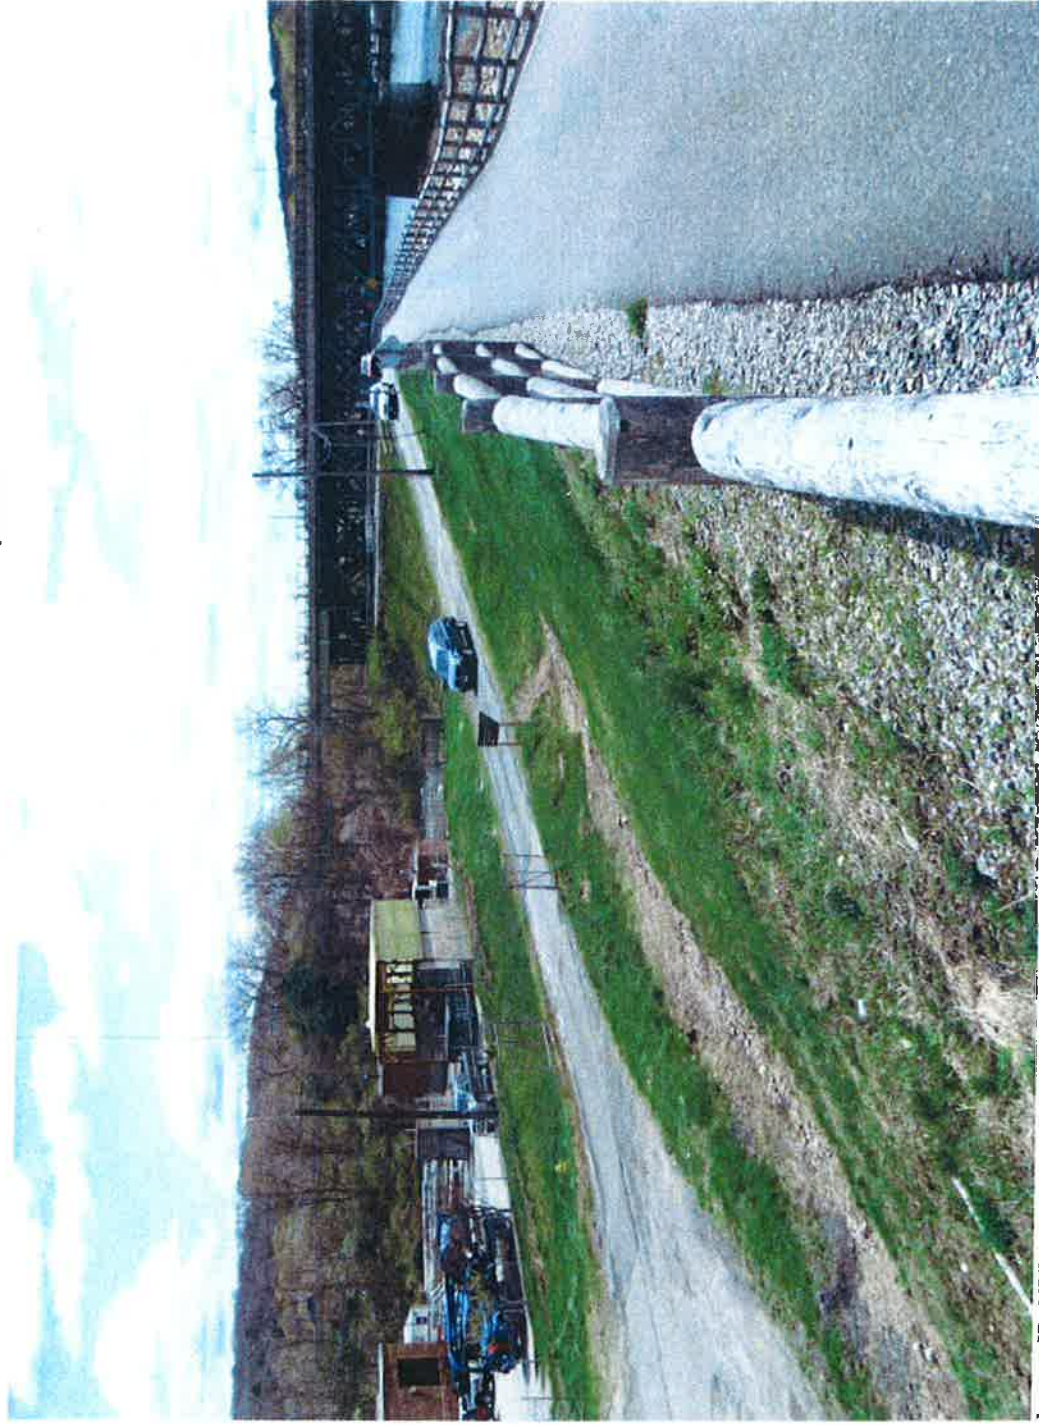
Inspect ID: NRDB\_2009\_a\_0025 Name: Protected side looking downstream Caption: View of the slope adjacent to Derby Pump Station. Slope is in generally good condition. The toe drain should be cleared of debris.

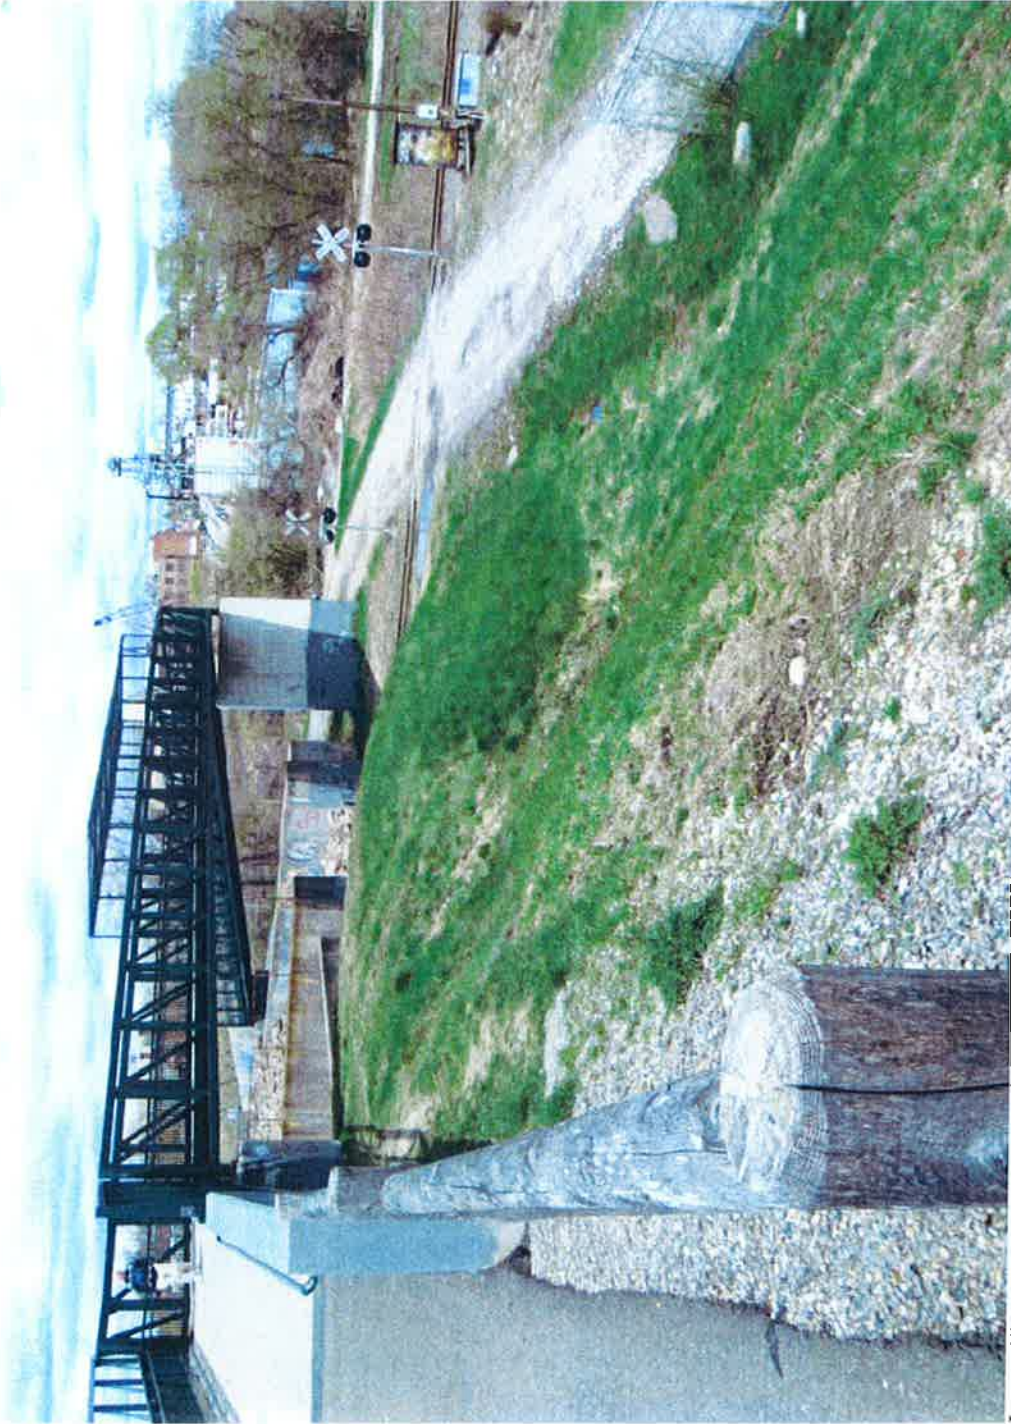
Inspect ID: NRDB\_2009\_a\_0026 Name: Animal burrow  
Caption: Another view of the slope adjacent to the Derby Pump station, looking upstream. An active animal burrow was found here. Burrow should be excavated and backfilled.

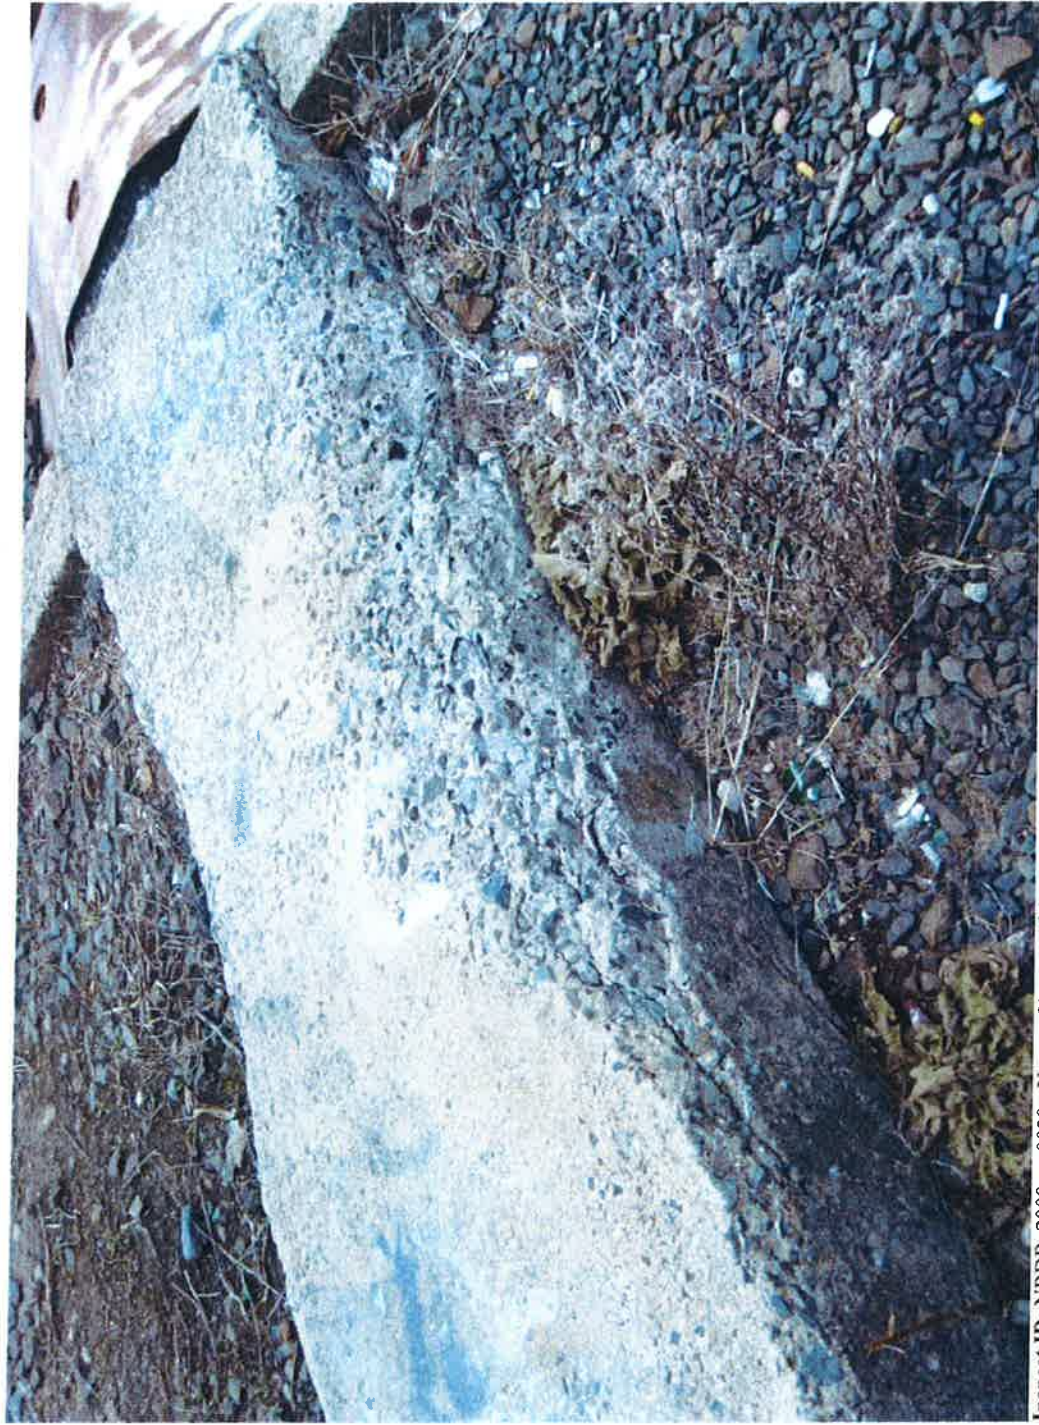
Inspect ID: NRDB\_2009\_a\_0029 Name: Closeup of the gate sill Caption: Closeup showing the shallowing along the closure sill.

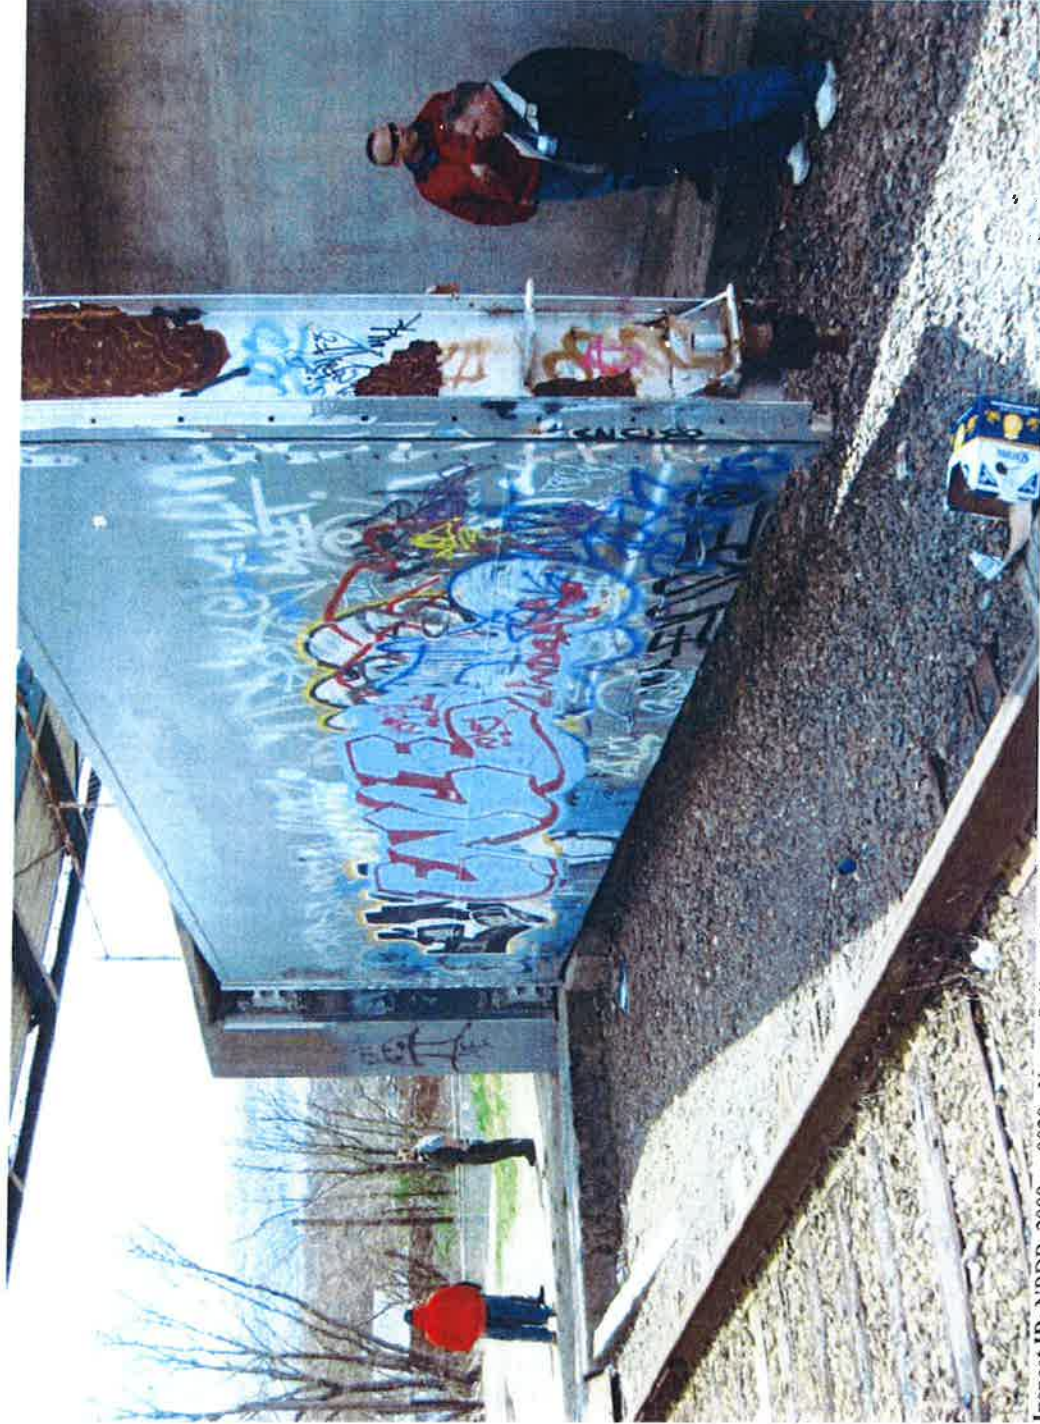
Inspect ID: NRDB\_2009\_a\_0029 Name: Railroad Gate #3 Caption: Railroad Gate #3. The gate is in good condition. The walls and sill are in fair to poor condition, with some cracking and spalling. Joints are in fair condition.

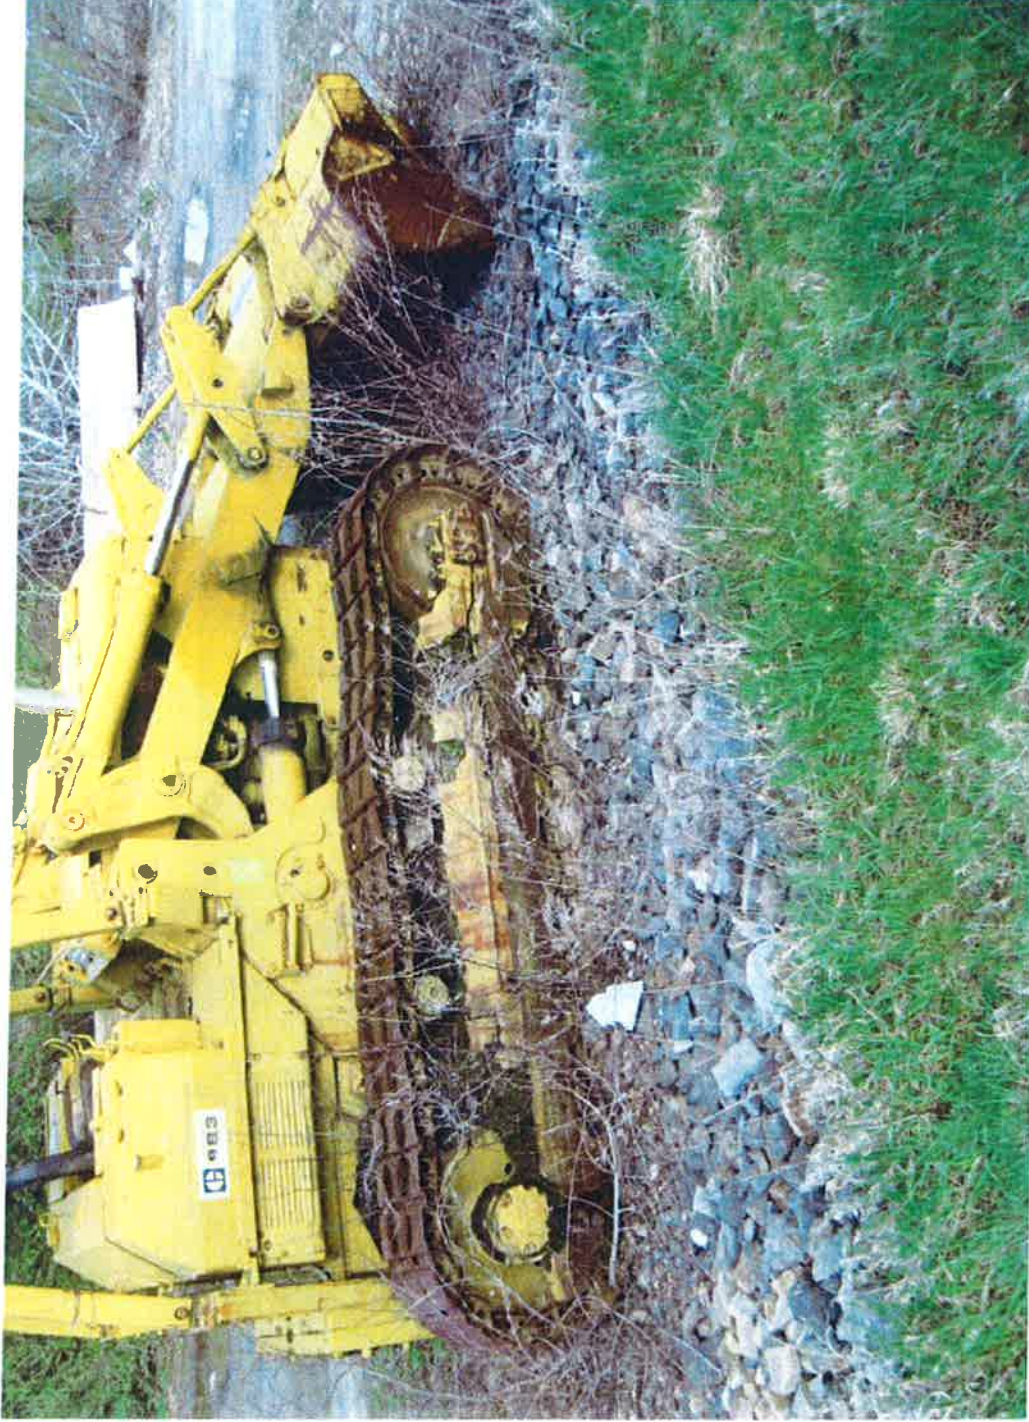
**Inspect ID:** NRDB\_2009\_a\_0040 **Name:** Bulldozer next to levee toe **Caption:** View of the bulldozer parked adjacent to the levee. This should be relocated at least 15 feet from the toe.

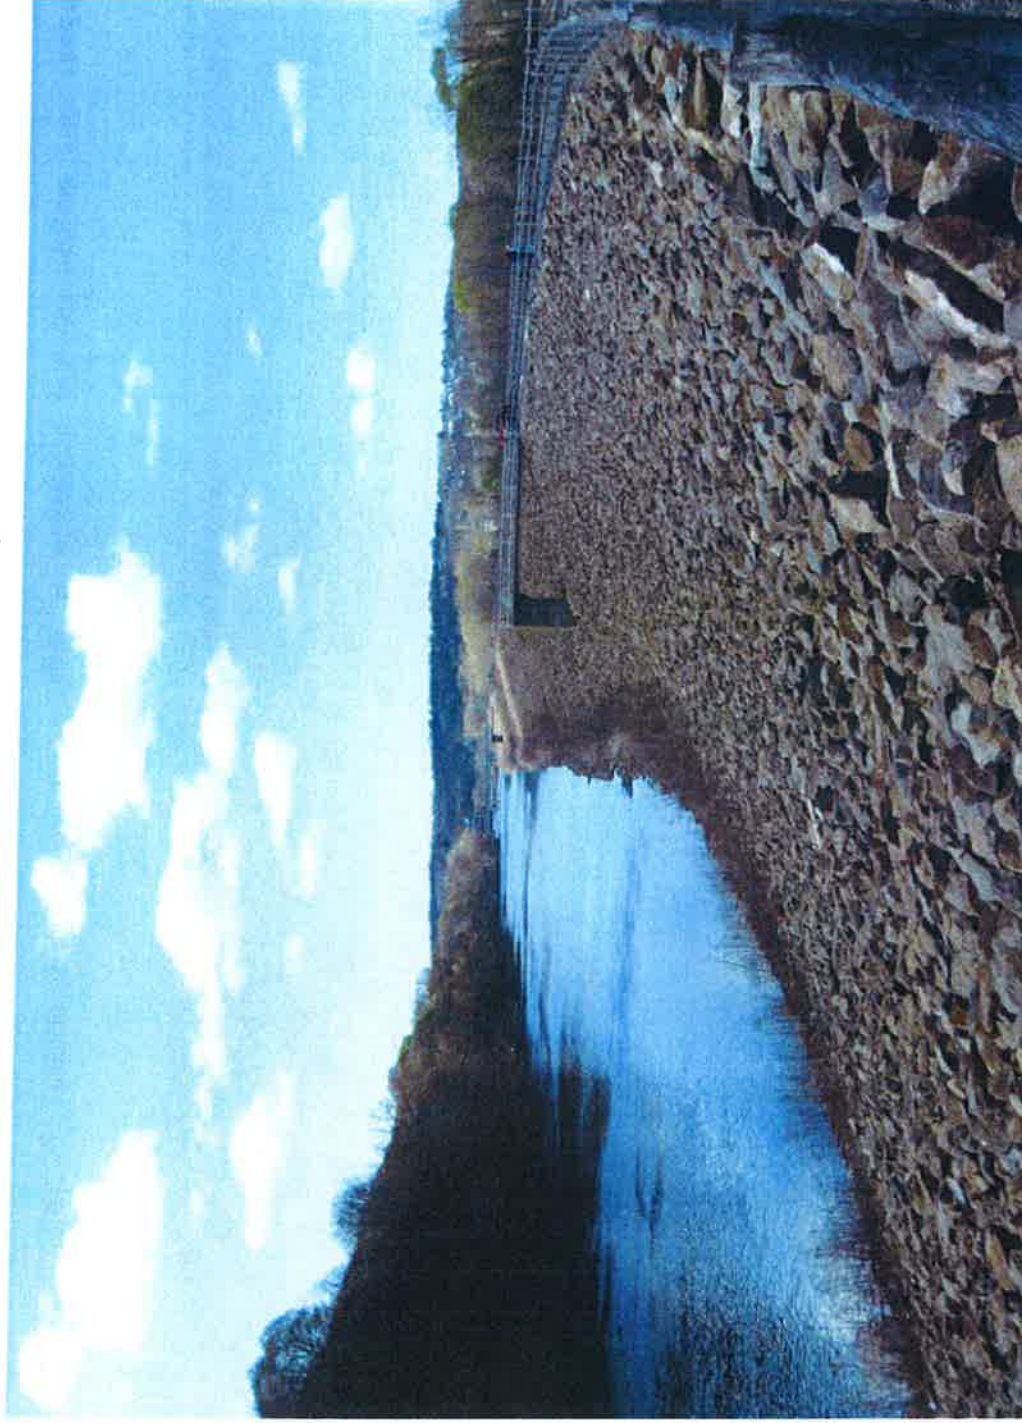
**Inspect ID:** NRDB\_2009\_a\_0041 **Name:** Channel slope looking downstream **Caption:** View of the channel riprap slope showing minor vegetation growing along the bank.

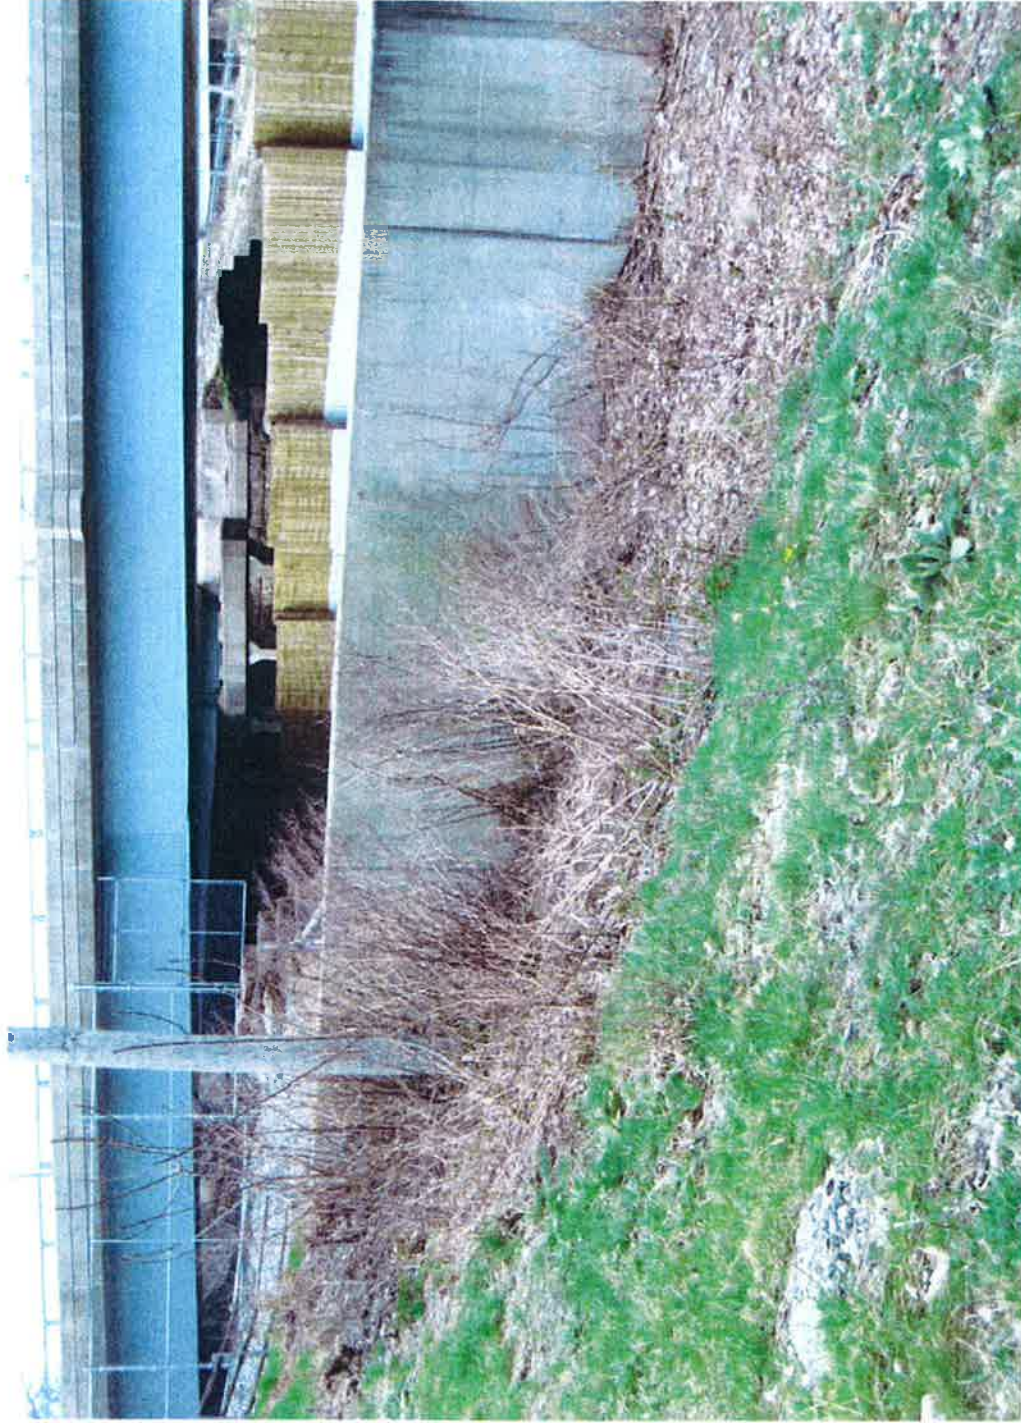
**Inspect ID:** NRDB\_2009\_a\_0017 **Name:** Floodwall adjacent to RR Gate # 1 **Caption:** View of the wall adjacent to RR Gate #1. Wall is in good condition. Note vegetation growth along the wall which needs to be cleared.

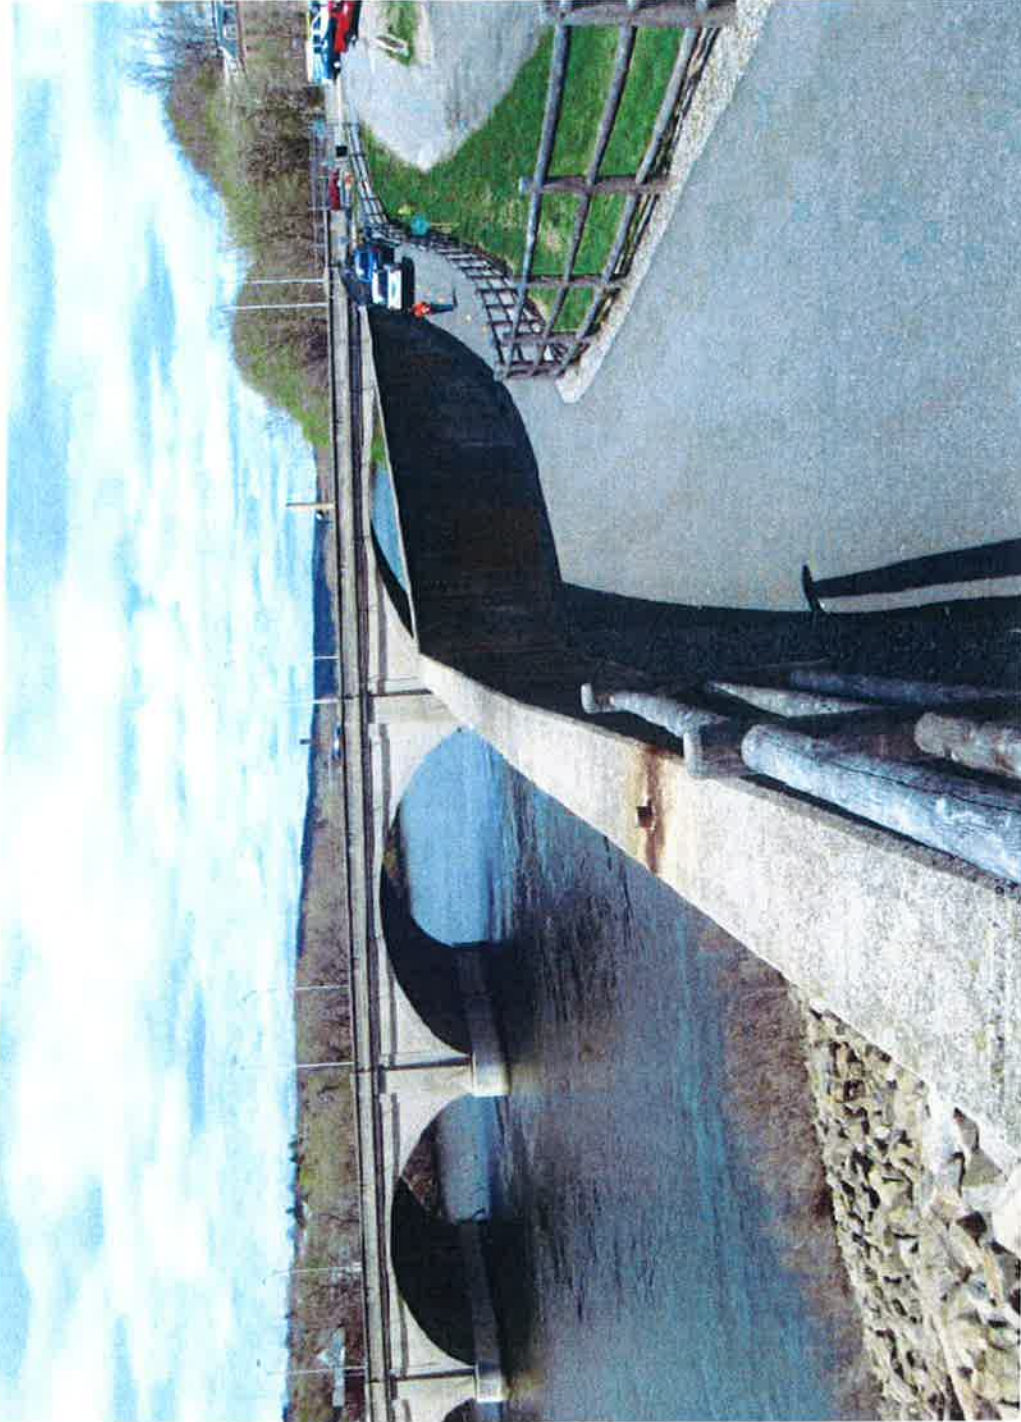
**Inspect ID:** NRDB\_2009\_a\_0031 **Name:** Floodwall looking upstream **Caption:** View of the floodwall along the Housatonic River. Wall is in good condition, with some patched areas along the riverside face. Joints are generally in good to fair condition.

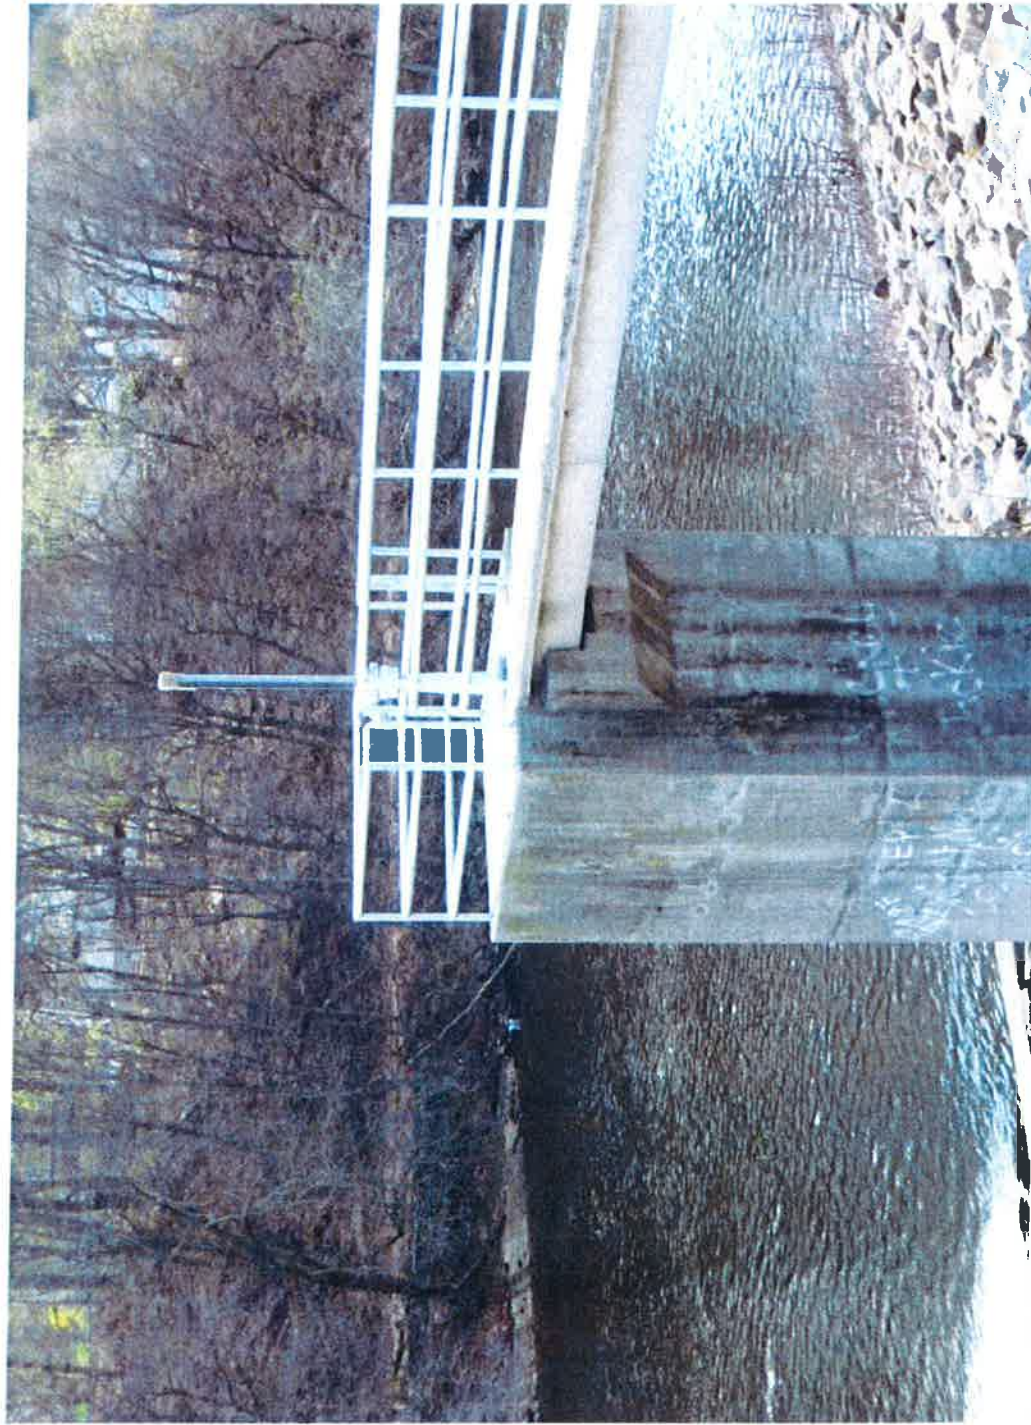
Inspect ID: NRDB\_2009\_a\_0042 Name: Sluice Gate #11 Caption: View of Sluice Gate #11. Structure is in good condition.

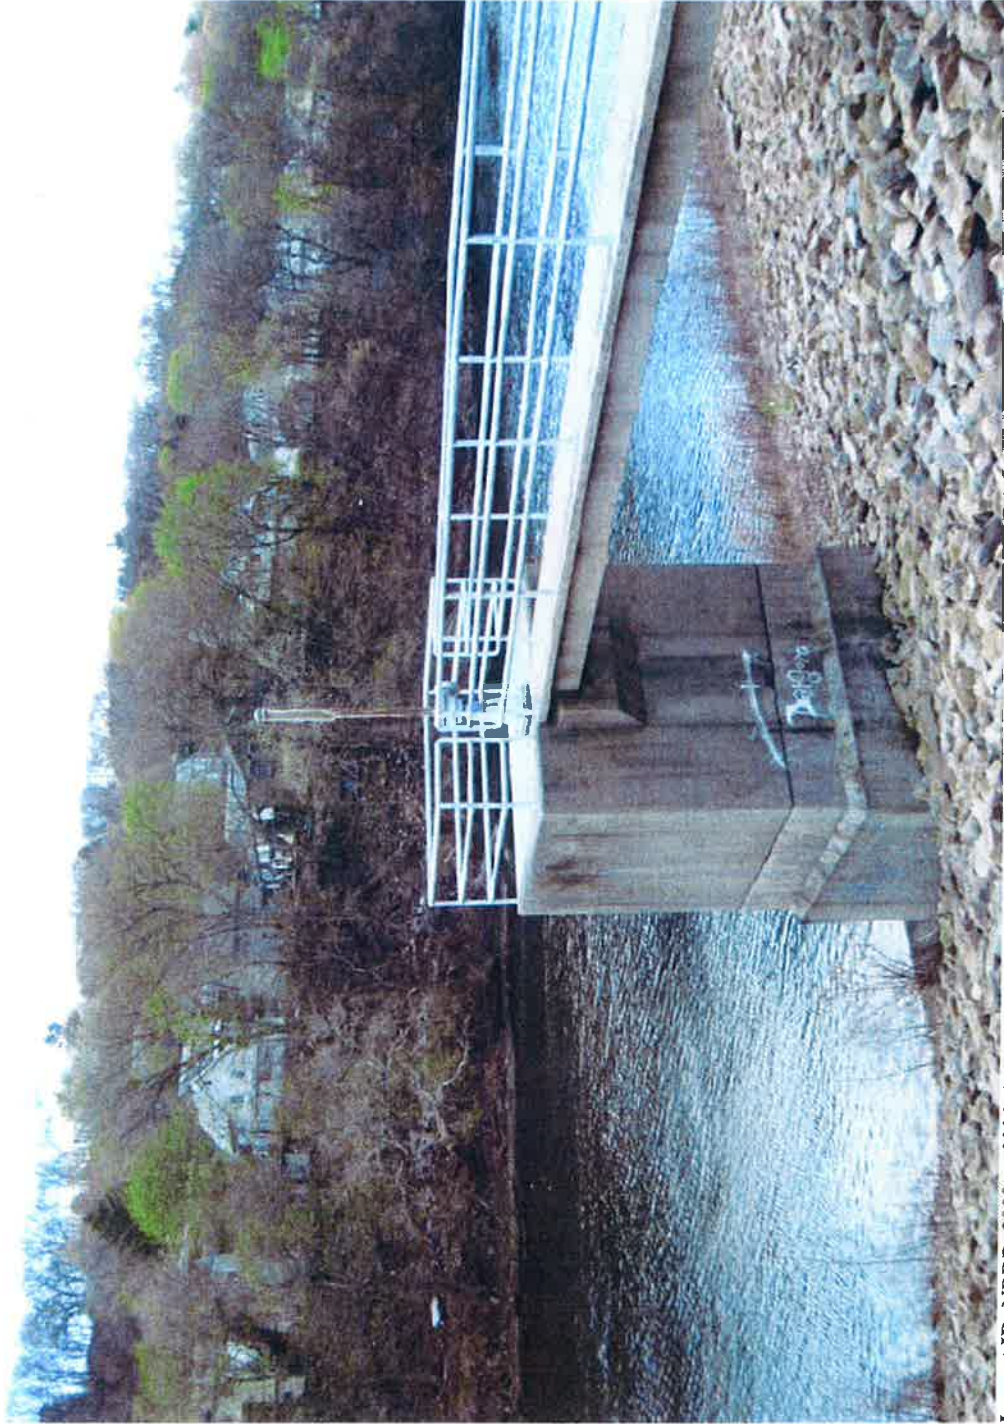
Inspect ID: NRDB\_2009\_a\_0006 Name: Sluice Gate # 1 Caption: View of Sluice Gate Structure # 1. Gate and tower are in good condition.

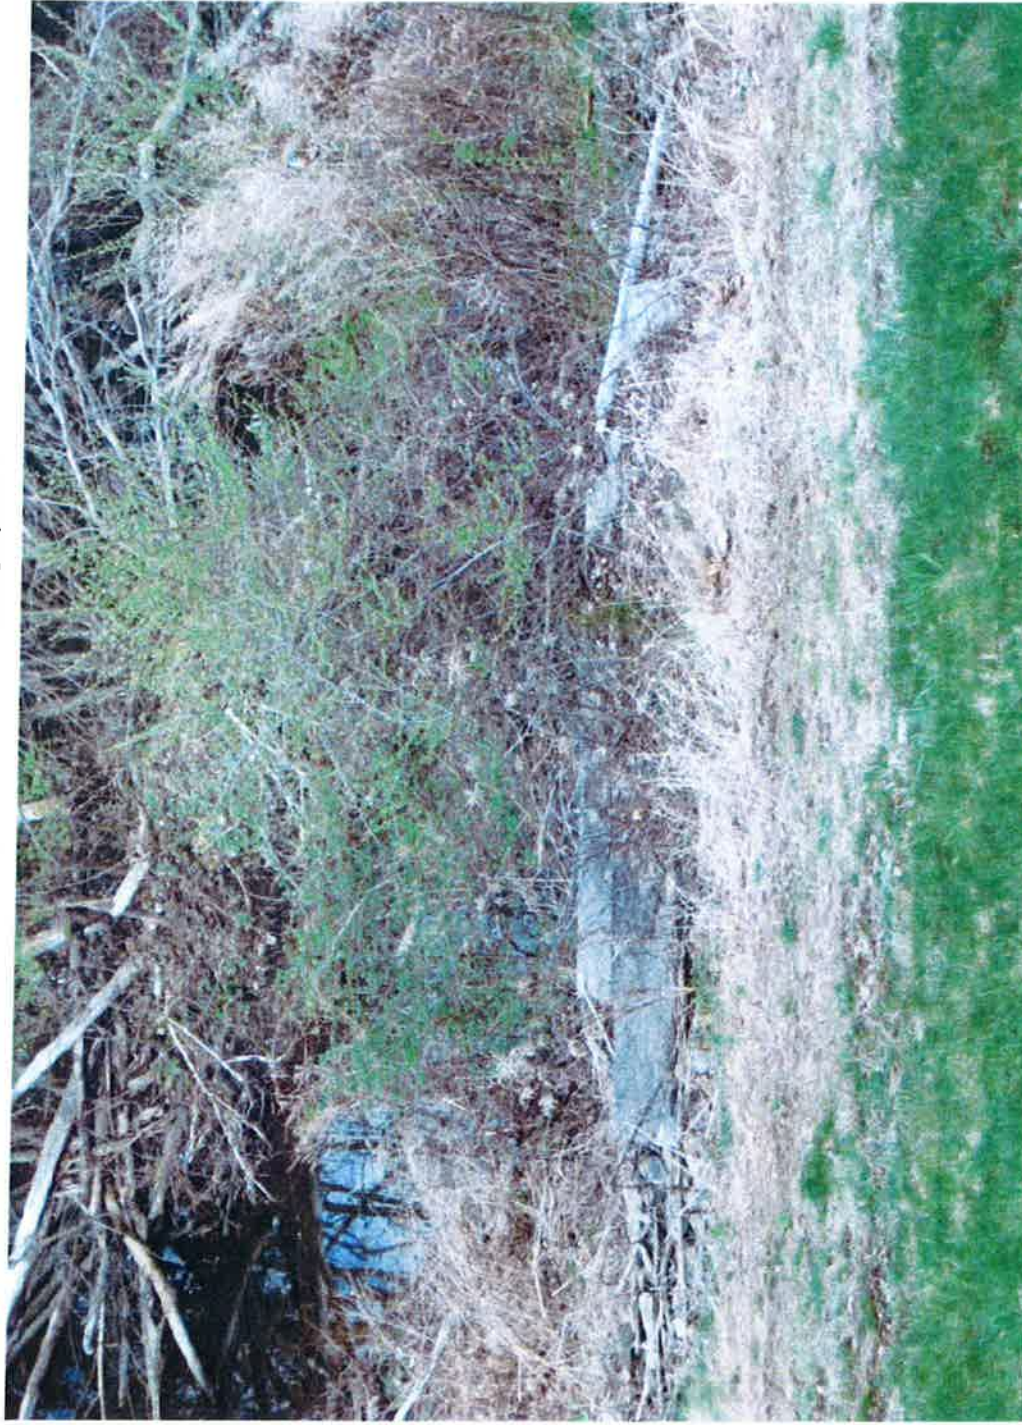
Inspect ID: NRDB\_2009\_a\_0007 Name: Inlet structure for Sluice Gate # 1 Caption: View of the heavy vegetation around the inlet structure for Sluice Gate # 1. Vegetation needs to be cleared.

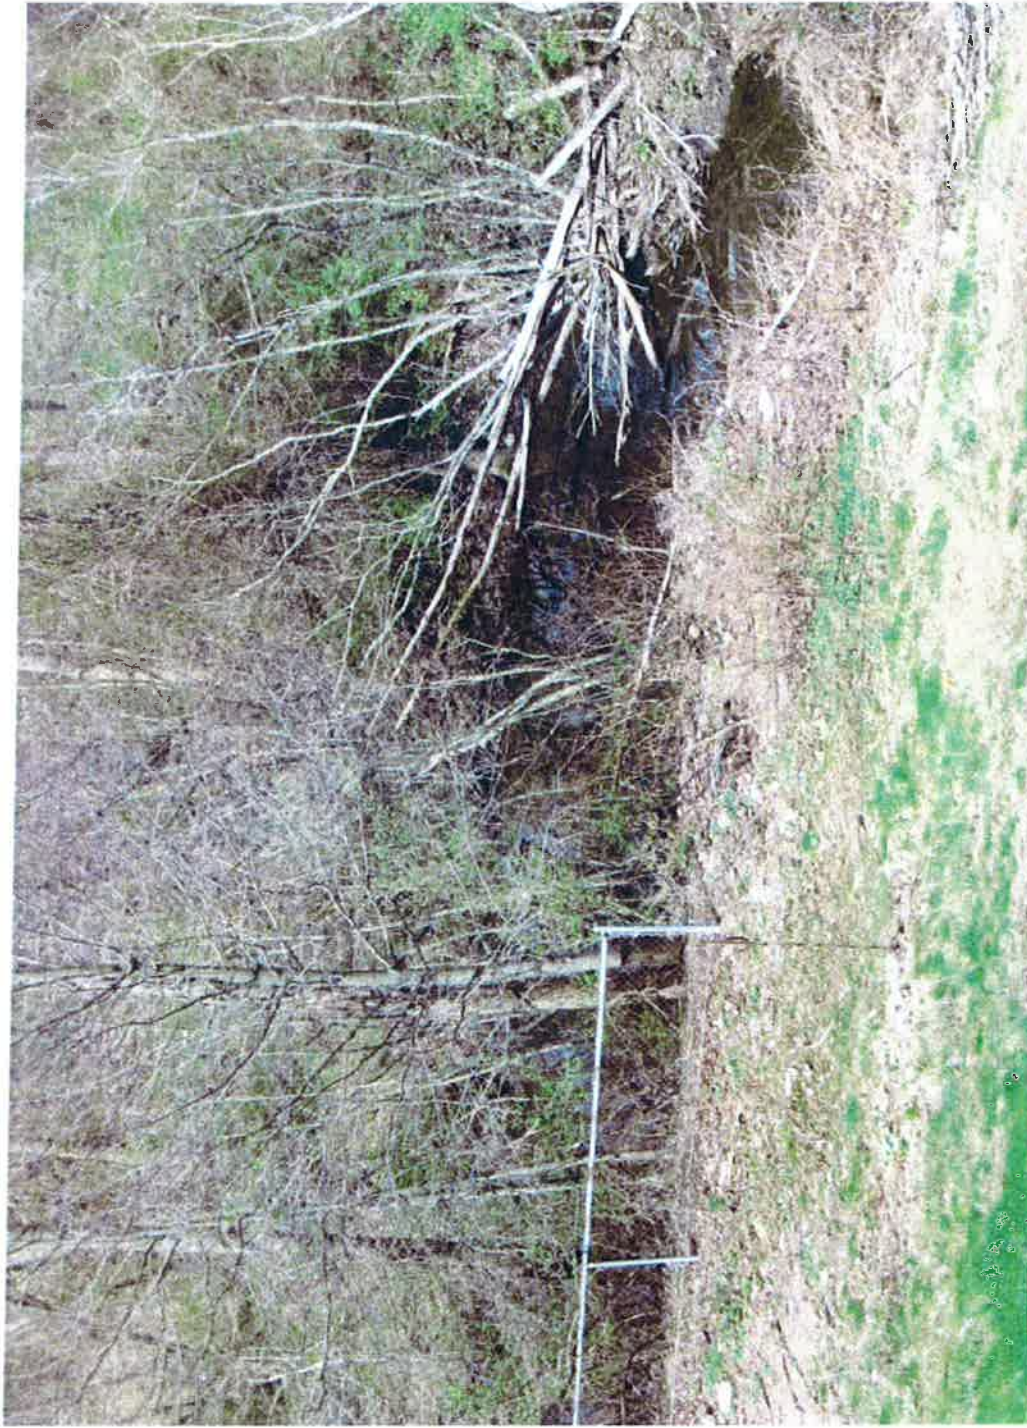
**Inspect ID:** NRDB\_2009\_a\_0007 **Name:** Water ponding at Sluice Gate # 1 Inlet **Caption:** View of the water ponding behind the inlet structure. This could be caused by the inlet being blocked by silt or debris. Conduit should be inspected by remote camera and cleared if necessary.

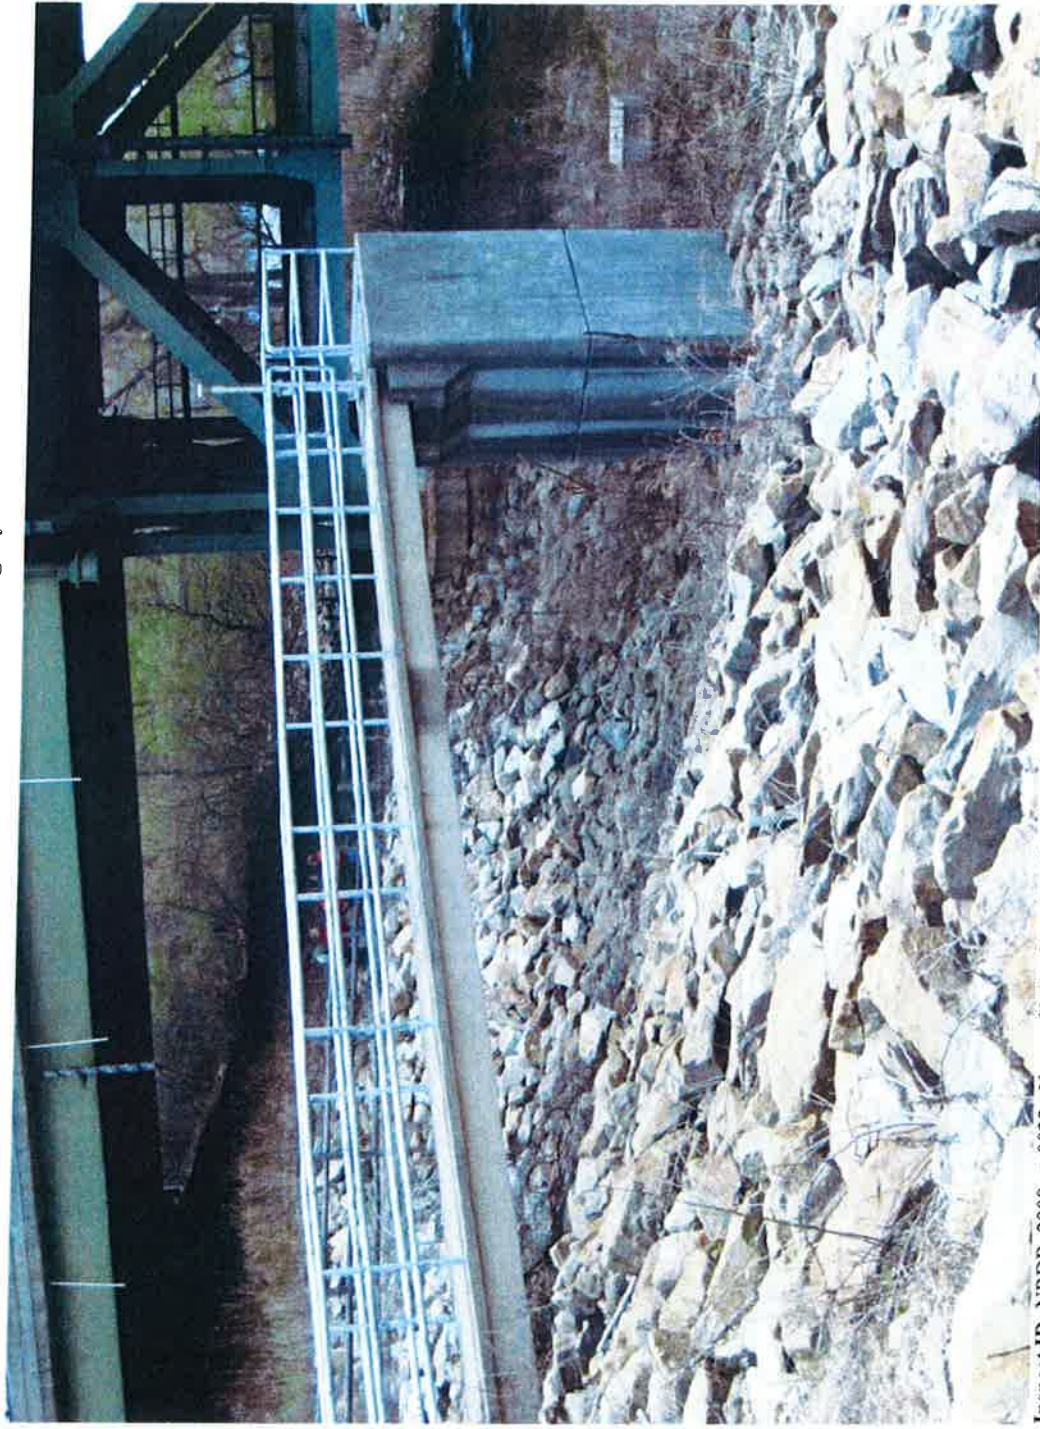
Inspect ID: NRDB\_2009\_a\_0022 Name: Sluice Gate # 3. Caption: Sluice Gate #3. Gate and structure are in good condition.
