- A. FLOOD DAMAGE REDUCTION SEGMENT/SYSTEM INSPECTION REPORT –  
Naugatuck River RB – Southend Ansonia, CT  
Date of Inspection – 4/22/2009 – Provided to Ansonia on February 3, 2010**

February 3, 2010

## Flood Damage Reduction Segment / System Inspection Report

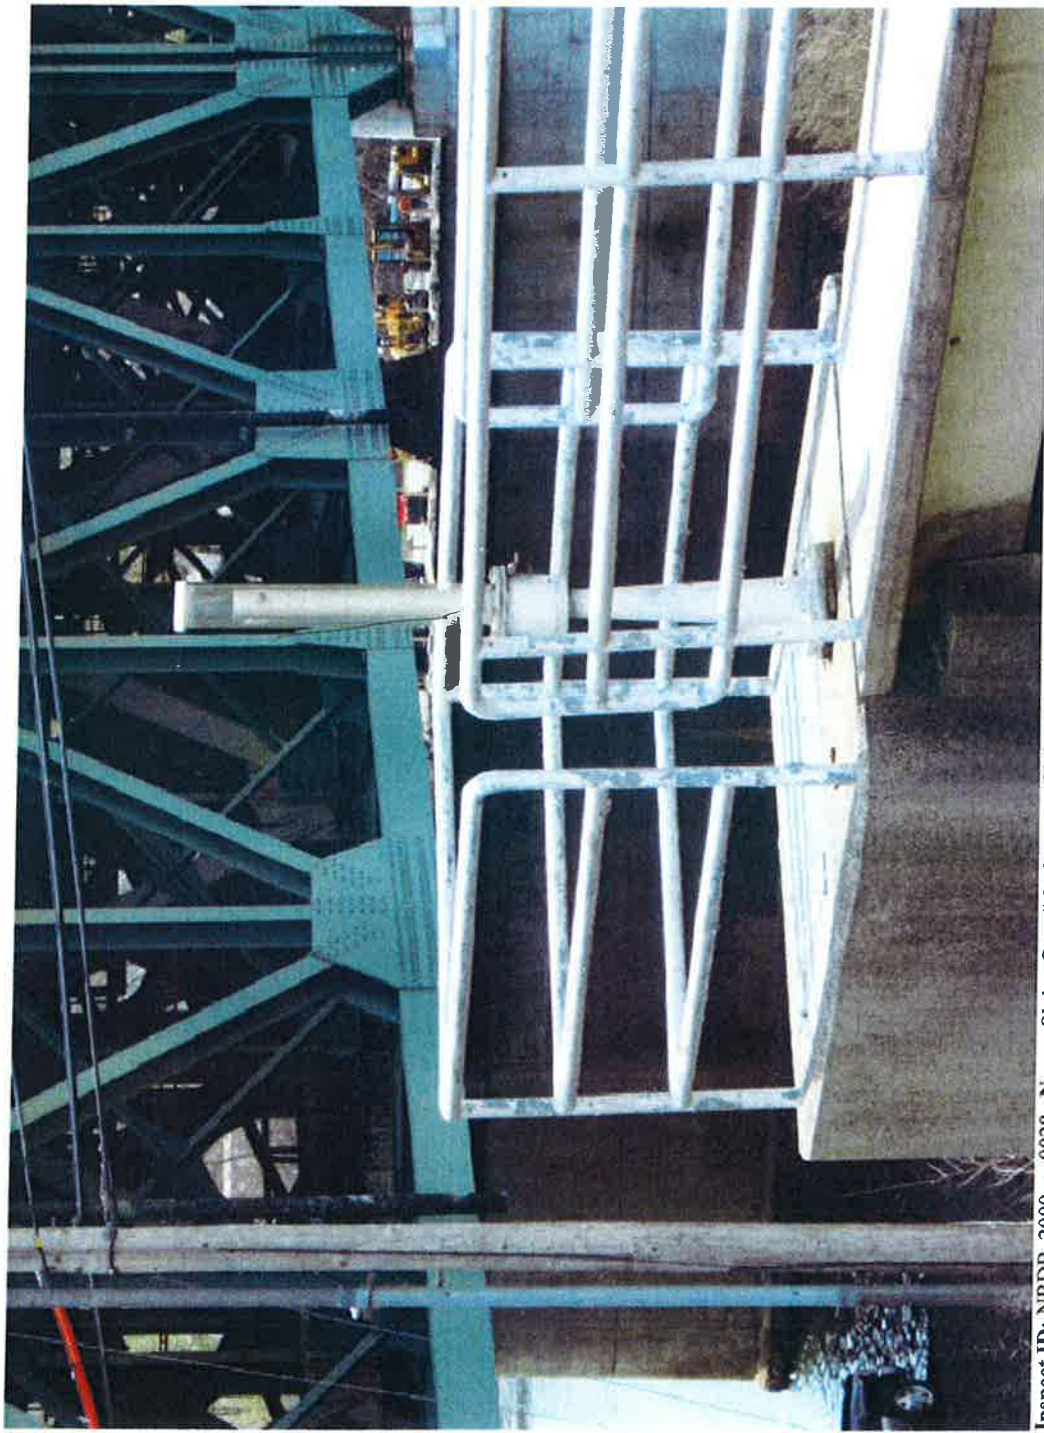
Inspect ID: NRDB\_2009\_a\_0028 Name: Sluice Gate # 2 Caption: Sluice Gate Structure #2. Structure and gate are in good condition.

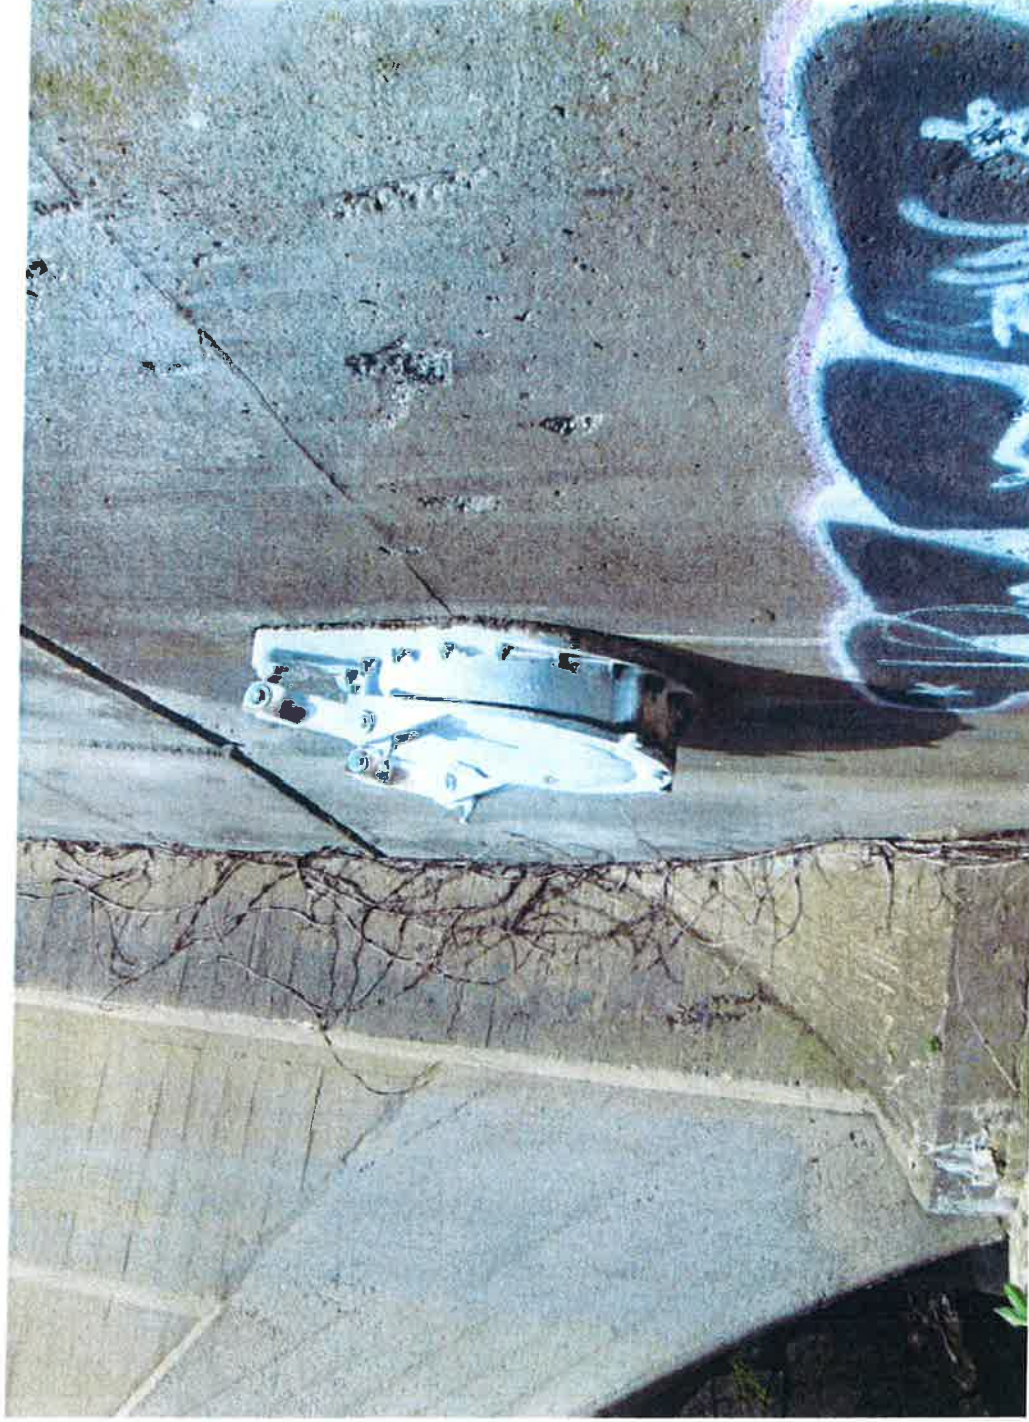
Inspect ID: NRDB\_2009\_a\_0032 Name: Flap gate Caption: One of the two flap gates at this location. Both gates are in good condition.

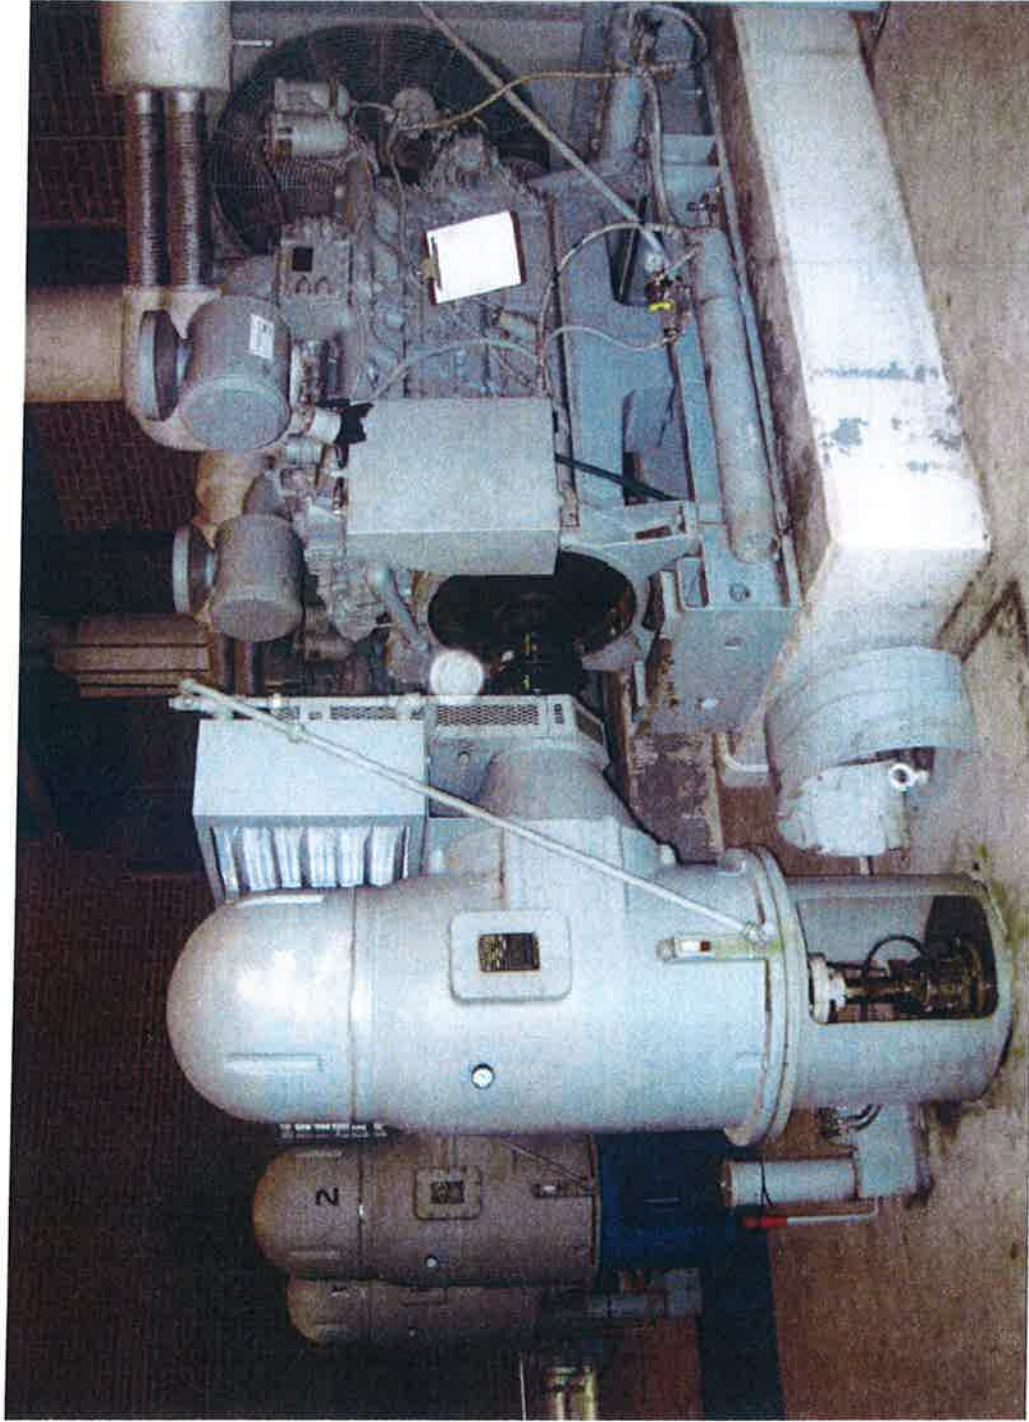
**Inspect ID:** NRDB\_2009\_a\_0027 **Name:** Pump in Derby Pump Station **Caption:** Pump in Derby Pump Station. The pumps and station are in good condition.

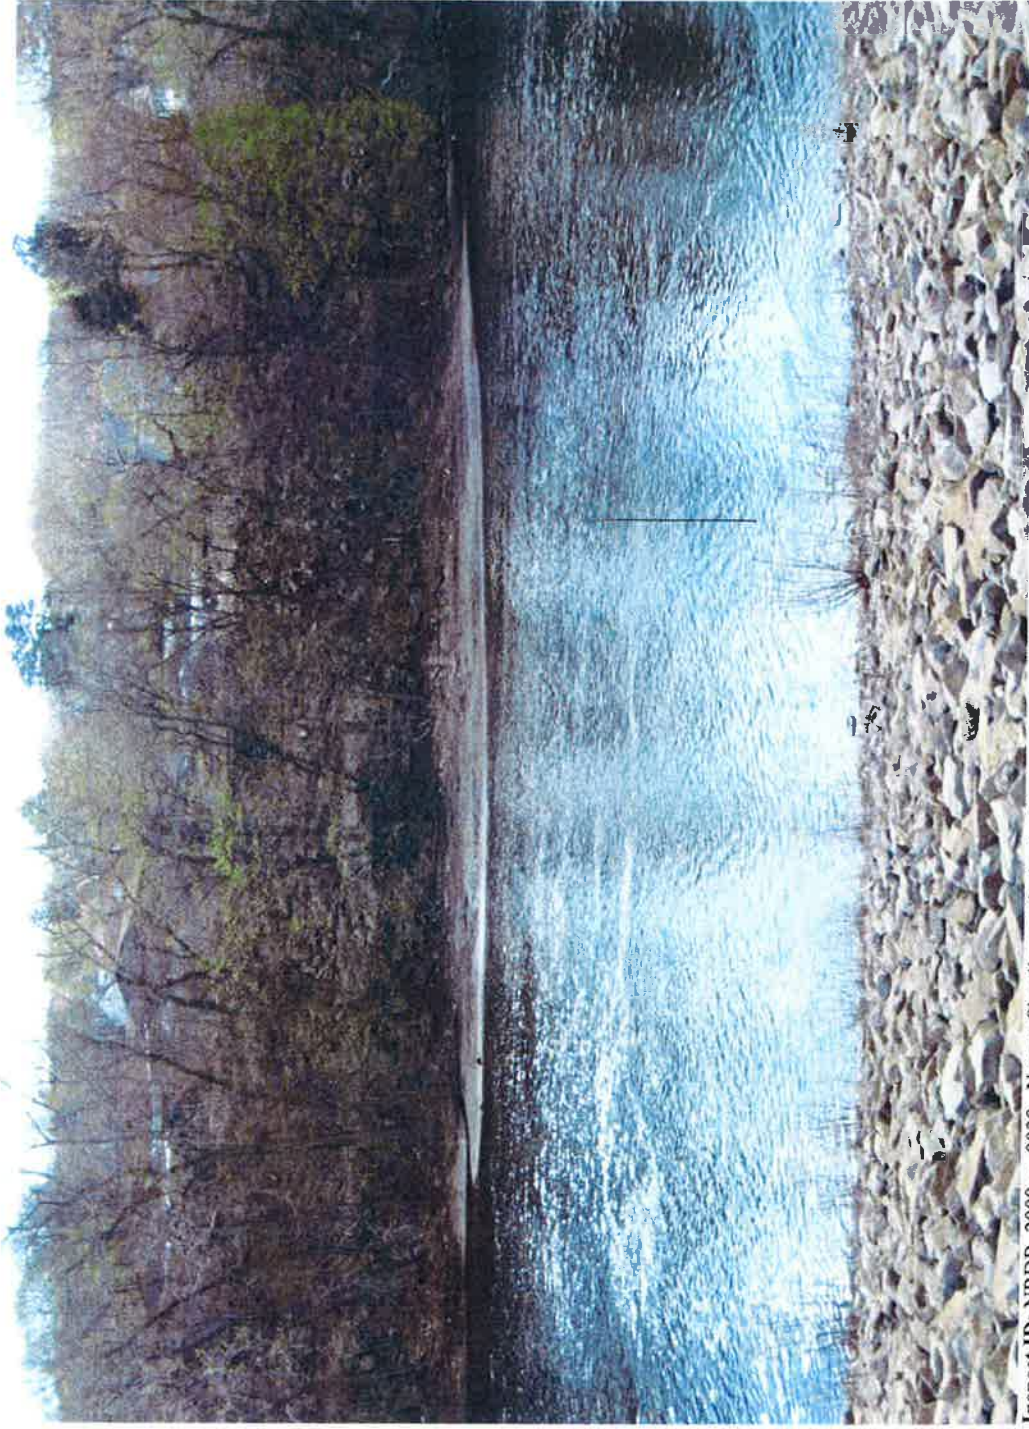
Inspect ID: NRDB\_2009\_a\_0039 Name: Shoaling on far bank Caption: View of shoaling present on the far bank of the channel.

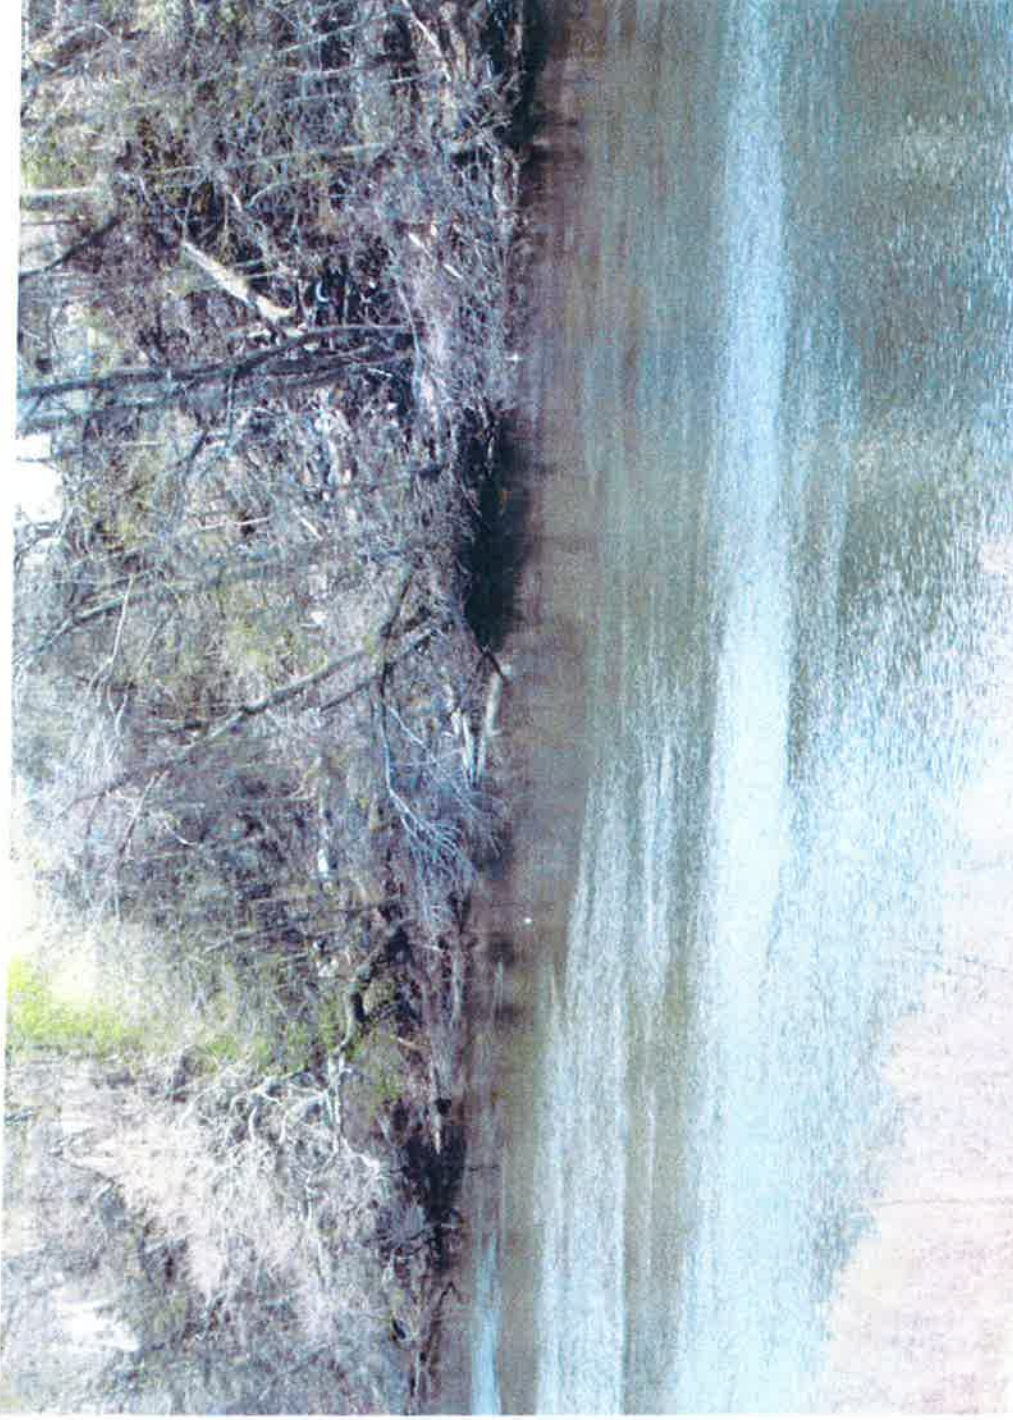
**Inspect ID:** NRDB\_2009\_a\_0008 **Name:** Debris along far bank of channel **Caption:** View of the trees and debris that have been dumped along the far bank of the channel. The debris should be cleared.
