ENGINEERING REPORT

ANALYSIS OF CLOSURES

HOUSATONIC RIVER and NAUGATUCK RIVER

ANSONIA and DERBY, CONNECTICUT

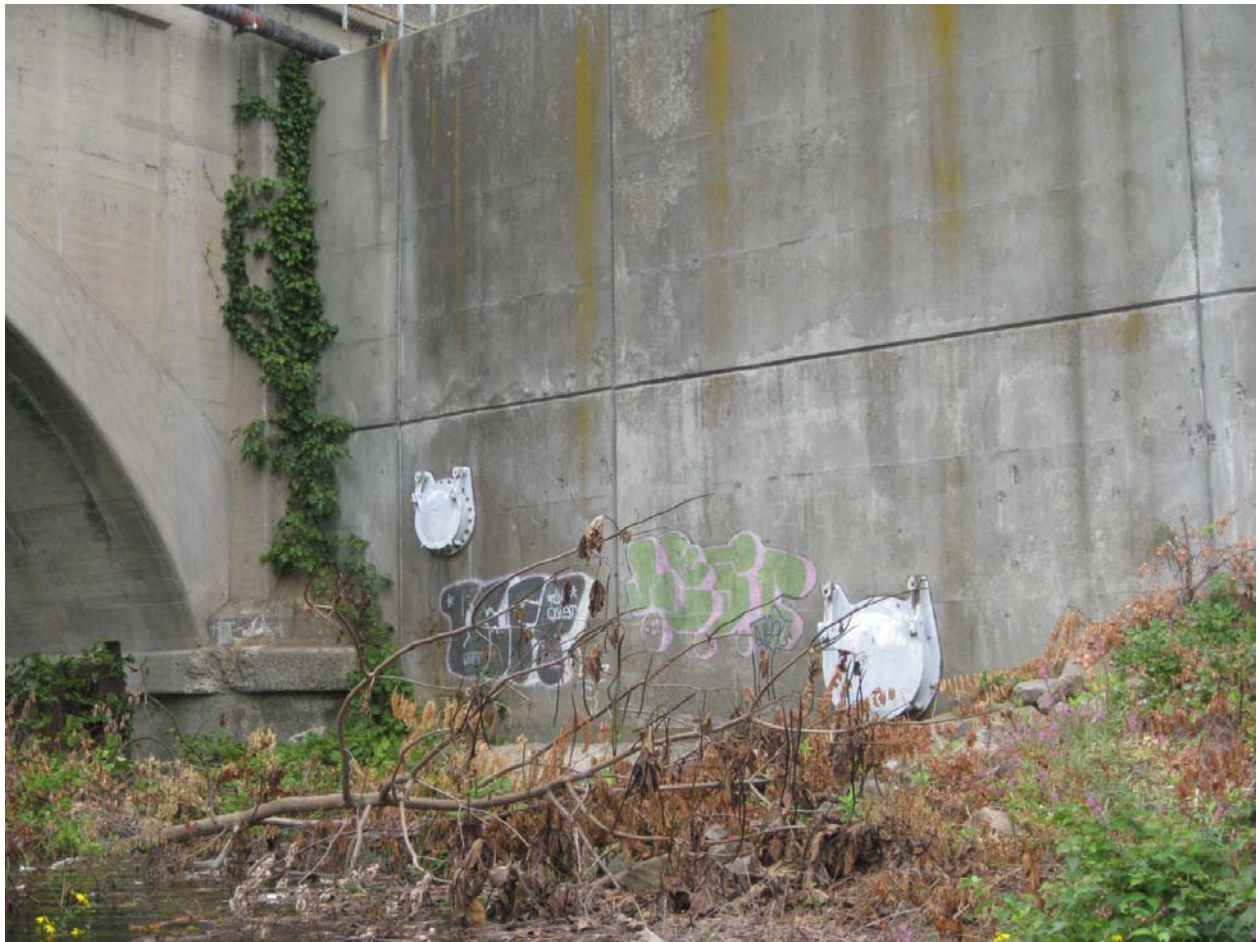
Pressure Conduit Storm Drain Outlet Pipes (Housatonic River)

These penetrations through the flood wall are for 24" and 36" pressure conduits that convey surface runoff from upland areas in Derby. The outlets are located adjacent to Bridge Street at the northern limits of the flood protection system along the Housatonic River. This conduit under normal conditions and during the base flood should be able to convey stormwater as the system is closed until the inlet, which is at a higher elevation than the base flood. These two outlet pipes are equipped with flap gates. Both flap gates appeared free of debris and appeared to be in good working order when MMI witnessed their operation. Closed circuit television (CCTV) inspections performed on the accessible portions of these pipes indicated that the pipes are in good condition. Additional information regarding the pipe and culvert inspections can be found in Appendix F – Engineering Report – Interior Drainage, provided in support of the overall FEMA certification package.

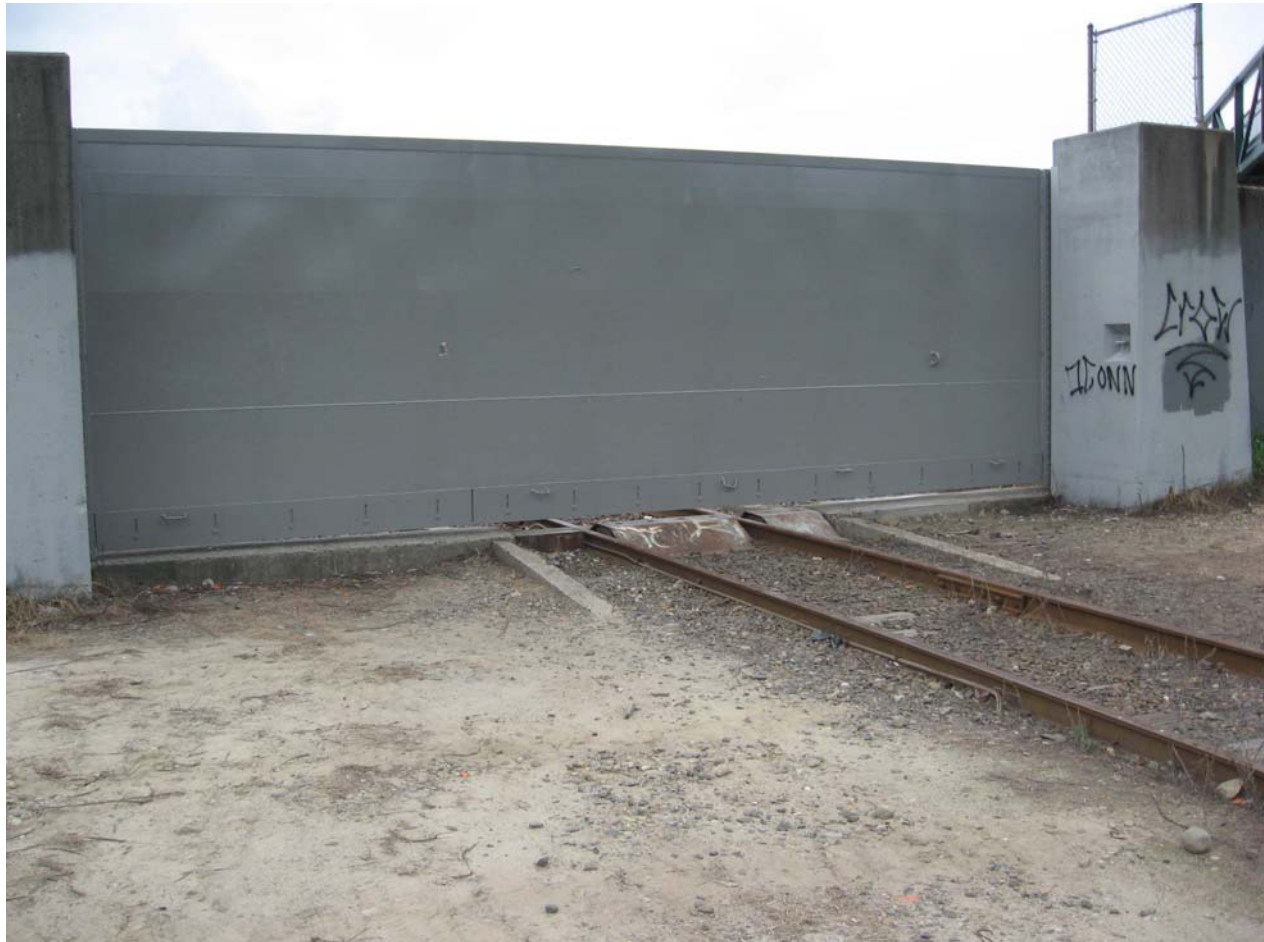
Railroad Flood Gate Structure #3

This opening is provided for the Housatonic Railroad Company. The elevation of the sill at the gate closure for this particular crossing is at an elevation of 21.74, slightly higher than the base flood elevation of approximately 21.55. MMI witnessed the operation of the door for Gates #3, and it was observed to be in good working order. Sandbags and sand stockpiles are stored at the Department of Public Works (DPW) Garage facility located at Coon Hollow Road.

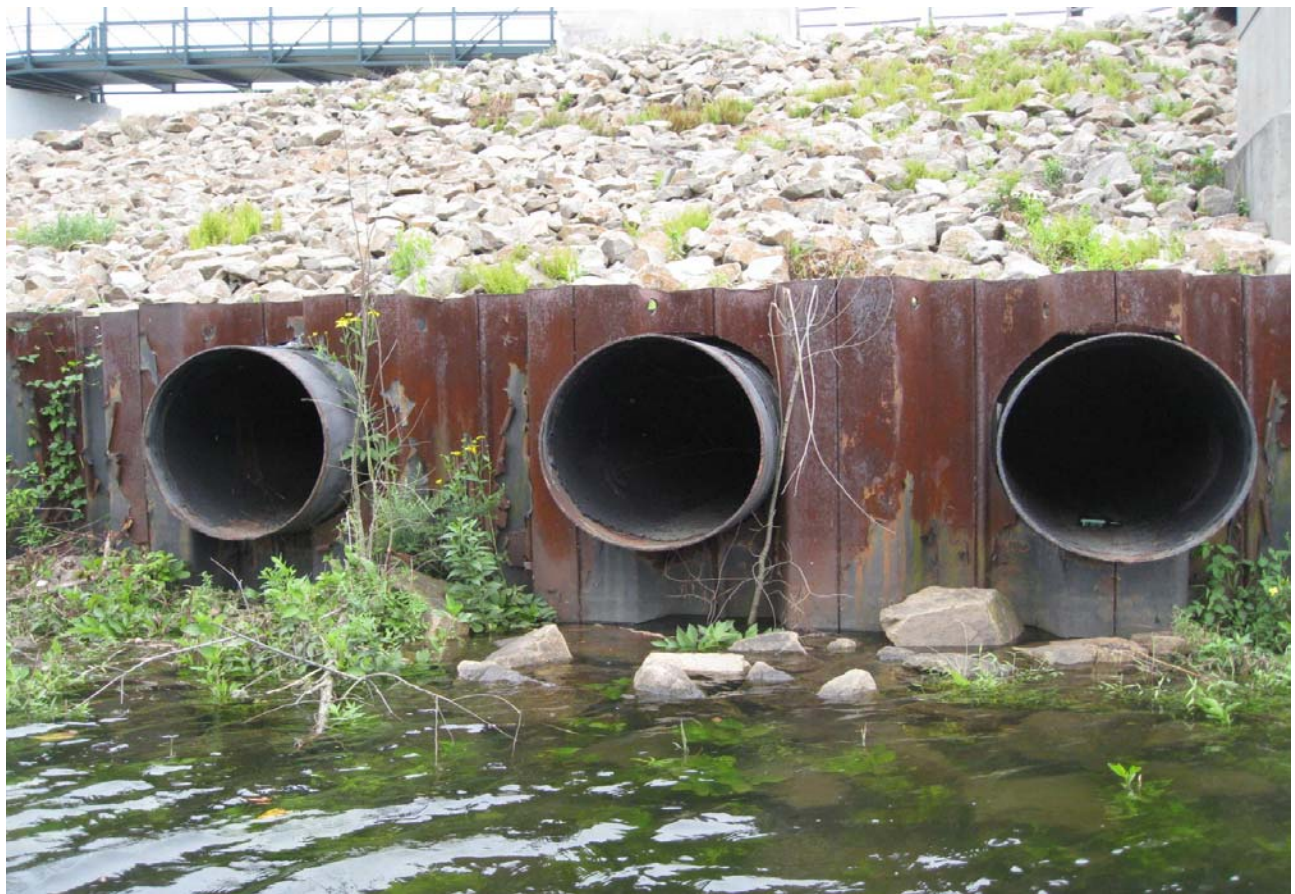
Force Main Discharge Piping From Derby Pumping Station

Three 36" steel force main discharge pipes exit the Derby Pumping Station and extend up and over the levee embankment. The outlets of the pipes are not equipped with flap gates; however, they were free of debris and sediment. The pipes reach a maximum height of 32.0 beneath the top of the levee, well above the base flood elevation of approximately 21.

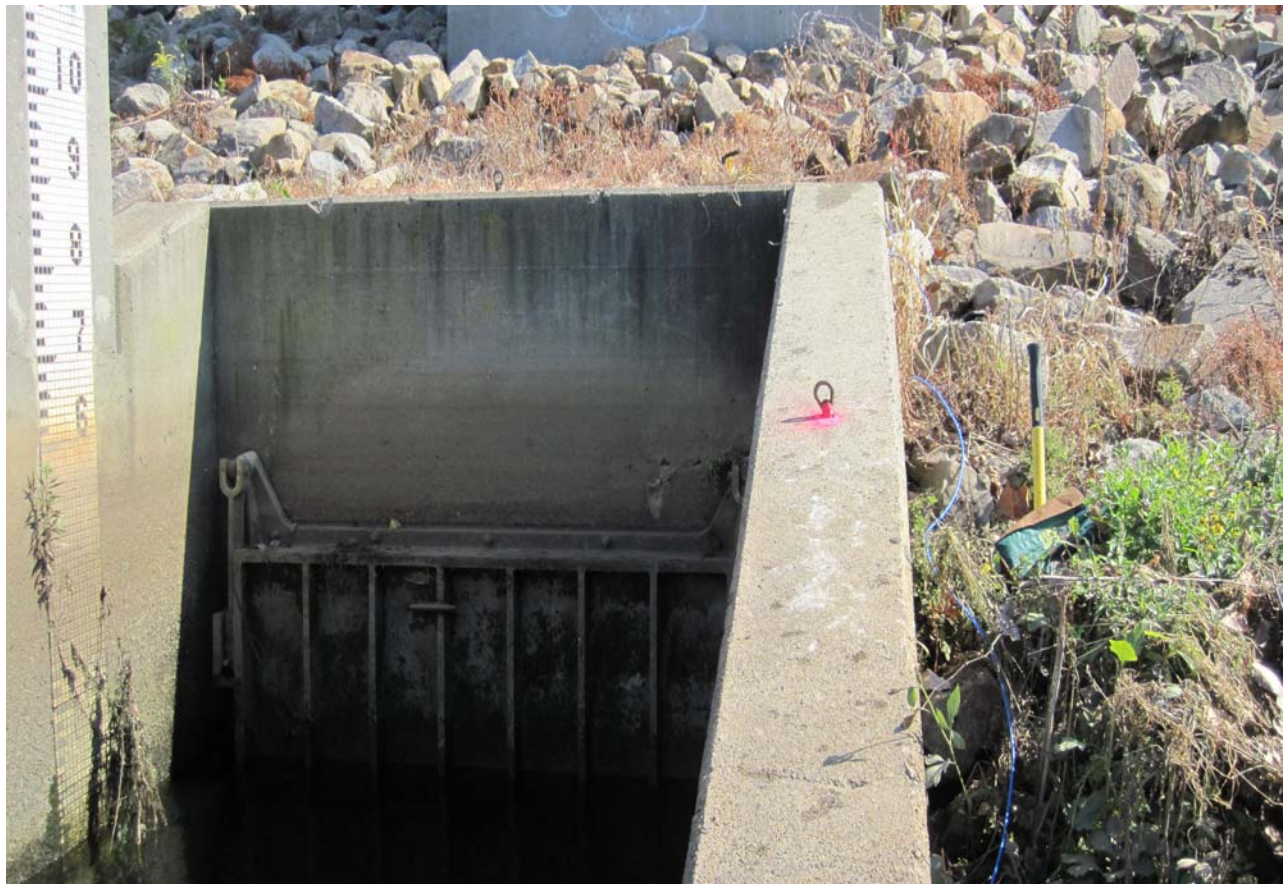
Gravity Storm Drainage Outlet With Sluice Gate Structure #2

This structure is an 8'x6' gravity storm drainage culvert adjacent to the Derby Pumping Station. Under normal flow conditions, this culvert conveys storm runoff from upland areas in Derby and the outflow from the Derby Water Pollution Control Authority (WPCA) Facility. The outlet is equipped with a flap gate and Sluice Gate #2 in order to prevent elevated river elevations from backing up into interior areas. The flap gate appeared in good working order at a site visit, and Sluice Gate #2 also appeared in good working order when MMI witnessed its operation with city staff. CCTV inspections performed indicated that this culvert is in good condition. Additional information regarding the pipe and culvert inspections can be found in Appendix F – Engineering Report – Interior Drainage, provided in support of the overall FEMA certification package.

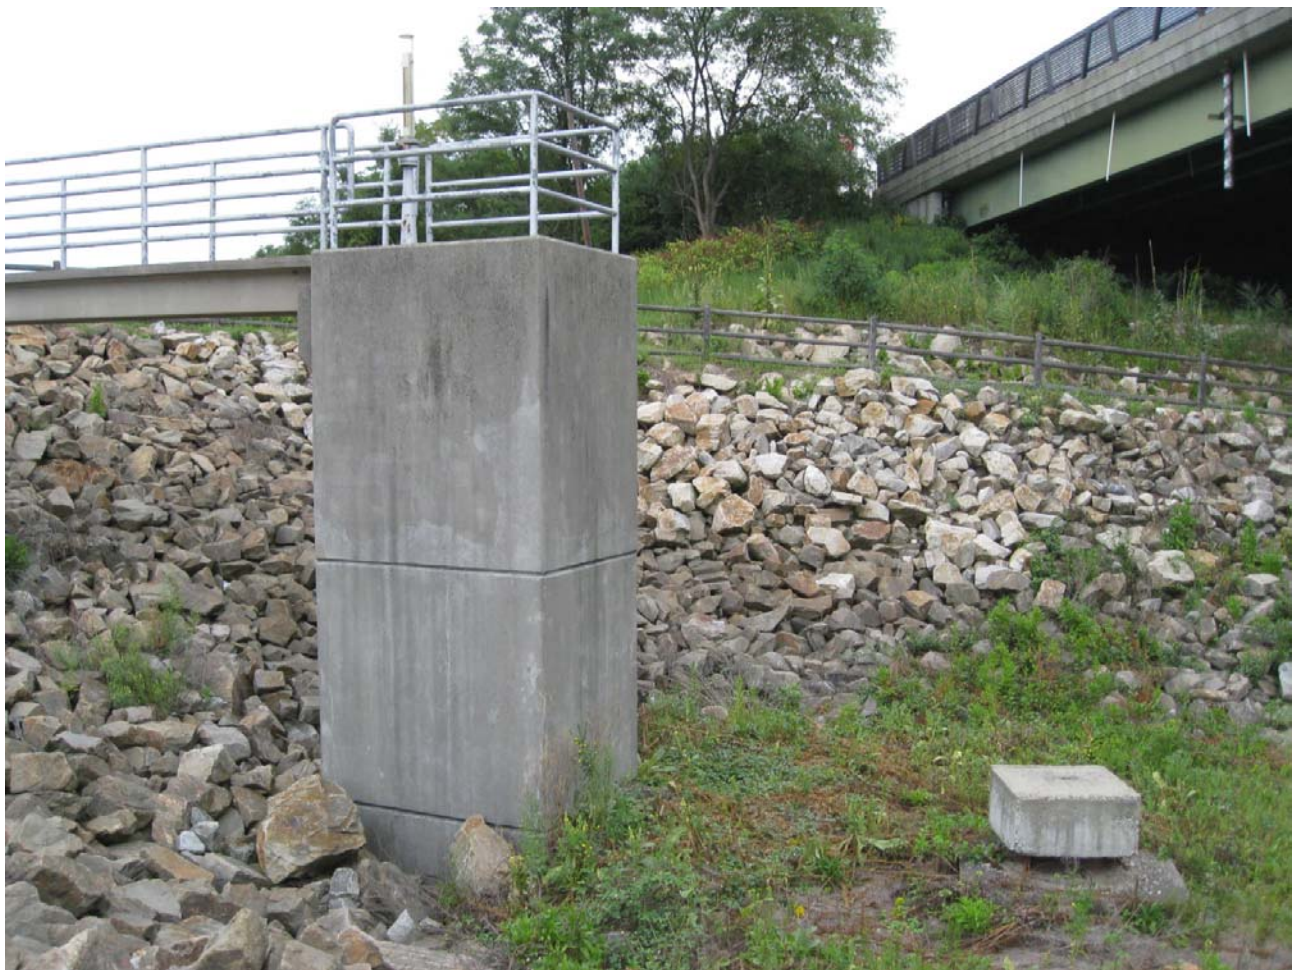
Sanitary Sewer Pipe With Sluice Gate Structure #3

This penetration through the levee consists of an 18" sanitary sewer pipe crossing beneath the levee with Sluice Gate #3, adjacent to the Derby WPCA Facility. The Operations and Maintenance Manual states that this gate is only closed in case of the rupture of the sewer pipe crossing the Naugatuck River (\pm 1,000 feet upslope of Sluice Gate #3). This gate was not reviewed as part of this analysis as it is not closed under base flood conditions as defined by FEMA.

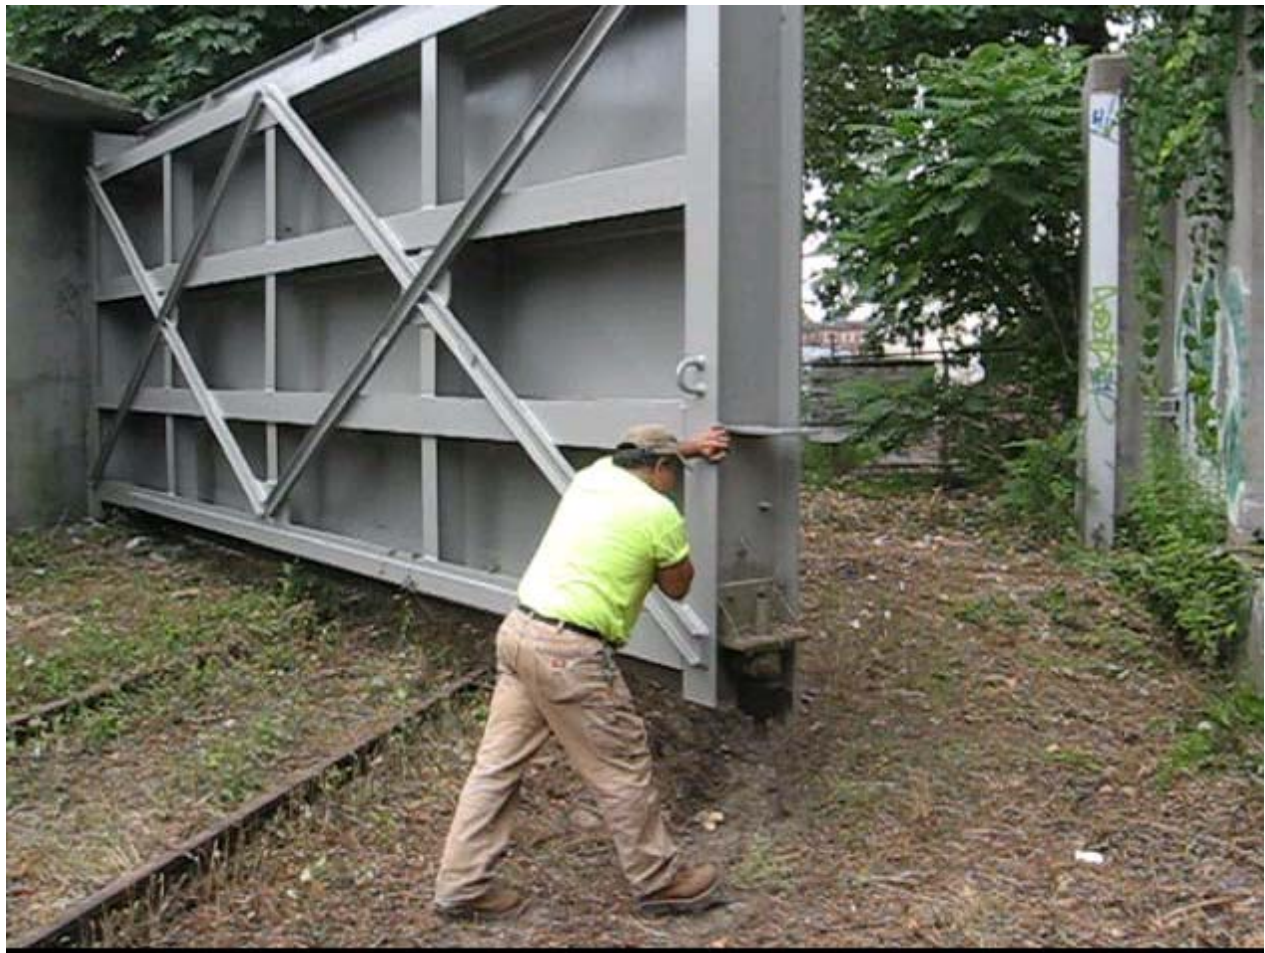
Railroad Gate #2A

The elevations of the sills at both gates are below the base flood condition. MMI witnessed the operation of the doors for both gates 2A and 2B, and they are in good working order. Sandbags and sand stockpiles are stored under cover at the DPW Garage facility on Coon Hollow Road.

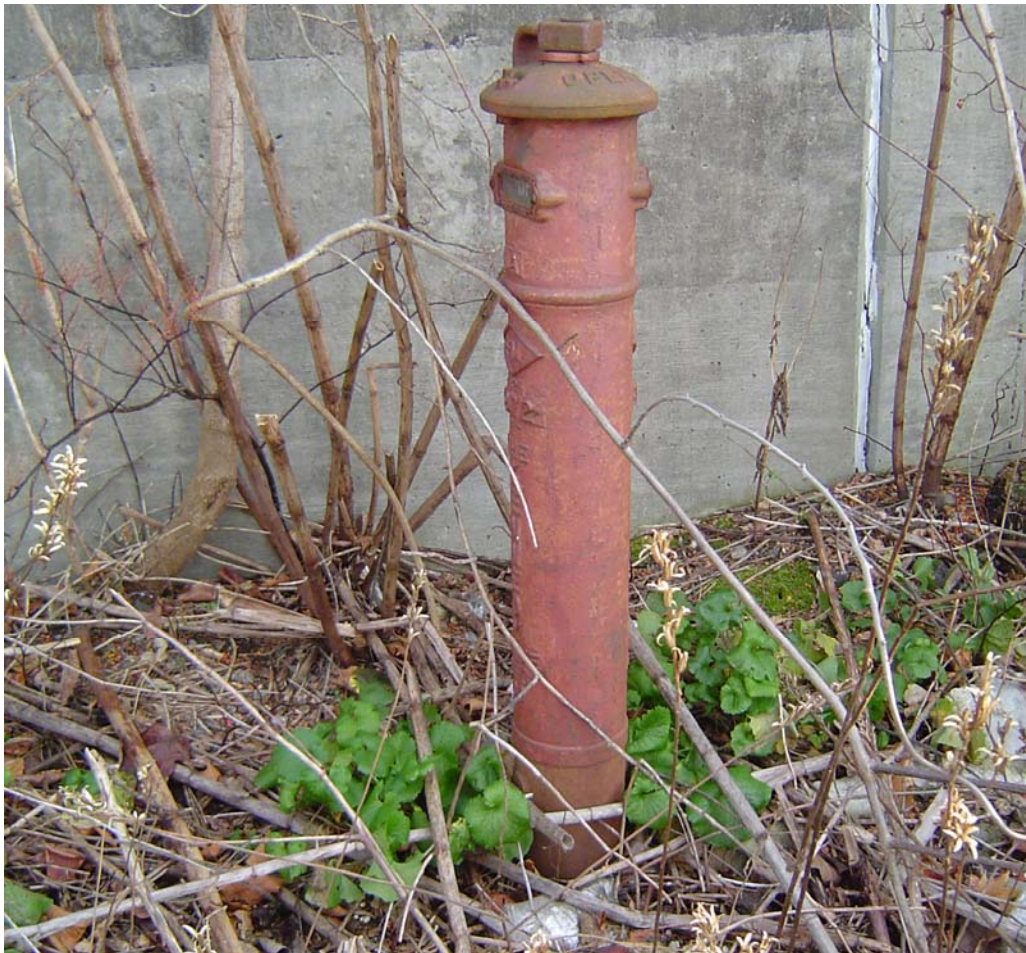
Post Indicator

An 8" storm drain pipe penetrates the floodwalls adjacent to Gate #2B. The landward side of this pipe is equipped with a post-indicator and valve that were located by MMI; however, operation of this valve was not witnessed during inspections. The post-indicator appeared wobbly, and the valve may need maintenance. In addition, the drain inlet grate is missing, and the structure needs to be cleaned of debris.

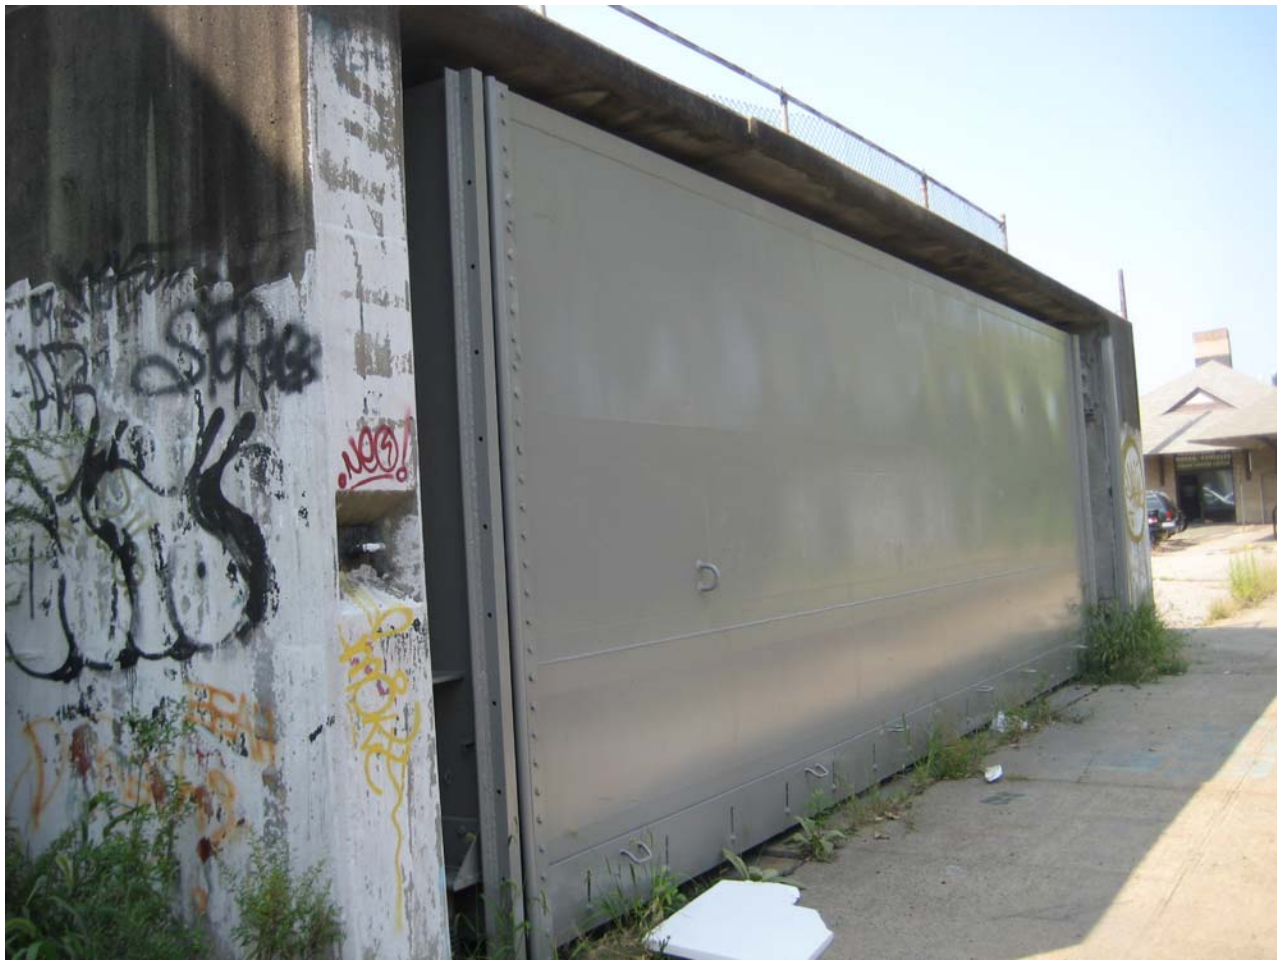
Railroad Flood Gate #1

This opening is provided for the Metro-North railroad crossing and Railroad Gate Structure #1 adjacent to the Derby train station. The elevation of the sill is below the base flood condition.

The Derby DPW has operated this gate as part of its ongoing inspection procedures and, based on its experience, the sluice gate is in good working order. MMI was not able to witness the closing of this gate as proper coordination with Metro-North could not be achieved during our review.

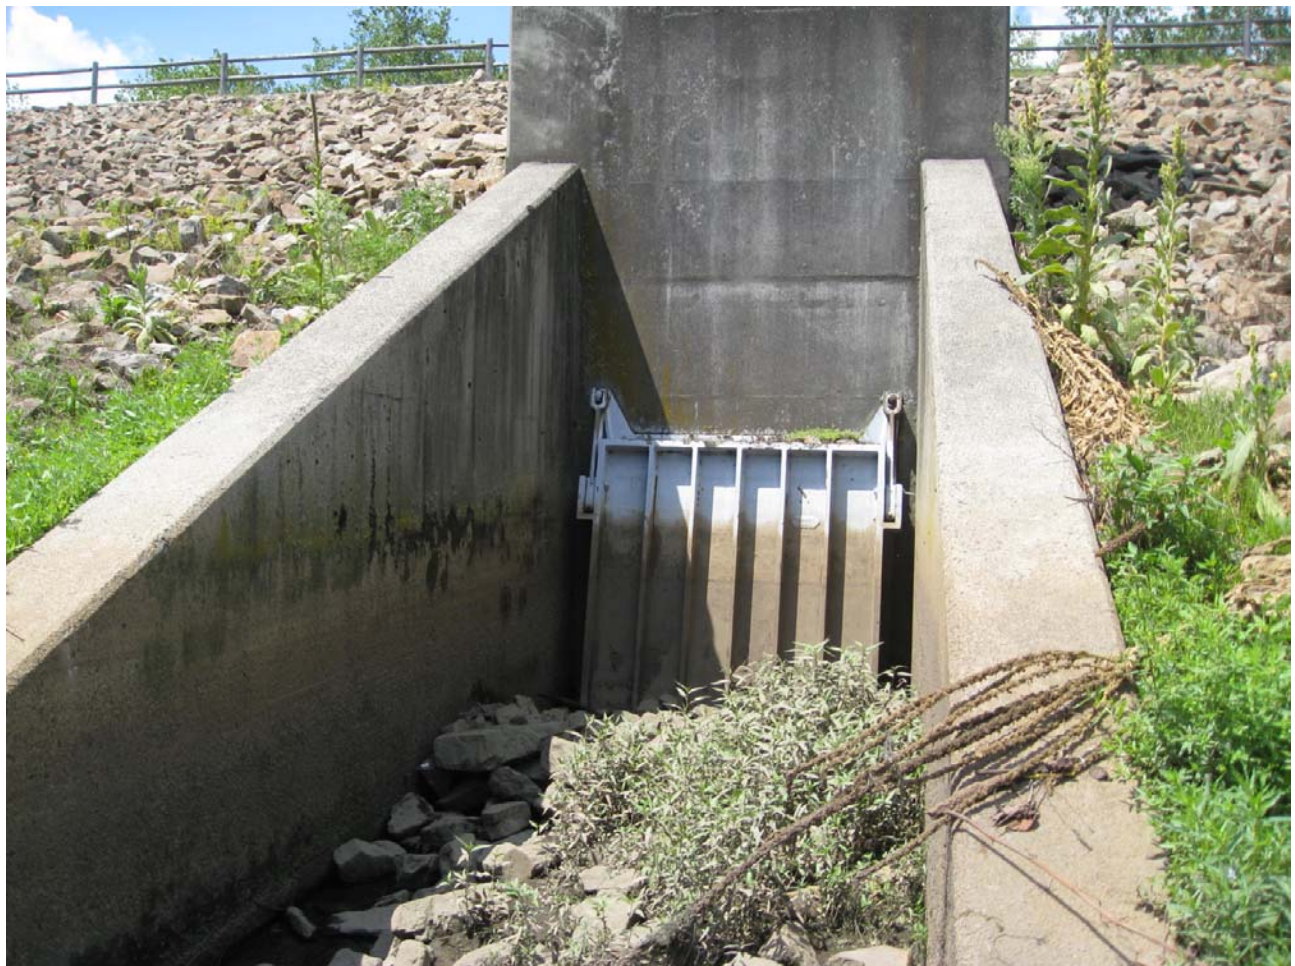
Gravity Storm Drainage Outlet With Sluice Gate Structure #1

This structure is a 6'x6' gravity storm drainage outlet adjacent to currently vacant City of Derby-owned property. Under normal flow conditions, this culvert conveys runoff from upland areas in Derby and low lying areas behind the levee. The area drained by this outlet is not equipped with a pump station or other means to evacuate accumulated water during elevated river conditions.

The outlet is equipped with a flap gate and Sluice Gate #1 in order to prevent elevated river elevations from backing up into landward areas. The flap gate appeared in good working order; however, debris had accumulated at the flap gate to prevent its closure at our initial site visit and as indicated in the latest USACE inspection report. The City of Derby was notified of the condition and has since removed the obstructions, and the gate has been returned to its proper operating condition. Sluice Gate #1 also appeared to be in good working order when MMI witnessed its operation with city staff. CCTV inspections performed indicated that this culvert is in good condition. Additional information regarding the pipe and culvert inspections can be found in Appendix F – Engineering Report – Interior Drainage, provided in support of the overall FEMA certification package.

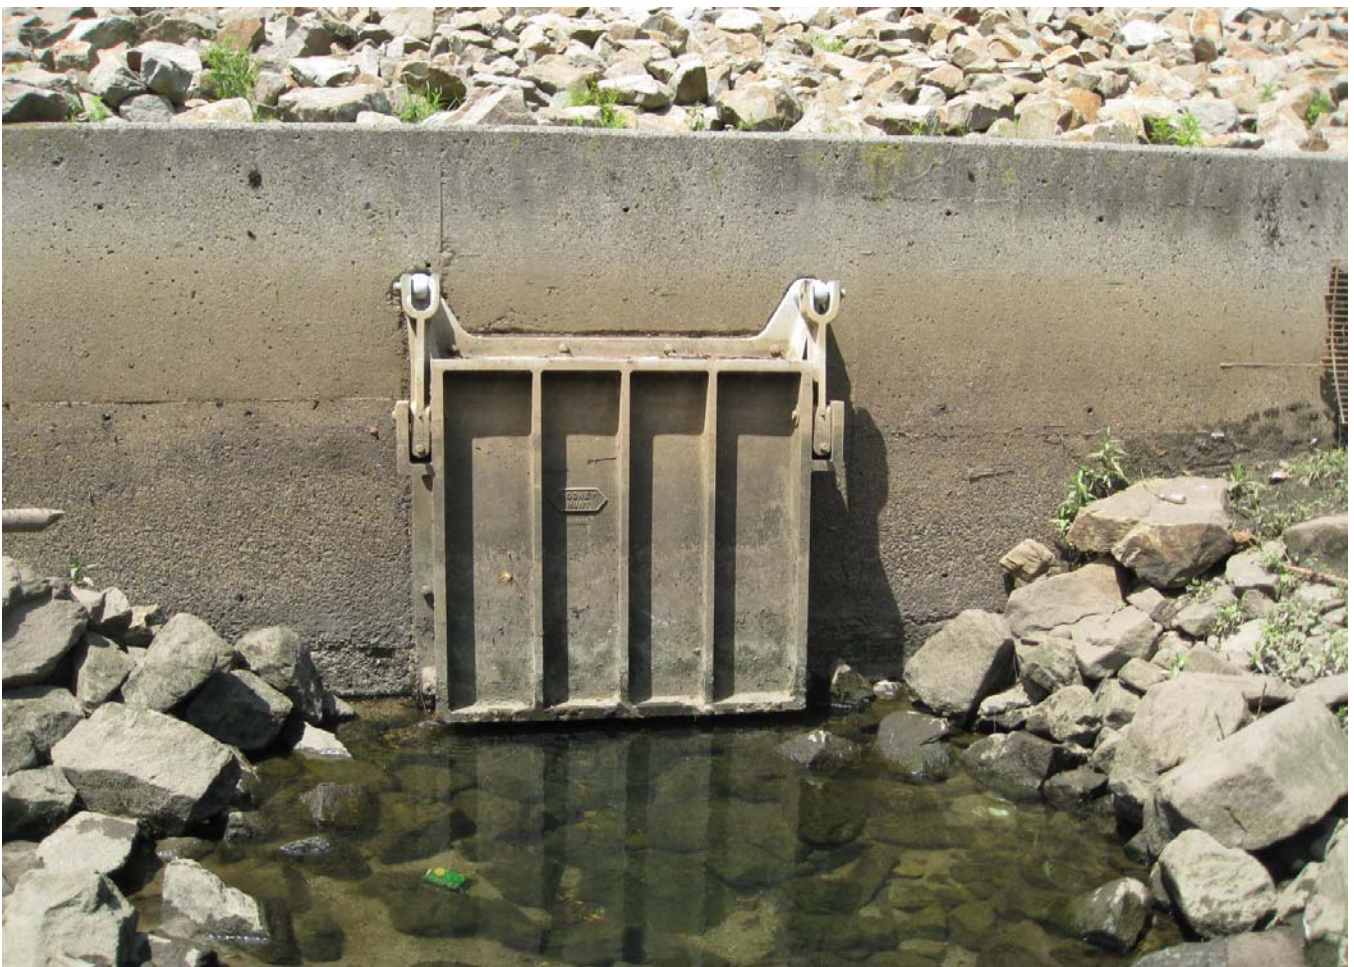
Pressure Conduit Storm Drainage Outlet With Sluice Gate Structure #11

This structure is a 4'x4' storm drainage pressure conduit culvert south of Division Street that conveys surface runoff from upland areas in Derby. This culvert which is fed by a 48" reinforced concrete pressure conduit under normal conditions conveys runoff from upland areas behind the levee to the Naugatuck River and during the base flood the sluice gate remains open since the inlet to this since is higher than base flood water surface elevation. This outlet is equipped with a flap gate and Sluice Gate Structure #11. Both the flap gate and sluice gate appeared free of debris and seemed to be in good working order when MMI witnessed their operation with city staff. CCTV inspections performed on this conduit indicated that the pipes are in good condition with sections of the pipe requiring cleaning of accumulated sediment and debris. Additional information regarding the pipe and culvert inspections can be found in Appendix F – Engineering Report – Interior Drainage, provided in support of the overall FEMA certification package.

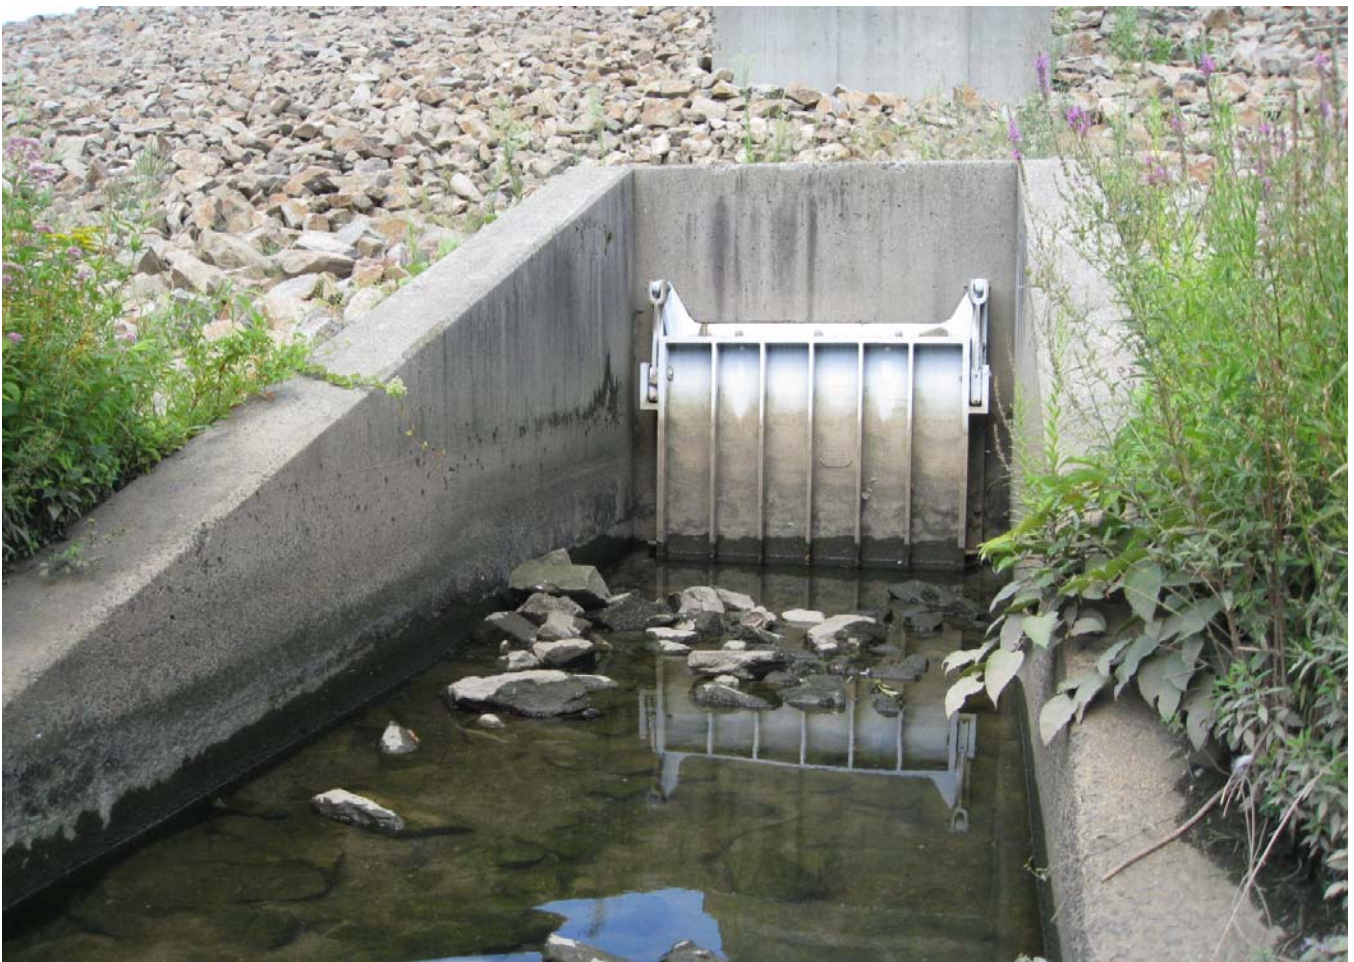
Gravity Storm Drainage Outlet With Sluice Gate Structure #10

This structure is a 6'x5' gravity storm drainage culvert adjacent to the Division Street pumping station. Under normal flow conditions, this culvert conveys runoff from upland areas west of the

Naugatuck River in southern Ansonia and northern Derby. The outlet is equipped with a flap gate and Sluice Gate #10 in order to prevent elevated river water surface elevations from backing up into landward areas. The flap gate appeared in good working order at a site visit, and Sluice Gate #10 is operated regularly by the City of Ansonia DPW as part of its ongoing inspection procedures. Based on its experience, the sluice gate is also in good working order. CCTV inspections performed indicated that this culvert is in good condition. Additional information regarding the pipe and culvert inspections can be found in Appendix F – Engineering Report – Interior Drainage, provided in support of the overall FEMA certification package.

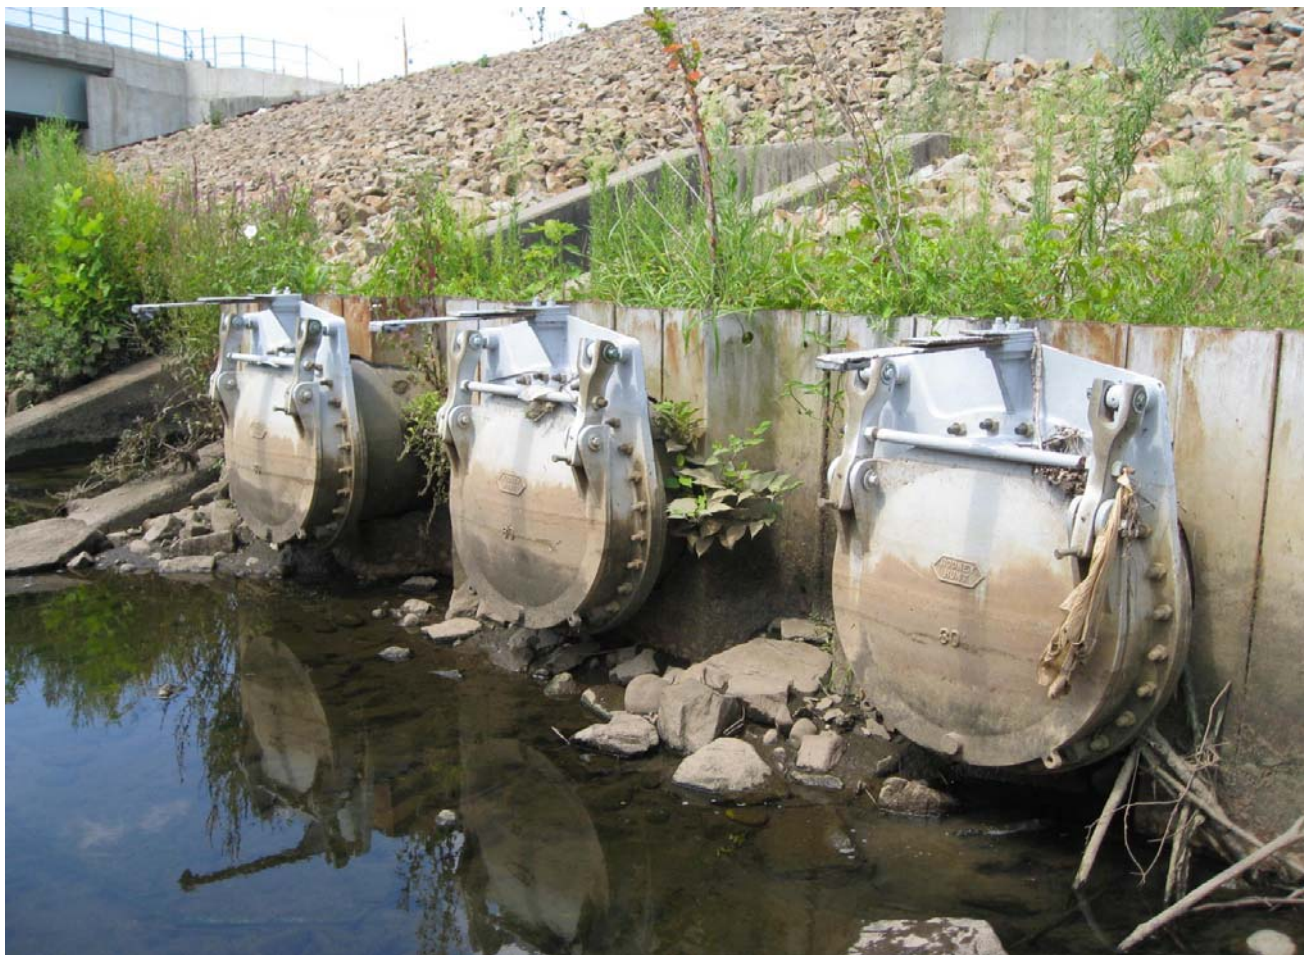
Force Main Discharge Pipes From the Division Street Pumping Station

Three 30” steel force main discharge pipes exit the Division Street Pumping Station and extend up and over the levee embankment. The three pipes have flap gates at the riverside discharge that appear in good condition although some sediment has accumulated in the pipes themselves due to siltation from elevated river levels and the lack of flow from the pump station. In the event that the pump station is used to convey storm drainage, the accumulated sediment will be quickly forced out of the pipes. The pipes reach a maximum height of 32.5 beneath the top of the levee, well above the base flood elevation of approximately 24.

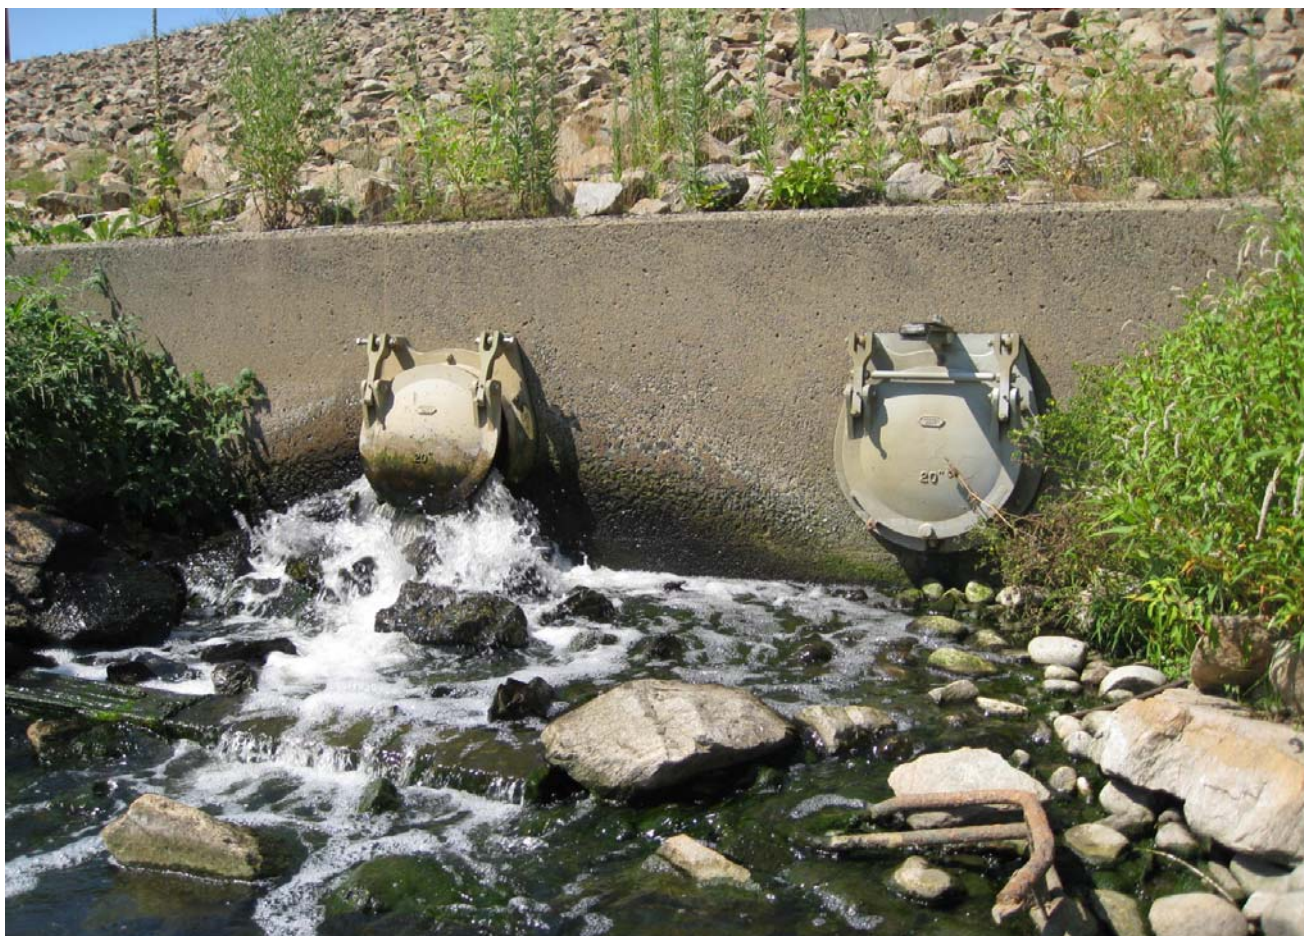
Sanitary Sewer Pipes With Sluice Gate Structure #8

This structure supports two sanitary sewer pipes (both 20”) which cross beneath the levee. These pipes are the outlet from the Ansonia WPCF with one pipe used as a gravity outlet with Sluice Gate #8 and one pipe as a force main discharge in the event of elevated river conditions. Both outlets have flap gates at the discharge that appear in good condition. The Operations and Maintenance Manual states that Sluice Gate #8 and the post-indicator valve are to be closed in case of the rupture of the pipe(s) crossing the river. As part of the new WPCA Sewage Treatment Plant currently under construction, the post-indicator valve and gate valve associated with this closure system are being replaced. Sluice Gate #8 is operated regularly by the City of

Ansonia DPW as part of its ongoing inspection procedures. Based on its experience, the sluice gate is in good working order.

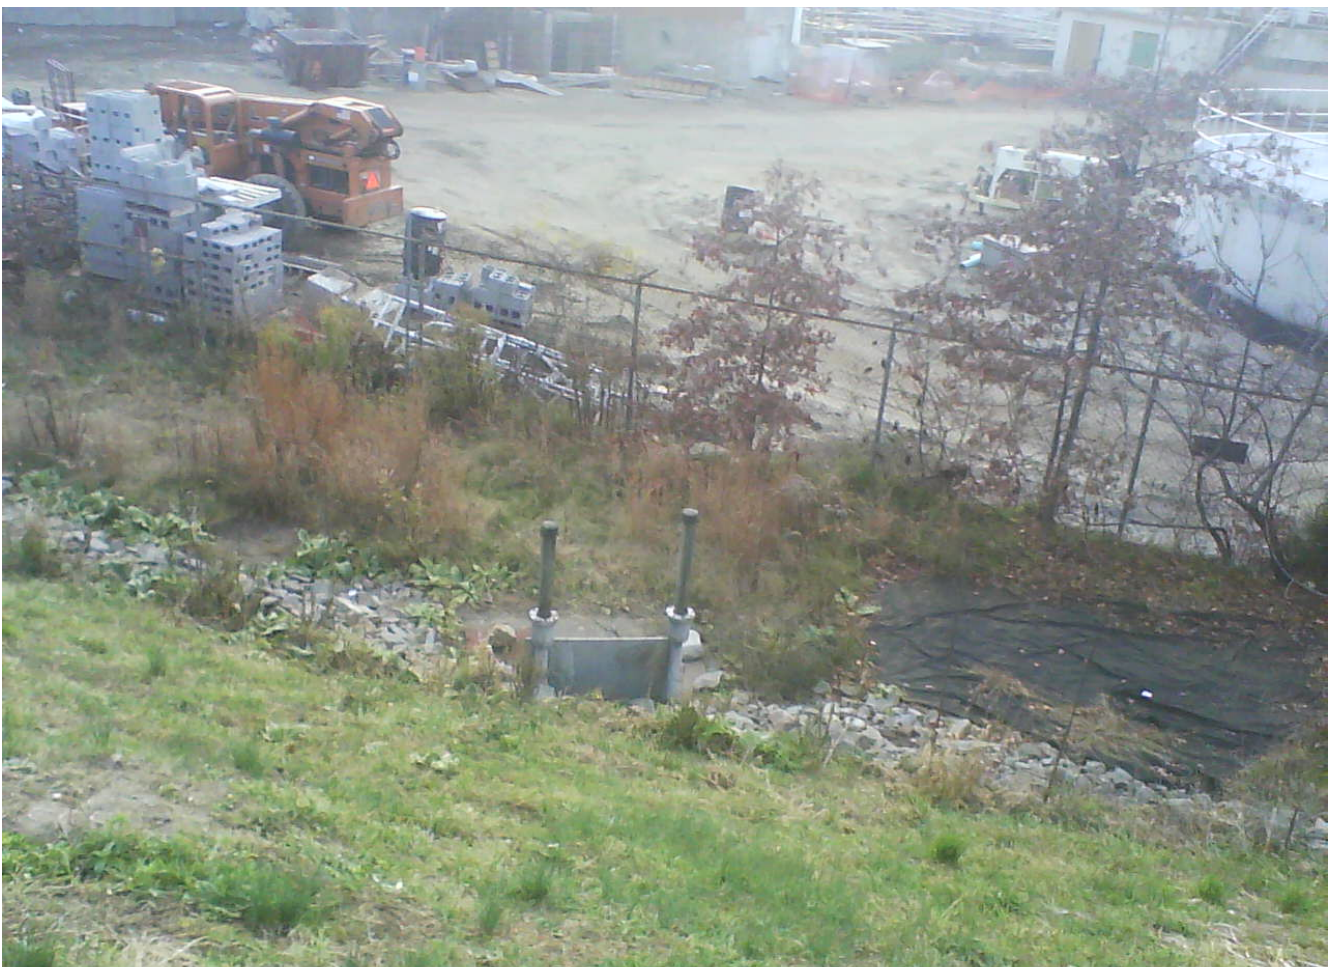
Sanitary Sewer Pipes With Sluice Gate Structure #7

This opening consists of dual sanitary sewer siphon pipes (16" and 20") crossing beneath the Naugatuck River with manually operated sluice gates on the landward side of the levee adjacent to the Ansonia WPCF. The Operations and Maintenance Manual states that these gates are only closed in case of the rupture of the pipe(s) crossing the river. This gate was not reviewed as part of this analysis as it is not closed under base flood conditions (or the 100-year flood).

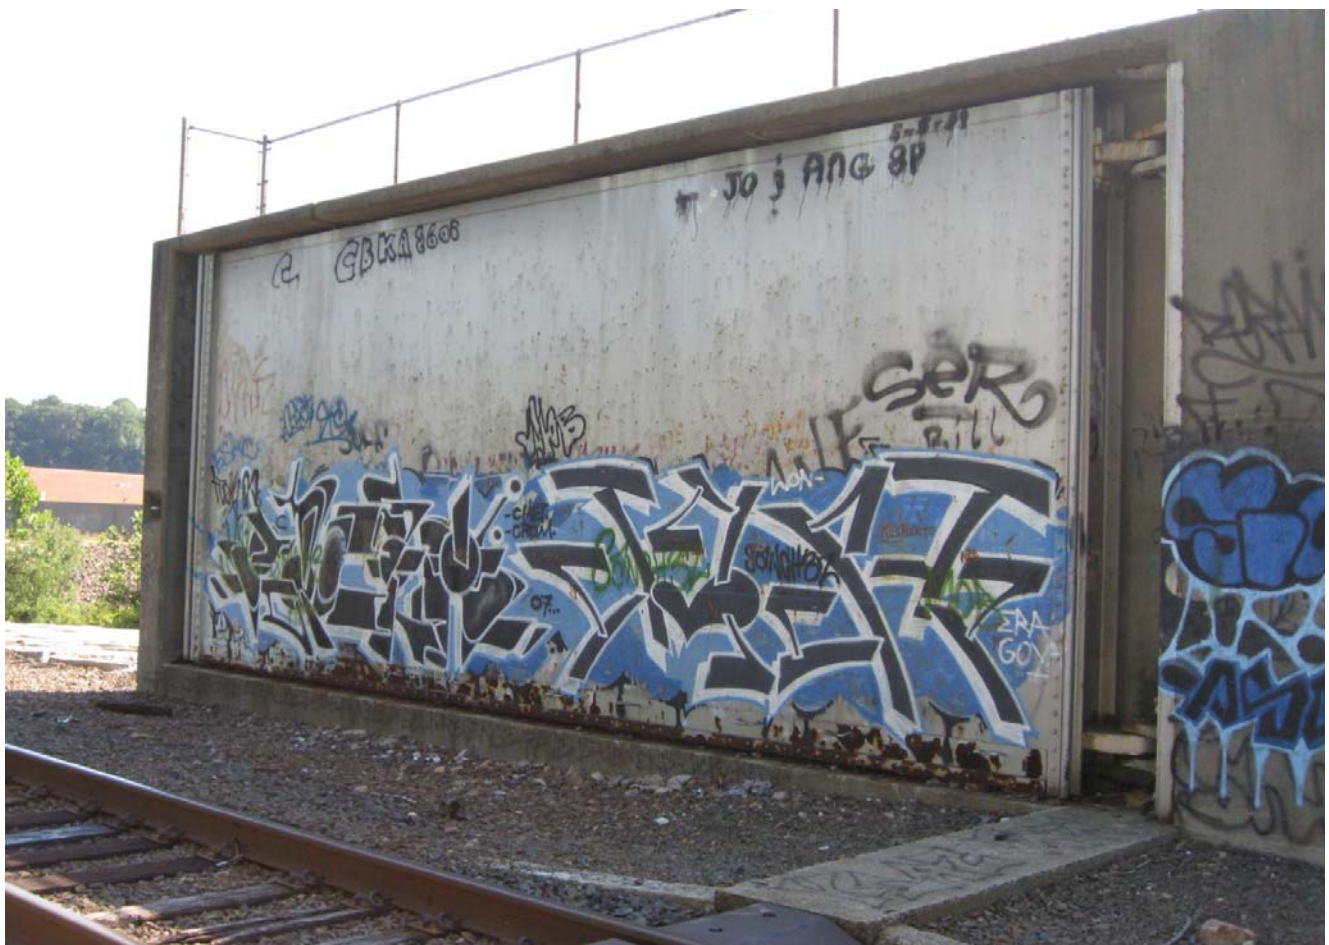
Railroad Flood Gate #4

This opening is provided for the Metro-North Railroad. The elevation of the sill at the gate closure for this particular crossing is at an elevation of 27.0, slightly higher than the base flood elevation of approximately 26.8. The Ansonia Department of Public Works (DPW) has operated this gate as part of their ongoing inspection procedures and based on their experience; the gate is in good working order. Sand bags and sand stockpiles are stored at the Ansonia DPW facility located at the end of North Division Street.

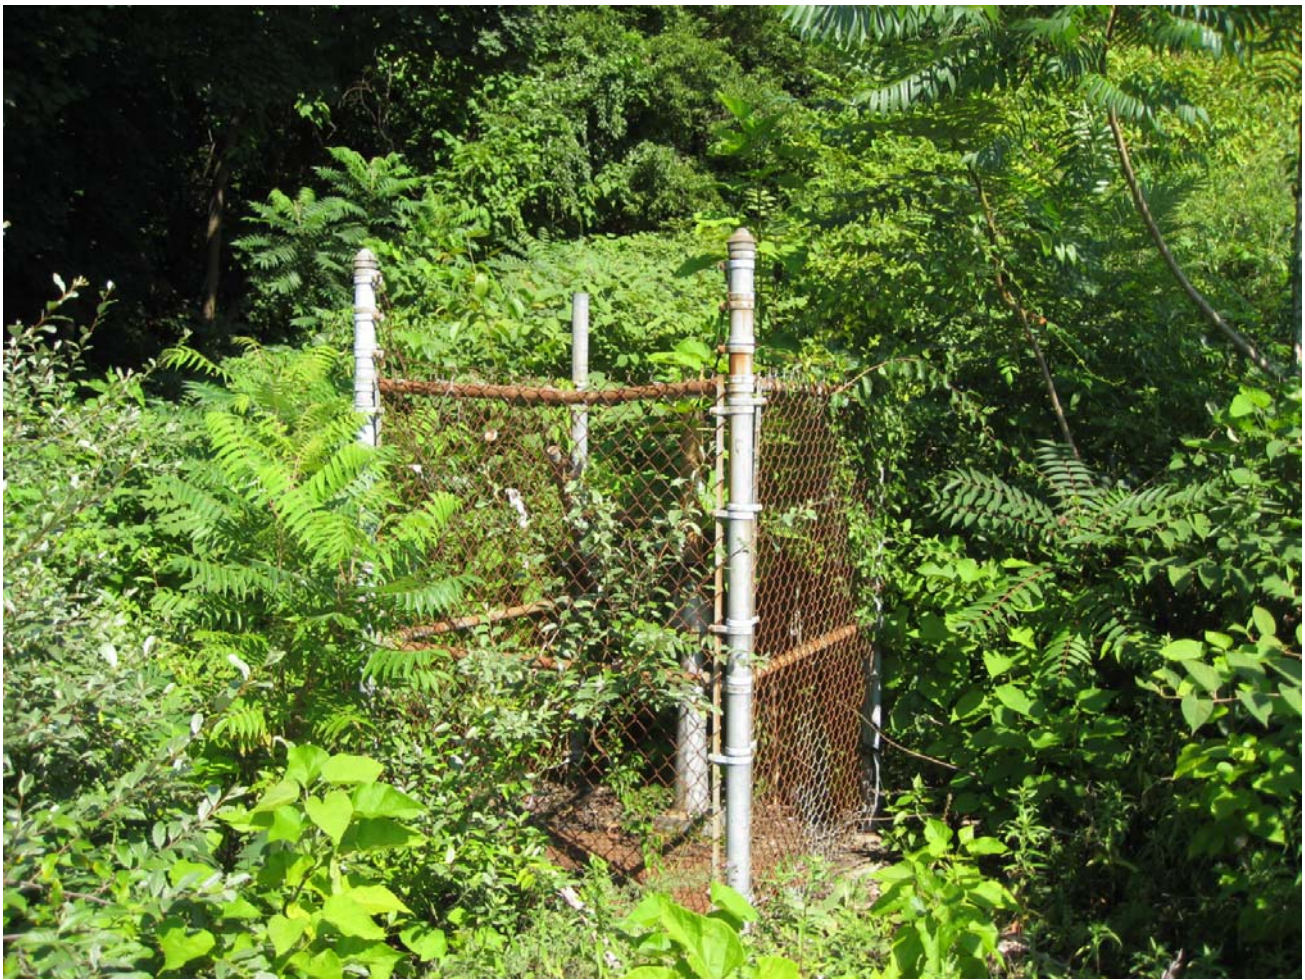
This structure supports a 24" sanitary sewer pipe crossing beneath the levee with a manually operated sluice gate on the landward side of the levee, adjacent to the Metro-North railroad bridge. The Operations and Maintenance Manual states that this gate is only closed in case of the rupture of the pipe crossing the river. This gate was not reviewed as part of this analysis as it is not closed under base flood conditions as defined by FEMA.

Sanitary Sewer Pipe With Sluice Gate Structure #5 (Vegetation has been cleared)
