ANSONIA & DERBY LEVEE
SECTION 1
ANSONIA & DERBY, CT

PHOTOGRAPHIC LOCATION PLAN

Drn By: ML	Scale: 1" = 260'	Project: 04019.001
Ch'kd By: VL	Date: 11/11/2010	Plate No. : 5

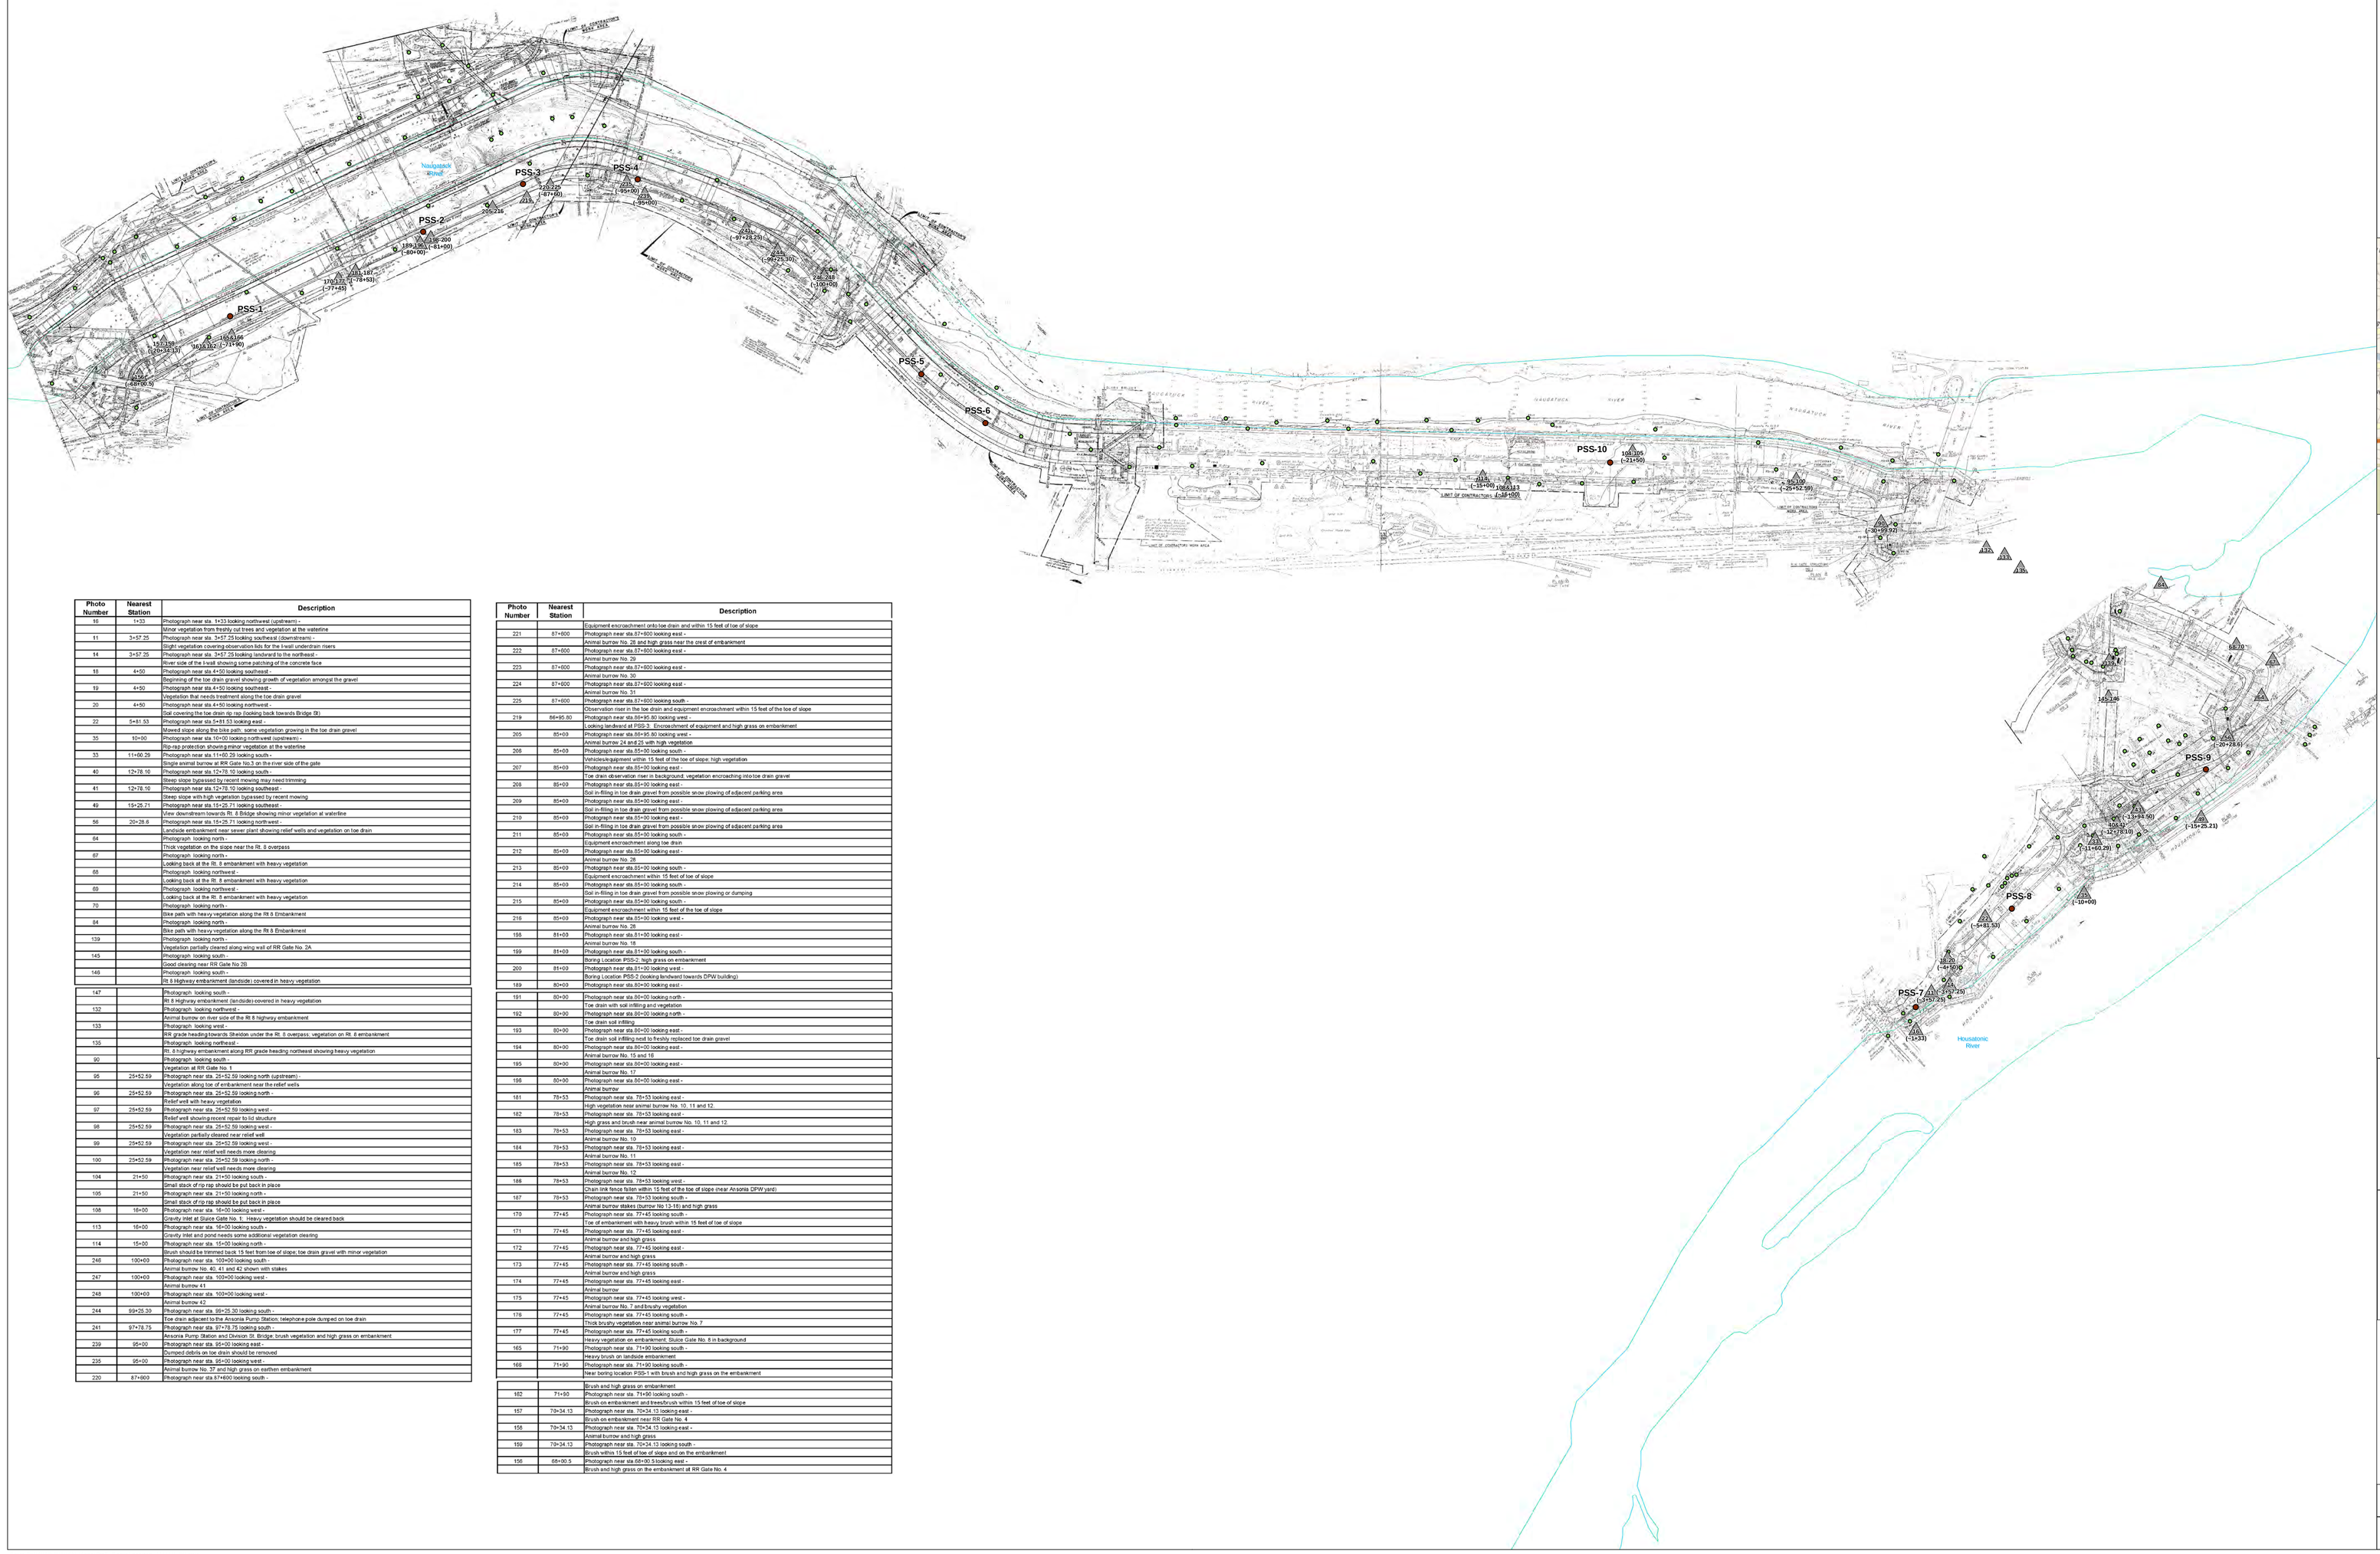
Photo Number	Nearest Station	Description
16	1+33	Photograph near sta. 1+33 looking northwest (upstream) -
		Minor vegetation from freshly cut trees and vegetation at the waterline
11	3+57.25	Photograph near sta. 3+57.25 looking southeast (downstream) -
		Slight vegetation covering storm drain lids for the 3 east underdrain risers
14	3+57.25	Photograph near sta. 3+57.25 looking landward to the northeast -
		River side of the 3 wall showing some patching of the concrete face
18	4+50	Photograph near sta.4+50 looking southeast -
		Beginning of the toe drain gravel showing growth of vegetation amongst the gravel
19	4+50	Photograph near sta.4+50 looking southeast -
		Vegetation that needs treatment along the toe drain gravel
20	4+50	Photograph near sta.4+50 looking northeast -
		Soil covering the toe drain rip rap (looking back towards Bridge 39)
22	5+51.53	Photograph near sta.5+51.53 looking east -
		Mowed slope along the bike path, some vegetation growing in the toe drain gravel

35	10+30	Photograph near sta.10+00 looking northwest (upstream) -
		Rip-rap protection showing minor vegetation at the waterline
53	11+00.29	Photograph near sta.11+00.29 looking south -
		Single animal burrow at RR Gate No.3 at the river side of the gate
40	12+78.10	Photograph near sta.12+78.10 looking south -
		Steep slope bypassed by recent mowing may need trimming
41	12+78.10	Photograph near sta.12+78.10 looking southeast -
		Steep slope with high vegetation bypassed by recent mowing
49	15+25.71	Photograph near sta.15+25.71 looking southeast -
		View downstream towards Rt. 8 Bridge showing minor vegetation at waterline
56	20+28.6	Photograph near sta.15+75.71 looking northwest -
		Landside embankment near sewer plant showing relief wells and vegetation on toe drain
64		Photograph looking north -
		Thick vegetation on the slope near the Rt. 8 overpass
67		Photograph looking north -
		Looking back at the Rt. 8 embankment with heavy vegetation

68		Photograph looking northwest -
		Looking back at the Rt. 8 embankment with heavy vegetation
69		Photograph looking northwest -
		Looking back at the Rt. 8 embankment with heavy vegetation
70		Photograph looking north -
		Bike path with heavy vegetation along the Rt 8 Embankment
84		Photograph looking north -
		Bike path with heavy vegetation along the Rt 8 Embankment
139		Photograph looking north -
		Vegetation partially cleared along wing wall of RR Gate No. 2A
145		Photograph looking south -
		Good clearing near RR Gate No 2B
146		Photograph looking south -
		Rt. 8 Highway embankment (landside) covered in heavy vegetation
147		Photograph looking south -
		Rt 8 Highway embankment (landside) covered in heavy vegetation
132		Photograph looking northwest -
		Animal burrow on river side of the Rt 8 highway embankment
133		Photograph looking west -
		RR grade heading towards Sheldon under the Rt. 8 overpass; vegetation on Rt. 8 embankment

135		Photograph looking northeast -
		Rt. 8 highway embankment along RR grade heading northeast showing heavy vegetation
90		Photograph looking south -
		Vegetation at RR Gate No. 3
95	25+52.59	Photograph near sta. 25+52.59 looking north (upstream) -
		Vegetation along toe of embankment near the relief wells
96	25+52.59	Photograph near sta.25+52.59 looking north -
		Relief well with heavy vegetation
97	25+52.59	Photograph near sta. 25+52.59 looking west -
		Relief well showing recent repair to lid structure
98	25+52.59	Photograph near sta. 25+52.59 looking west -
		Vegetation partially cleared near relief well
99	25+52.59	Photograph near sta. 25+52.59 looking west -
		Vegetation near relief well needs more clearing
100	25+52.59	Photograph near sta. 25+52.59 looking north -
		Vegetation near relief well needs more clearing
104	21+50	Photograph near sta. 21+50 looking south -
		Small stack of rip rap should be put back in place

105	21+50	Photograph near sta. 21+50 looking north -
		Small stack of rip rap should be put back in place
108	16+00	Photograph near sta. 16+00 looking west -
		Gravity Inlet at Sluice Gate No. 1. Heavy vegetation should be cleared back
113	16+00	Photograph near sta. 16+00 looking south -
		Gravity Inlet and pond needs some additional vegetation clearing
114	15+00	Photograph near sta. 15+00 looking north -
		Brush should be trimmed back 15 feet from toe of slope; toe drain gravel with minor vegetation
246	100+00	Photograph near sta. 100+00 looking south -
		Animal burrow No. 40, 41 and 42 shown with stakes
247	100+00	Photograph near sta. 100+00 looking west -
		Animal burrow 43
248	100+00	Photograph near sta. 100+00 looking west -
		Animal burrow 43
244	99+25.20	Photograph near sta. 99+25.20 looking south -
		Toe drain adjacent to the Ansonia Pump Station; telephone pole dumped on toe drain
241	97+78.75	Photograph near sta. 97+78.75 looking south -

Ansonia Pump Station and Division St. Bridge; brush vegetation and high grass on embankment
239	95+00	Photograph near sta. 95+00 looking east -
		Dumped debris on toe drain should be removed
235	95+00	Photograph near sta. 95+00 looking west -
		Animal burrow No. 37 and high grass on earthen embankment
230	87+600	Photograph near sta.87+600 looking south -

Photo Number	Nearest Station	Description
221	87+600	Equipment encroachment onto toe drain and within 15 feet of toe of slope
		Photograph near sta.87+600 looking east -
222	87+600	Animal burrow No. 28 and high grass near the crest of embankment
		Photograph near sta.87+600 looking east -
223	87+600	Animal burrow No. 29
		Photograph near sta.87+600 looking east -
224	87+600	Animal burrow No. 30
		Photograph near sta.87+600 looking east -
225	87+600	Animal burrow No. 31
		Photograph near sta.87+600 looking south -
219	86+95.80	Observation riser in the toe drain and equipment encroachment within 15 feet of the toe of slope
		Photograph near sta.86+95.80 looking west -
205	85+00	Looking landward at PSS-3. Encroachment of equipment and high grass on embankment
		Photograph near sta.85+95.80 looking west -
206	85+00	Animal burrow 24 and 25 with high vegetation
		Photograph near sta.85+00 looking south -
207	85+00	Vehicles/equipment within 15 feet of the toe of slope; high vegetation

Photograph near sta.85+00 looking east -
208	85+00	Toe drain observation riser in background. vegetation encroaching into toe drain gravel
		Photograph near sta.85+00 looking east -
209	85+00	Soil in-filling in toe drain gravel from possible snow plowing of adjacent parking area
		Photograph near sta.85+00 looking east -
210	85+00	Soil in-filling in toe drain gravel from possible snow plowing of adjacent parking area
		Photograph near sta.85+00 looking east -
211	85+00	Soil in-filling in toe drain gravel from possible snow plowing of adjacent parking area
		Photograph near sta.85+00 looking south -
212	85+00	Equipment encroachment along toe drain
		Photograph near sta.85+00 looking east -
213	85+00	Animal burrow No. 26
		Photograph near sta.85+00 looking south -
214	85+00	Equipment encroachment within 15 feet of toe of slope
		Photograph near sta.85+00 looking south -
215	85+00	Soil in-filling in toe drain gravel from possible snow plowing or dumping

Photograph near sta.85+00 looking south -
216	85+00	Equipment encroachment within 15 feet of the toe of slope
		Photograph near sta.85+00 looking west -
166	81+00	Animal burrow No. 18
		Photograph near sta.81+00 looking east -
169	81+00	Animal burrow No. 19
		Photograph near sta.81+00 looking south -
200	81+00	Boring Location PSS-2. high grass on embankment
		Photograph near sta.81+00 looking west -
189	80+00	Boring Location PSS-2 (looking landward towards DPW building)
		Photograph near sta.80+00 looking east -
191	80+00	Photograph near sta.80+00 looking north -
		Toe drain with soil infilling and vegetation
192	80+00	Photograph near sta.80+00 looking north -
		Toe drain soil infilling
193	80+00	Photograph near sta.80+00 looking east -
		Toe drain soil infilling next to freshly replaced toe drain gravel
194	80+00	Photograph near sta.80+00 looking east -
		Animal burrow No. 15 and 16
195	80+00	Photograph near sta.80+00 looking east -

Animal burrow No. 17
196	80+00	Photograph near sta.80+00 looking east -
		Animal burrow
181	78+53	Photograph near sta. 78+53 looking east -
		high vegetation near animal burrow Nos. 10, 11 and 12.
182	78+53	Photograph near sta. 78+53 looking east -
		High grass and brush near animal burrow No. 10, 11 and 12
183	78+53	Photograph near sta. 78+53 looking east -
		Animal burrow No. 10
184	78+53	Photograph near sta. 78+53 looking east -
		Animal burrow No. 11
185	78+53	Photograph near sta. 78+53 looking east -
		Animal burrow No. 12
188	78+53	Photograph near sta. 78+53 looking west -
		Chain link fence fallen within 15 feet of the toe of slope (near Ansonia DPW yard)
167	78+53	Photograph near sta. 78+53 looking south -
		Animal burrow stakes (burrow No 12-18) and high grass
170	77+45	Photograph near sta. 77+45 looking south -
		Toe of embankment with heavy brush within 15 feet of toe of slope
171	77+45	Photograph near sta. 77+45 looking east -

Animal burrow and high grass
172	77+45	Photograph near sta. 77+45 looking east -
		Animal burrow and high grass
173	77+45	Photograph near sta. 77+45 looking south -
		Animal burrow and high grass
174	77+45	Photograph near sta. 77+45 looking east -
		Animal burrow
175	77+45	Photograph near sta. 77+45 looking west -
		Animal burrow No. 7 and Brushy vegetation
176	77+45	Photograph near sta. 77+45 looking north -
		Thick brushy vegetation near animal burrow No. 7
177	77+45	Photograph near sta. 77+45 looking south -
		Heavy vegetation on embankment. Sluice Gate No. 6 in background
165	71+90	Photograph near sta. 71+90 looking south -
		Heavy brush on landside embankment
168	71+90	Photograph near sta. 71+90 looking south -
		Near boring location PSS-1 with brush and high grass on the embankment
		Brush and high grass on embankment
162	71+50	Photograph near sta. 71+50 looking south -
		Brush on embankment and trees/brush within 15 feet of toe of slope

157	70+34.13	Photograph near sta. 70+34.13 looking east -
		Brush on embankment near RR Gate No. 4
158	70+34.13	Photograph near sta. 70+34.13 looking east -
		Animal burrow and high grass
159	70+34.13	Photograph near sta. 70+34.13 looking south -
		Brush within 15 feet of toe of slope and on the embankment
156	68+90.5	Photograph near sta 68+90.5 looking east -
		Brush and high grass on the embankment at RR Gate No. 4
