A. **FLOOD DAMAGE REDUCTION SEGMENT/SYSTEM INSPECTION REPORT – Naugatuck River RB – Southend Ansonia, CT**
Date of Inspection – 4/22/2009 – Provided to Ansonia on February 3, 2010

Flood Damage Reduction Segment / System Inspection Report

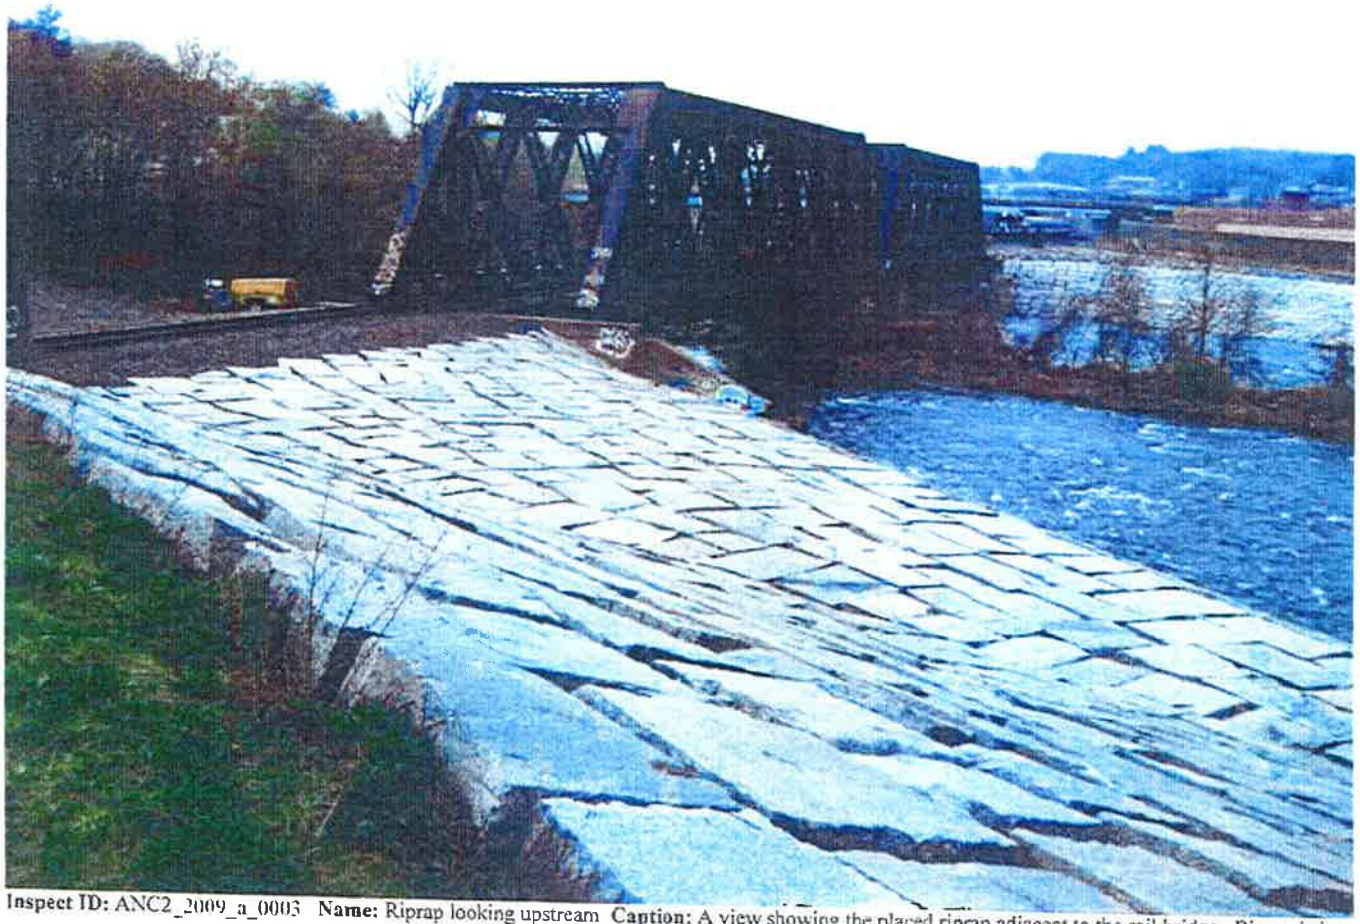
Inspect ID: ANC2_2009_a_0003 **Name:** Riprap looking upstream **Caption:** A view showing the placed riprap adjacent to the rail bridge. Riprap is in good condition.

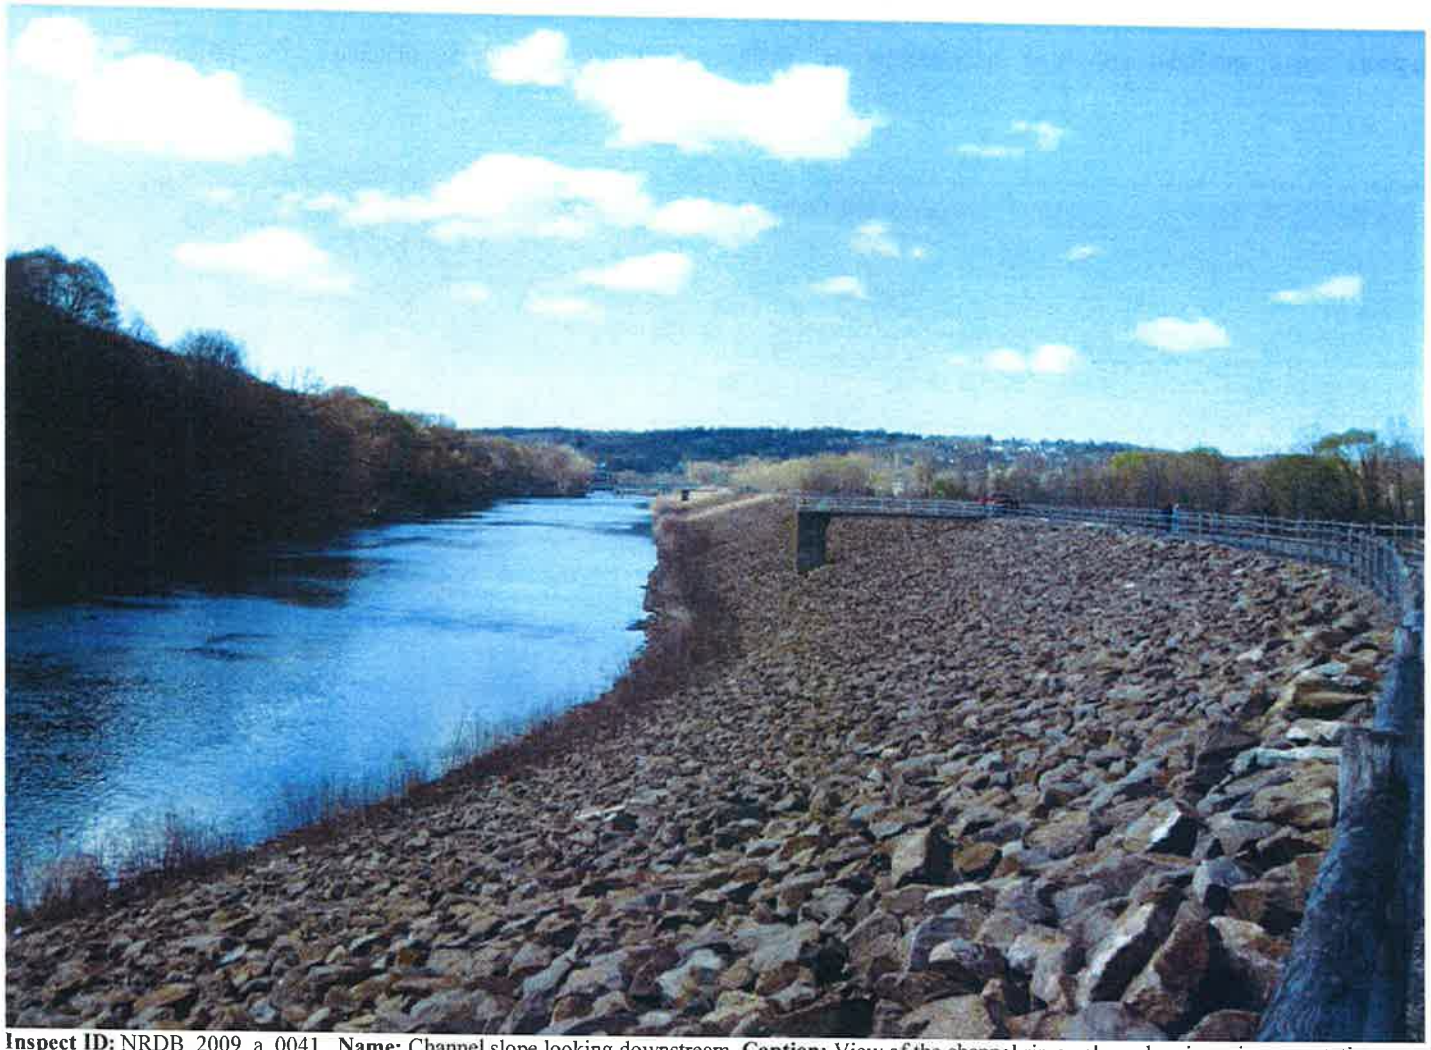
Inspect ID: NRDB_2009_a_0041 **Name:** Channel slope looking downstream **Caption:** View of the channel riprap slope showing minor vegetation growing along the bank.

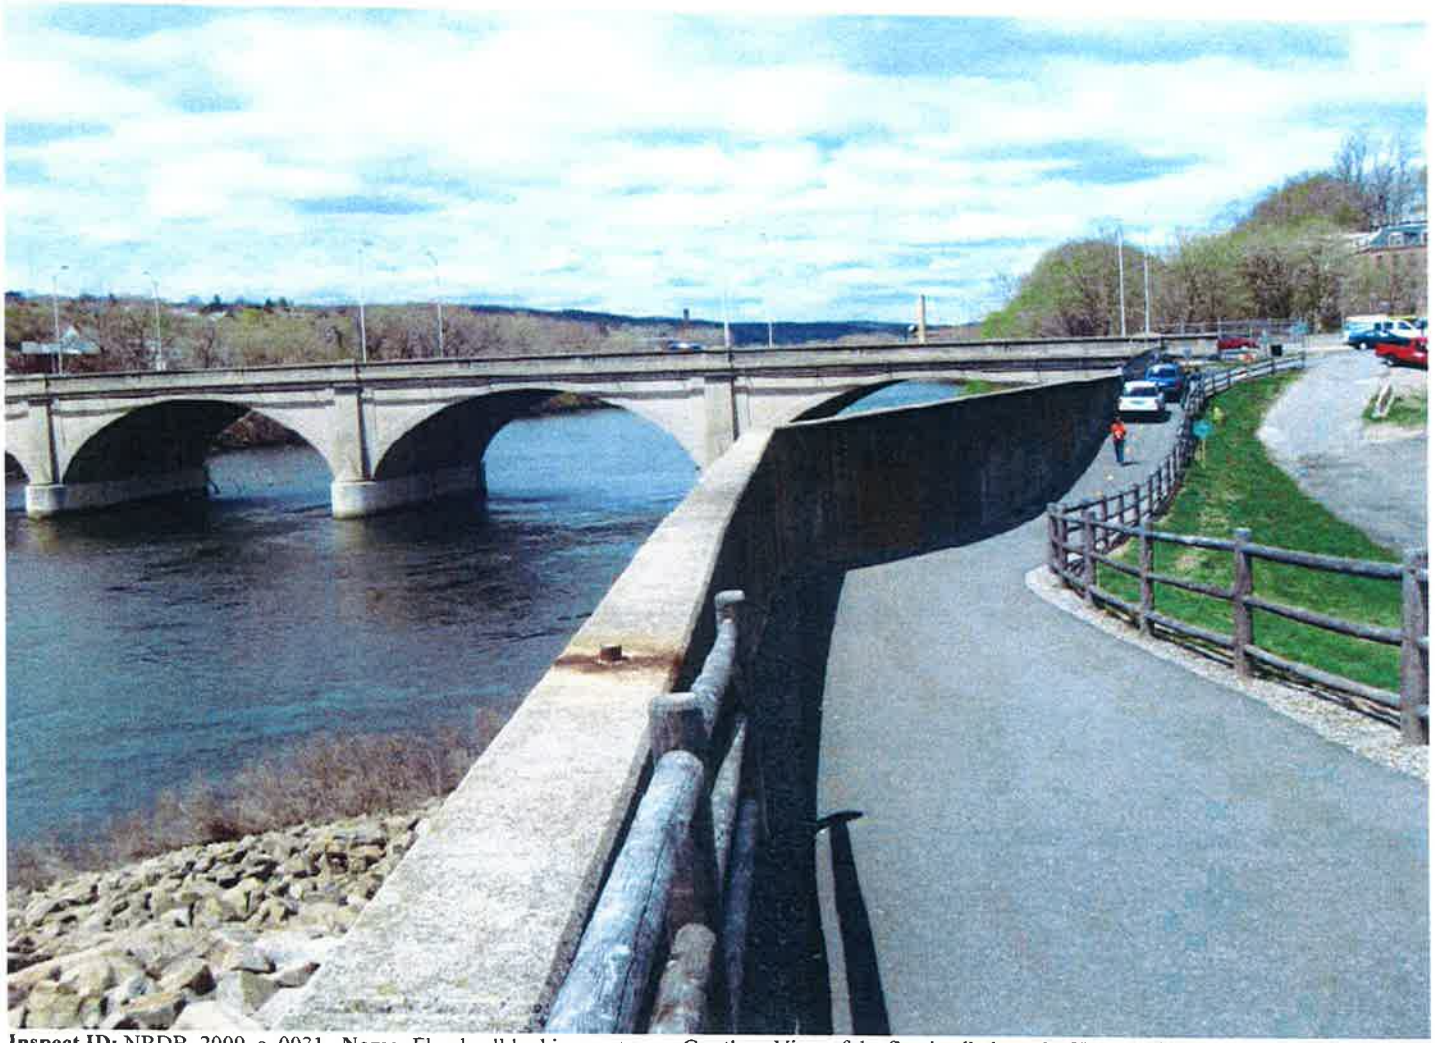
Inspect ID: NRDB_2009_a_0031 **Name:** Floodwall looking upstream **Caption:** View of the floodwall along the Housatonic River. Wall is in good condition, with some patched areas along the riverside face. Joints are generally in good to fair condition.

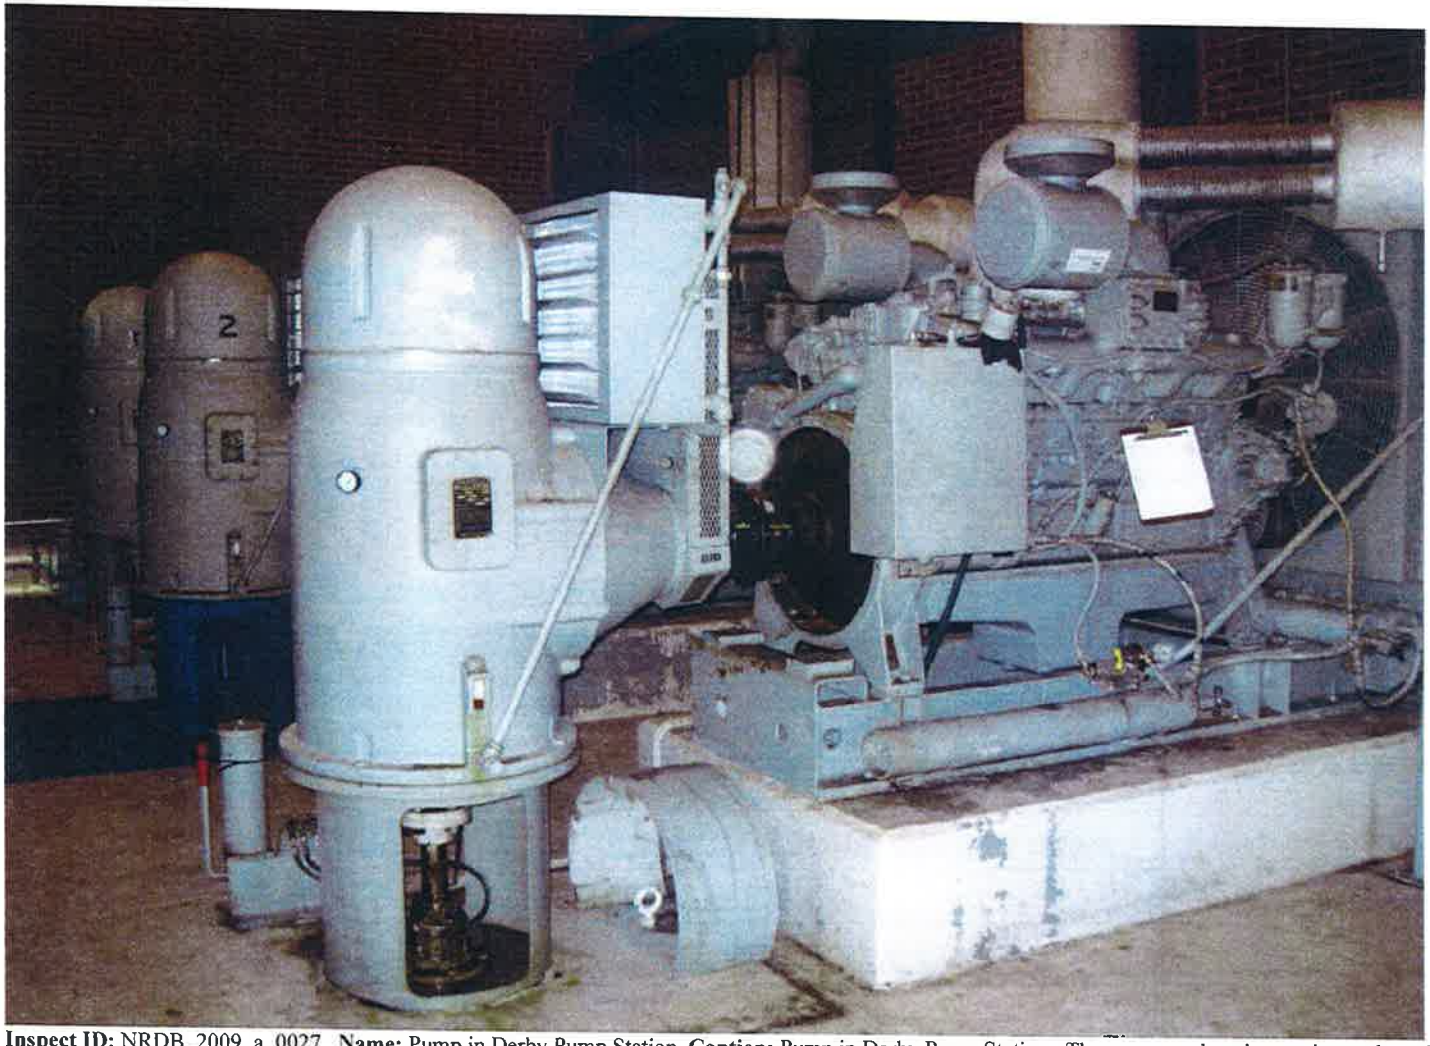
Inspect ID: NRDB_2009_a_0027 **Name:** Pump in Derby Pump Station **Caption:** Pump in Derby Pump Station. The pumps and station are in good condition.
