CCTV Inspections
Naugatuck River Levee System
Ansonia, CT
August-September 2010

TV Inspection with Pipe-Run Graph

PACP Sewer Report

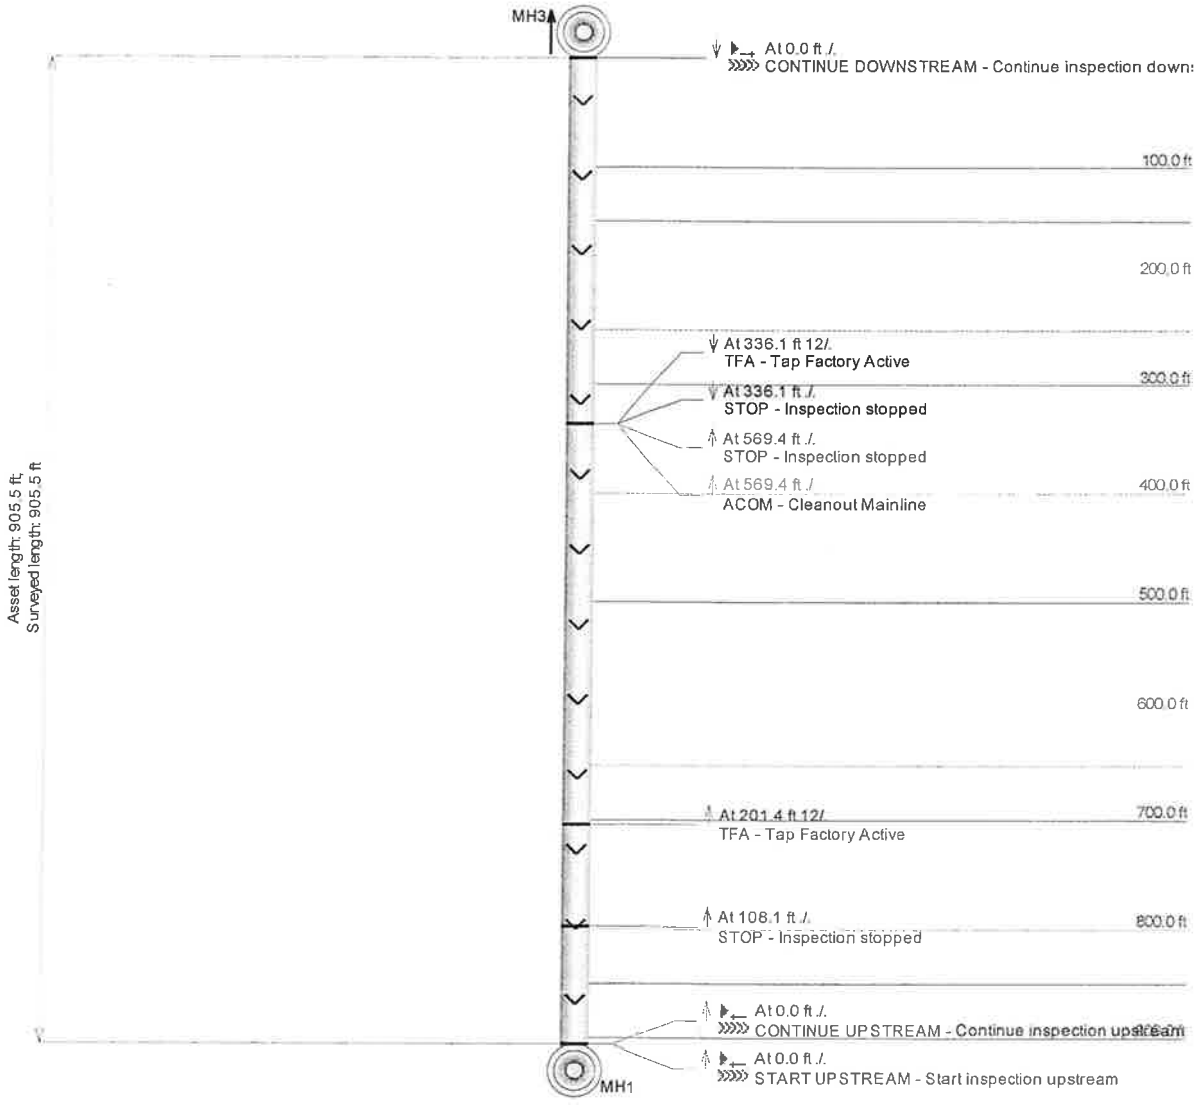
Distance (Feet)	Video Ref.	Group/ Descripto	Modifier/ Severity	Continuous Defect	S/M/L	Value Inches 1st	Value Inches 2nd	%	Joint	Circumferential Location at	Circumferential Location to	Image Ref.	Remarks
336.1	1405	TFA				6				12			CLEAN OUT
201.4	568	TFA				6				12			
569.4	508	ACOM											clean out

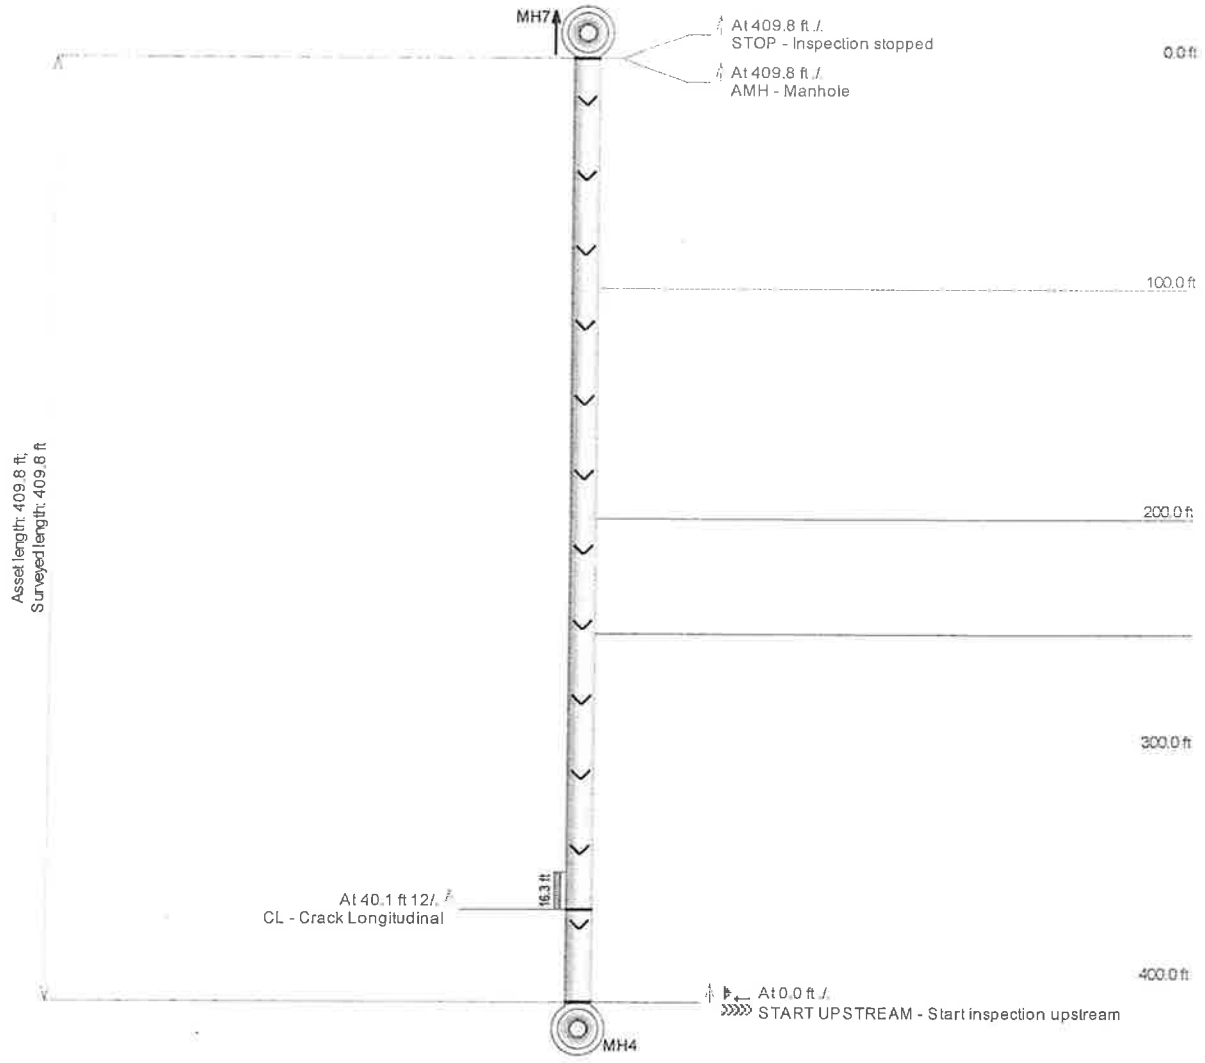
Distance (Feet)	Video Ref.	Group/ Descripto	Modifier/ Severity	Continuous Defect	S/M/L	Value Inches 1st	Value Inches 2nd	%	Joint	Circumferential Location at	Circumferential Location to	Image Ref.	Remarks
40.1	146	CL		S1						12			
56.4	146	CL		F1						12			
409.8	533	AMH											MH7

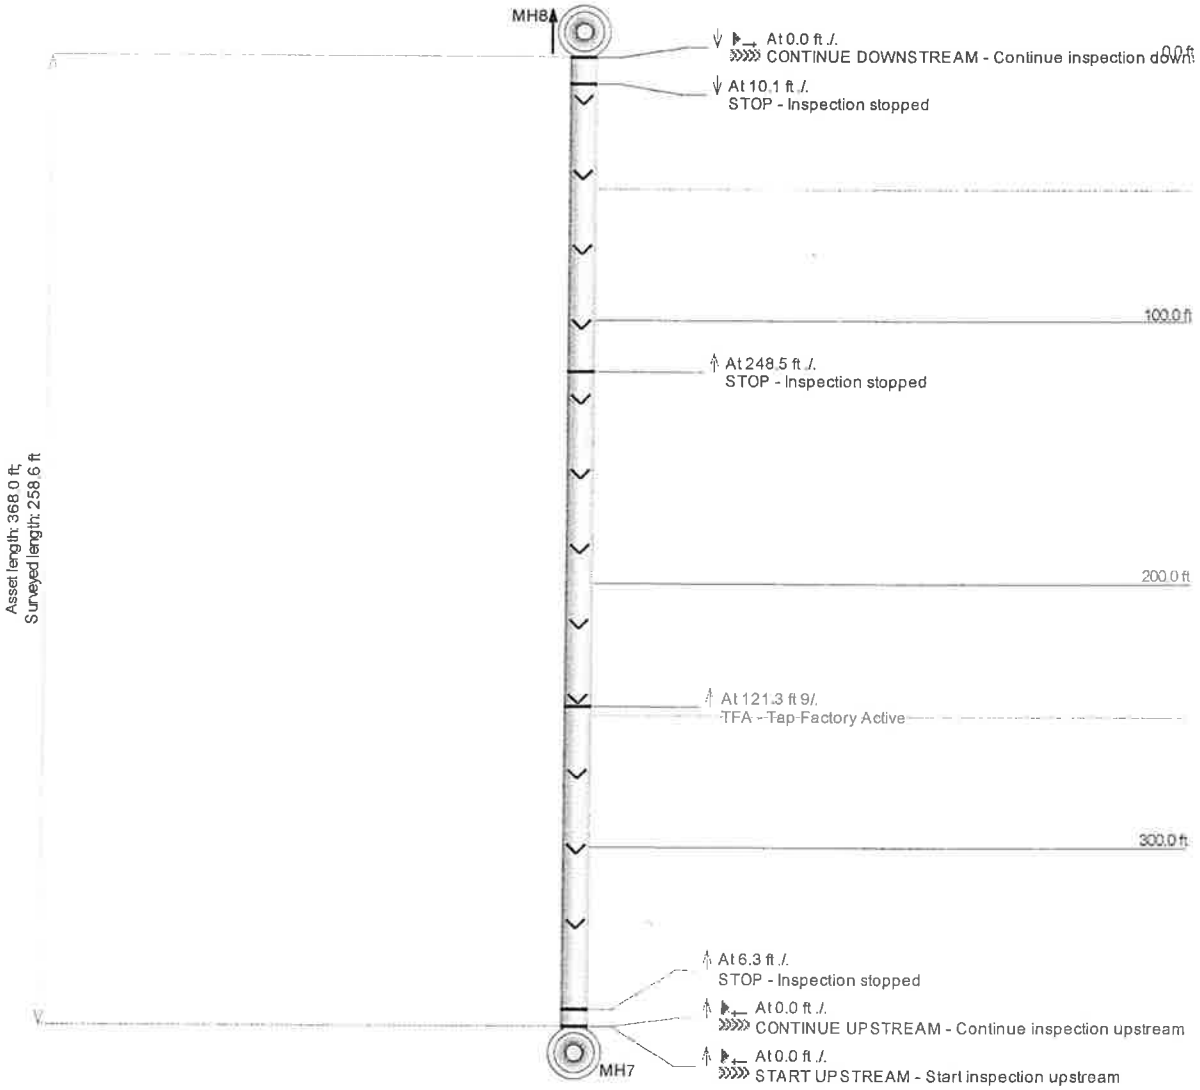
Distance (Feet)	Video Ref.	Group/ Descripto	Modifier/ Severity	Continuous Defect	S/M/L	Value Inches 1st	Value Inches 2nd	Value %	Joint	Circumferential Location at	Circumferential Location to	Image Ref.	Remarks
121.3	121	TFA				24				9

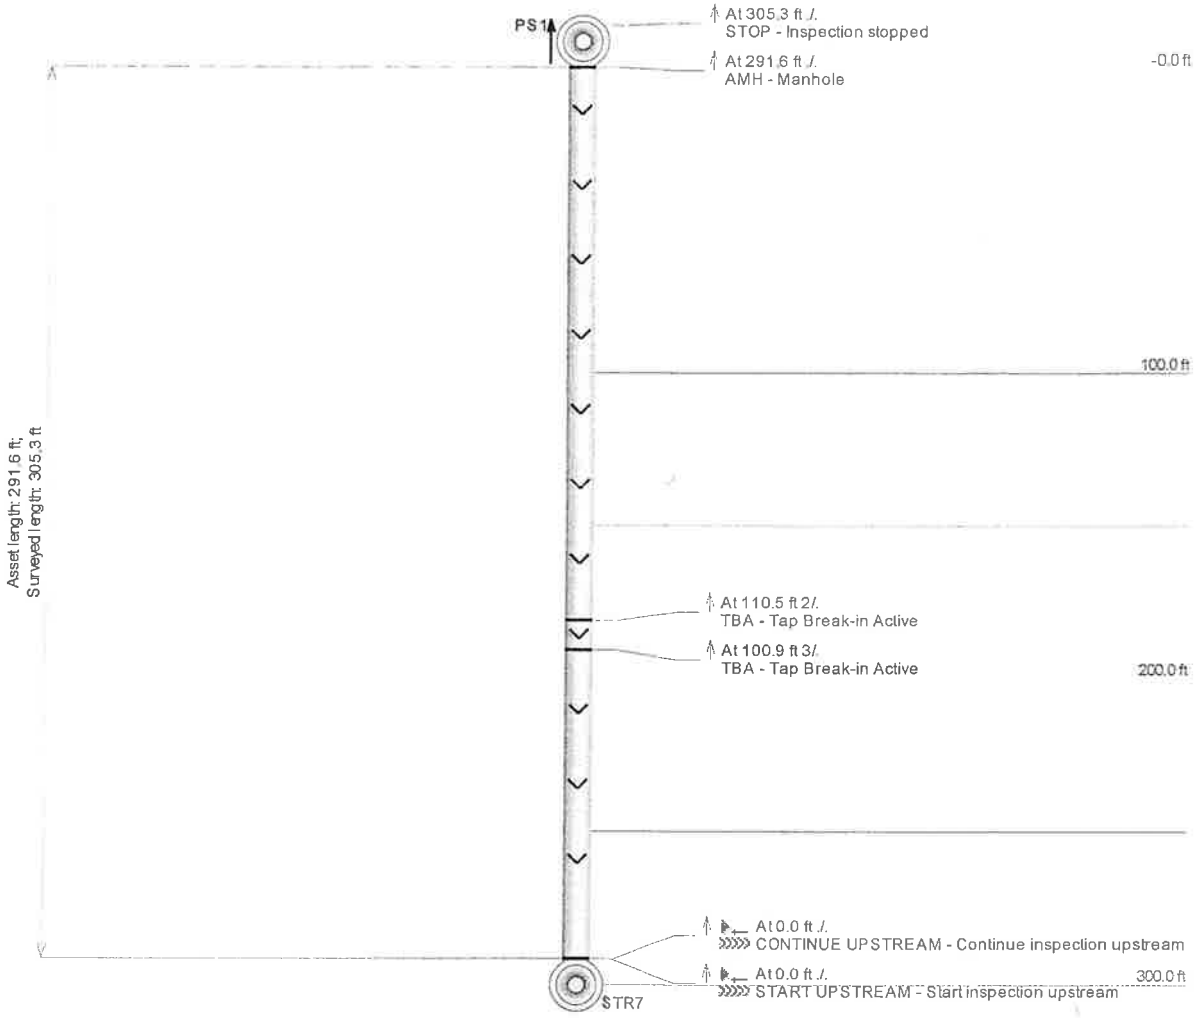
Distance (Feet)	Video Ref.	Group/ Descripto	Modifier/ Severity	Continuous Defect	S/M/L	Value Inches 1st	Value Inches 2nd	%	Joint	Circumferential Location at	Circumferential Location to	Image Ref.	Remarks
100.9	103	TBA				18				3			
110.5	156	TBA				10				2			
291.6	443	AMH											STR7

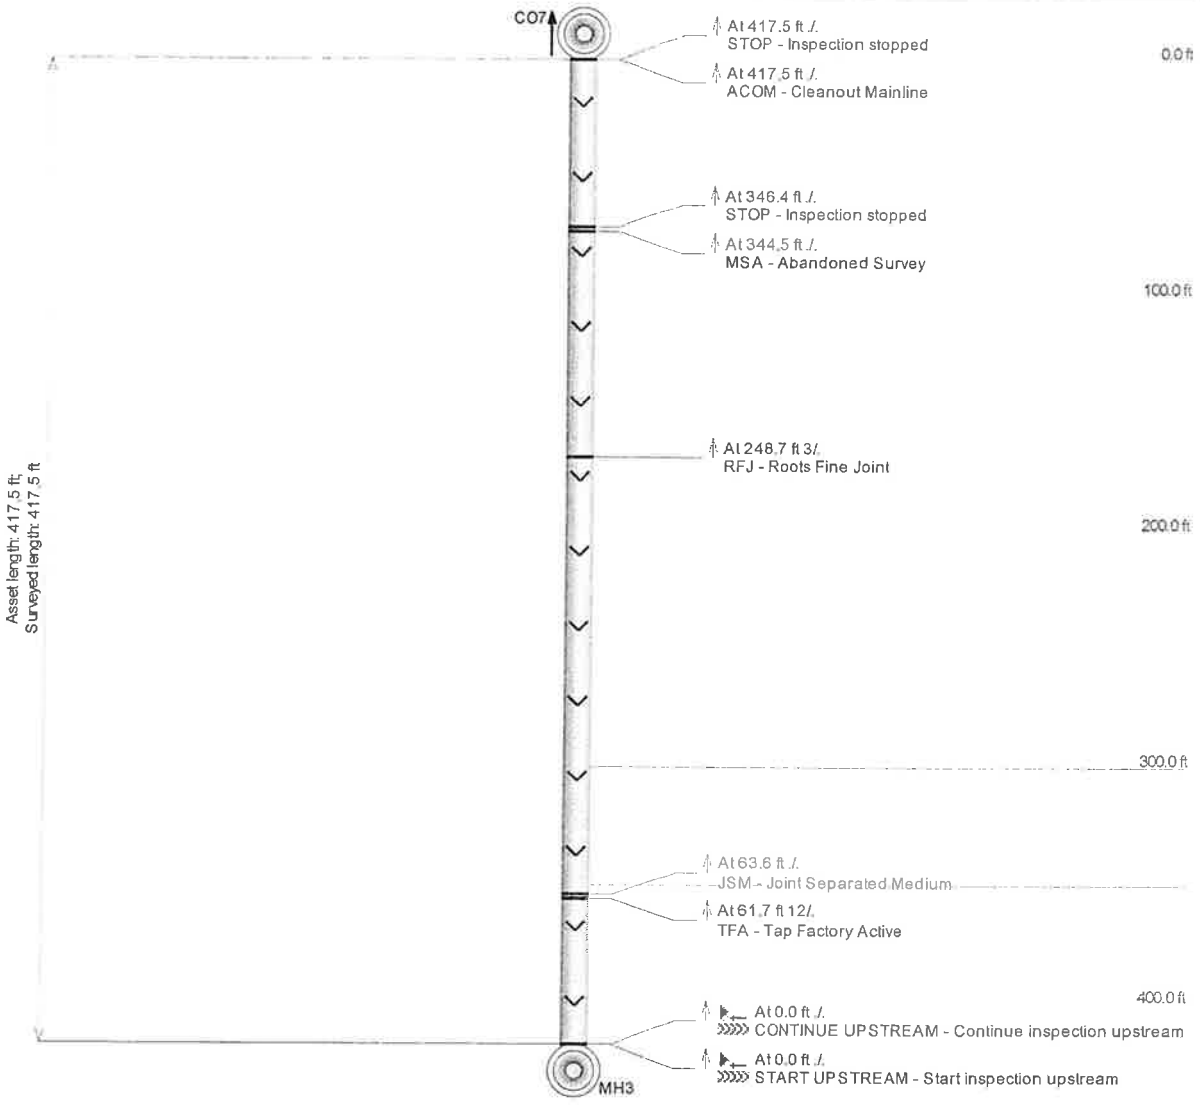
Distance (Feet)	Video Ref.	Group/ Descripto	Modifier/ Severity	Continuous Defect	S/M/L	Value Inches 1st	Value Inches 2nd	%	Joint	Circumferential Location at	Circumferential Location to	Image Ref.	Remarks
61.7	158	TFA				6				12			CLEAN OUT
63.6	200	JSM			M								
248.7	921	RFJ							J	3			
344.5	762	MSA											CRAWLER COULD NOT PULL CABLE
417.5	394	ACOM											CO7

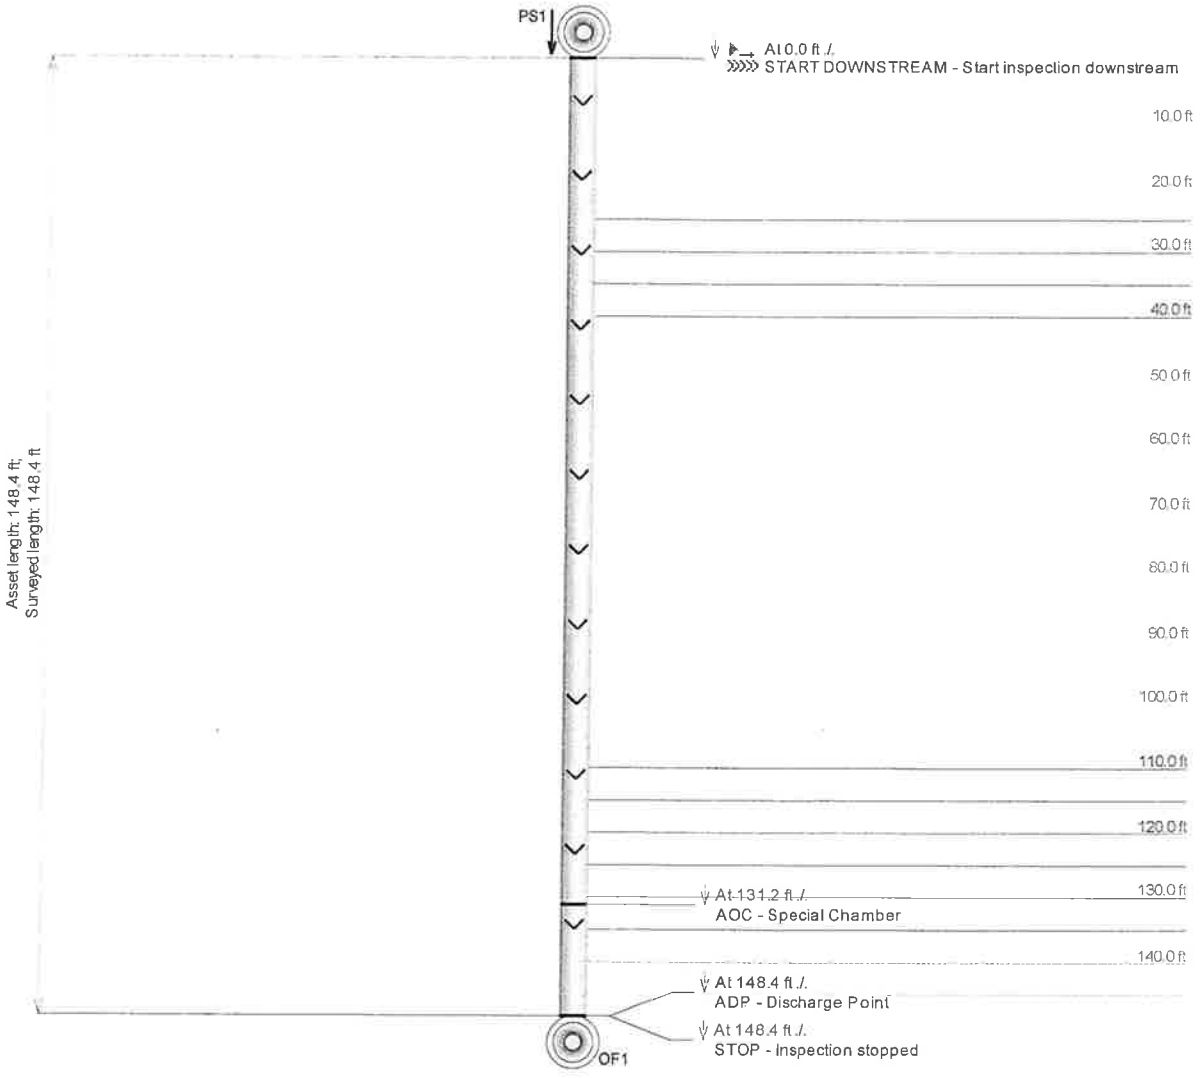
Distance (Feet)	Video Ref.	Group/ Descripto	Modifier/ Severity	Continuous Defect	S/M/L	Value Inches 1st	Value Inches 2nd	Value %	Joint	Circumferential Location at	Circumferential Location to	Image Ref.	Remarks
131.2	112	AOC											
148.4	156	ADP

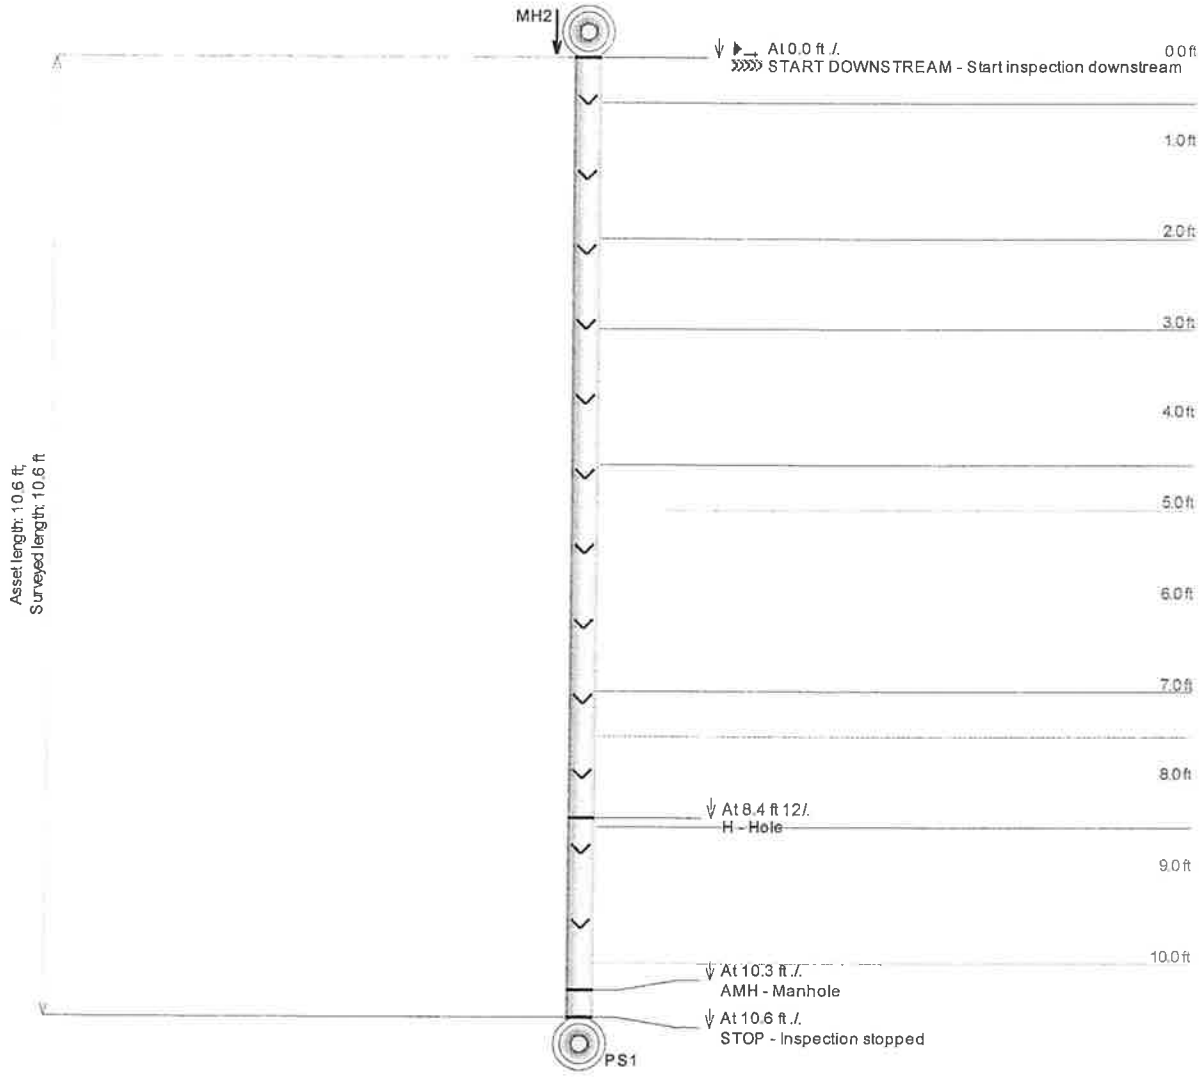
Distance (Feet)	Video Ref.	Group/ Descripto	Modifier/ Severity	Continuous Defect	S/M/L	Value Inches 1st	Value Inches 2nd	Value %	Joint	Circumferential Location at	Circumferential Location to	Image Ref.	Remarks
8.4	77	H								12			
10.3	109	AMH											PS1

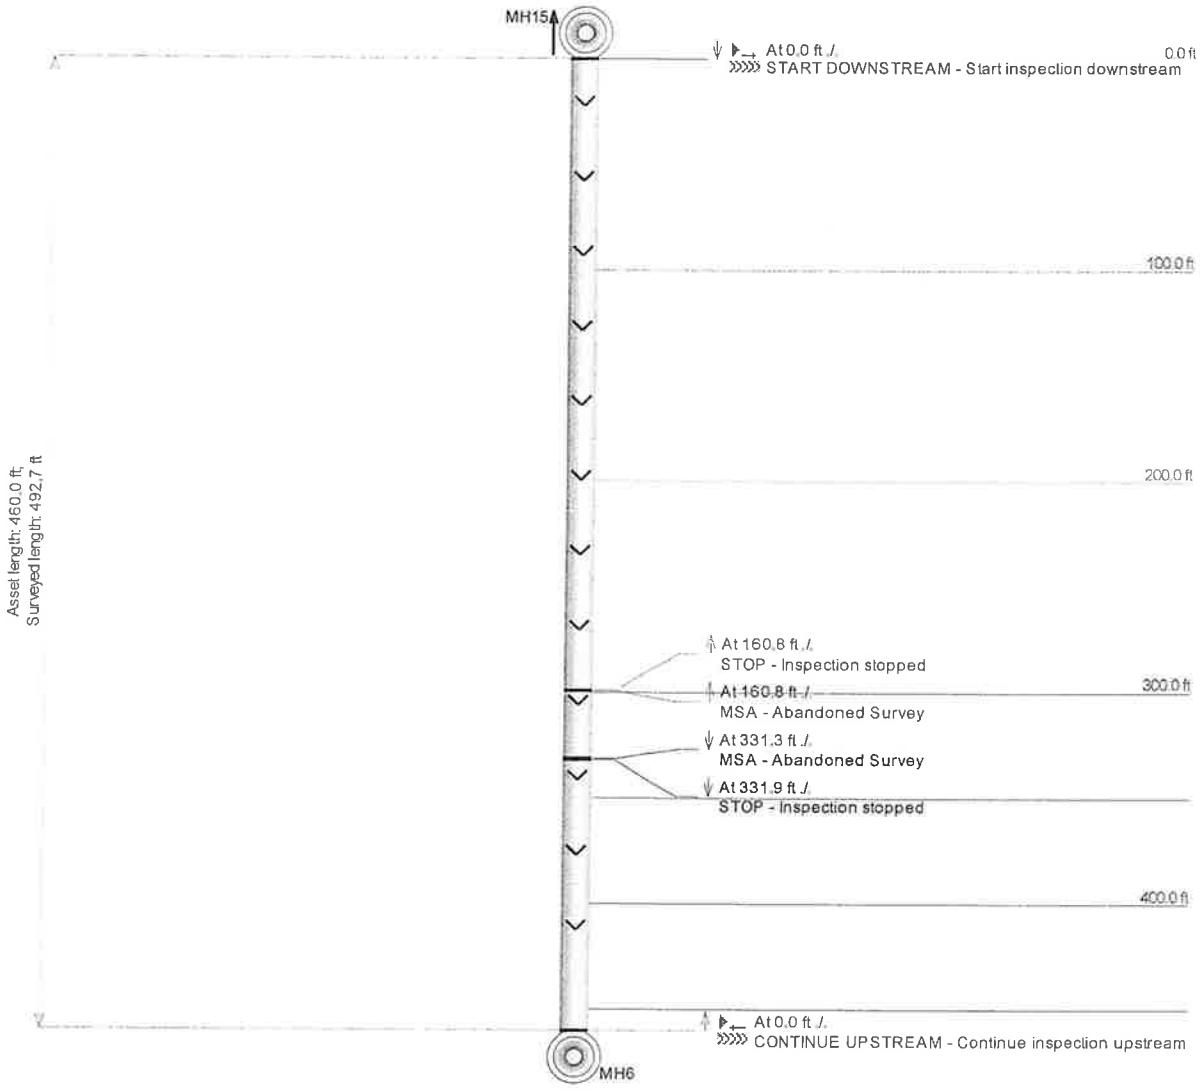
Distance (Feet)	Video Ref.	Group/ Descripto	Modifier/ Severity	Continuous Defect	S/M/L	Value Inches 1st	Value Inches 2nd	%	Joint	Circumferential Location at	Circumferential Location to	Image Ref.	Remarks
331.3	1031	MSA											COULD NOT CRAWL ANY MORE
160.8	302	MSA											OVERLAPPED TV

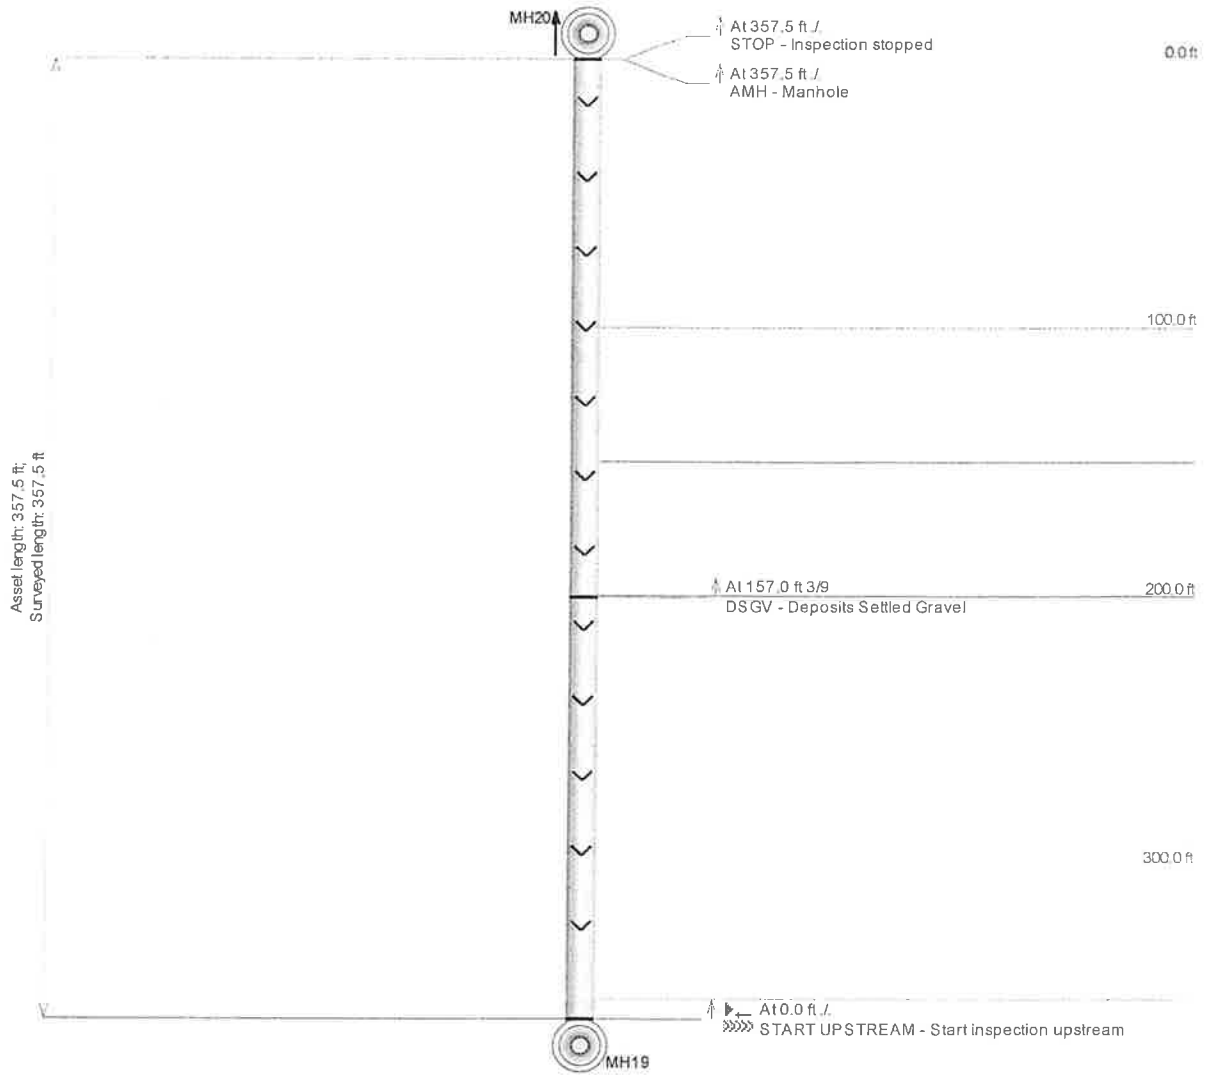
Distance (Feet)	Video Ref.	Group/ Descripto	Modifier/ Severity	Continuous Defect	S/M/L	Value Inches 1st	Value Inches 2nd	%	Joint	Circumferential Location at	Circumferential Location to	Image Ref.	Remarks
157.0	113	DSGV					20		3	9			
357.5	637	AMH											MH20

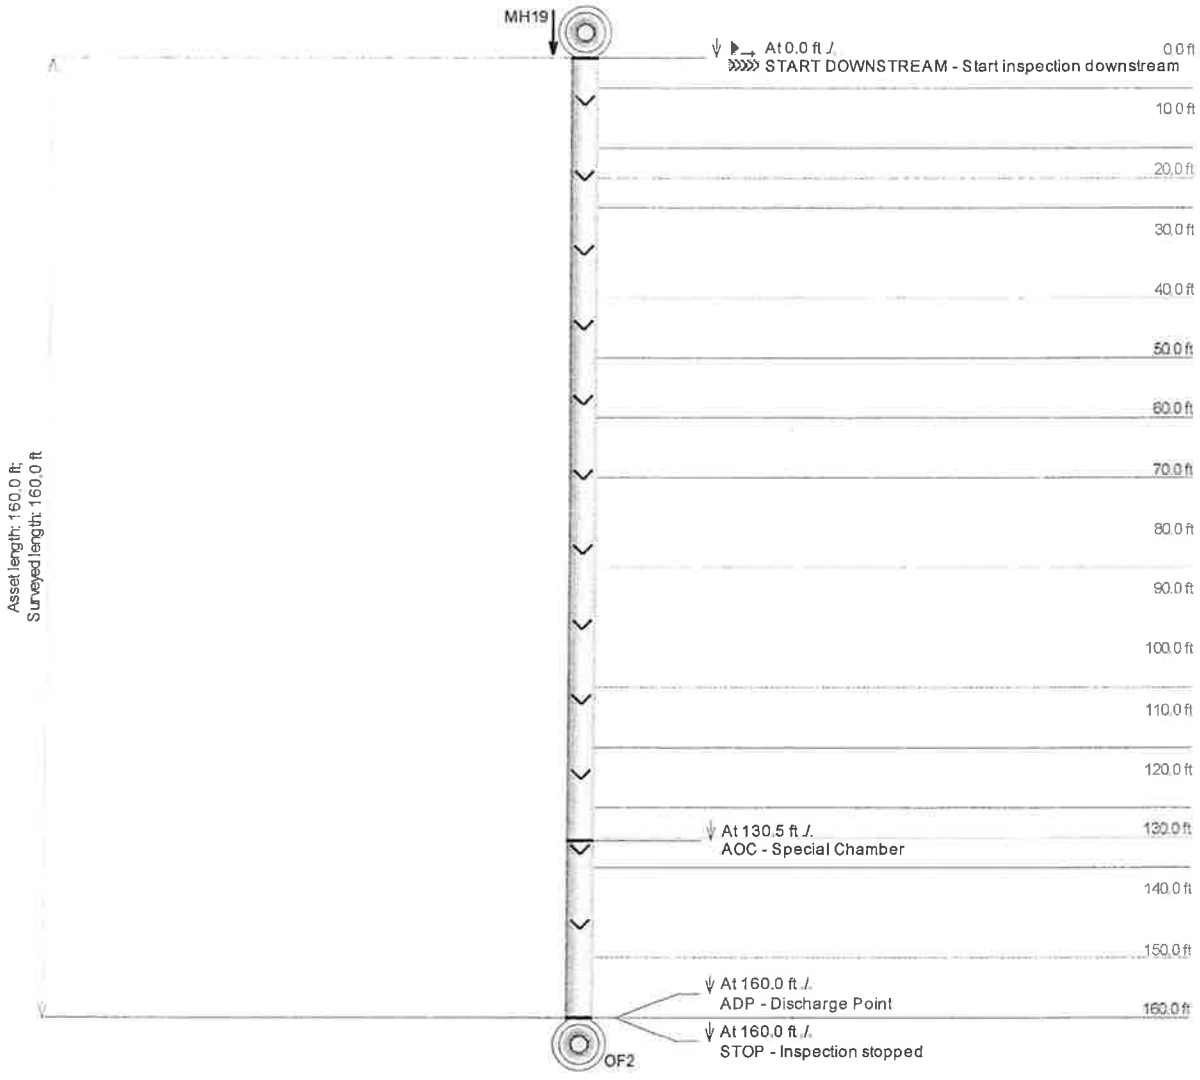
Distance (Feet)	Video Ref.	Group/ Descripto	Modifier/ Severity	Continuous Defect	S/M/L	Value Inches 1st	Value Inches 2nd	%	Joint	Circumferential Location at	Circumferential Location to	Image Ref.	Remarks
130.5	125	AOC											
160.0	205	ADP											OF2

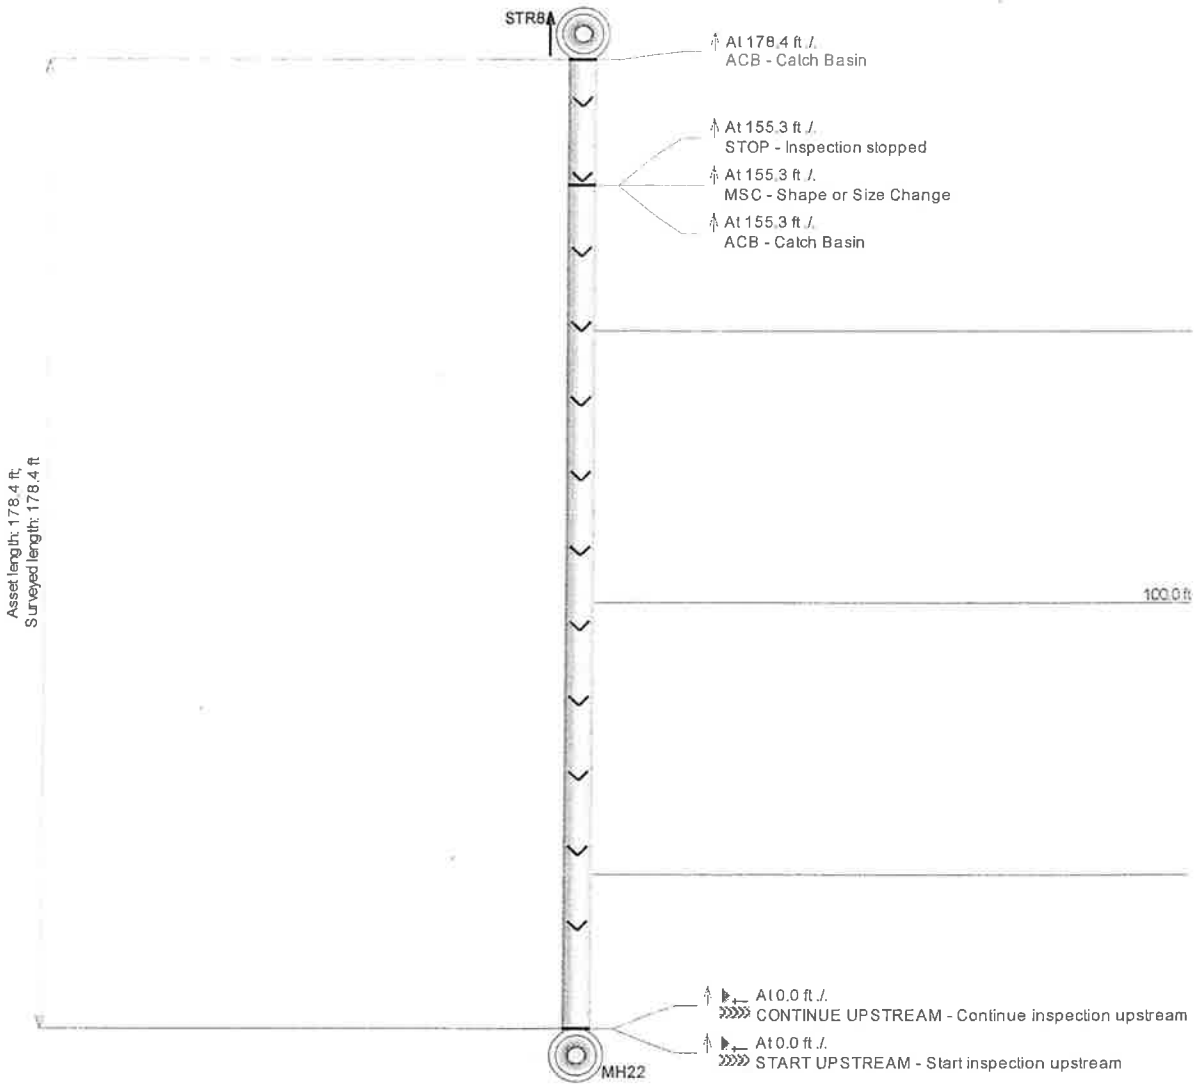
Distance (Feet)	Video Ref.	Group/ Descripto	Modifier/ Severity	Continuous Defect	S/M/L	Value Inches 1st	Value Inches 2nd	%	Joint	Circumferential Location at	Circumferential Location to	Image Ref.	Remarks
155.3	151	ACB											STR8
155.3	0	MSC				36							
178.4	323	ACB
