# STERLING OPERA HOUSE COMPREHENSIVE STUDY

JULY 13, 2026

# STUDY TEAM

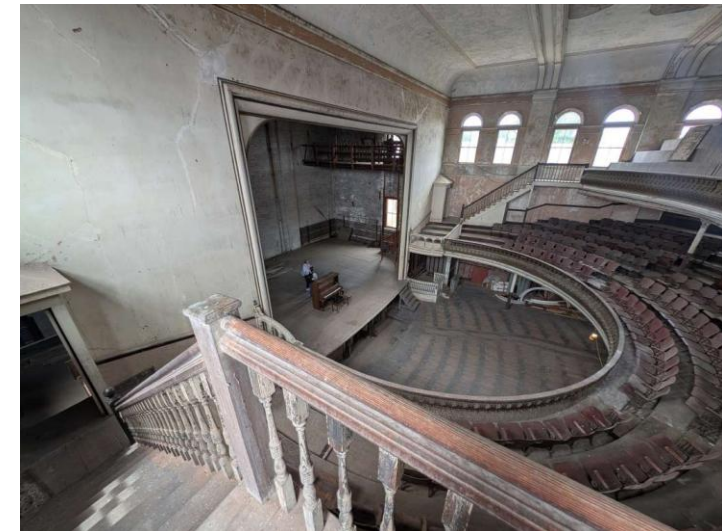
Fig. 2

- The existing conditions of the Sterling Opera House do not reflect its acoustics at its finest moments in the past, nor do they indicate the potential for its use in the future.
- The interior wall finishes are stripped in most locations (Fig. 1) and there are no operable HVAC systems contributing to its background noise conditions. To a large extent, it is a "blank slate" acoustically.
- The basic form of the facility as an intimate proscenium theater (Fig. 2) with a relatively small stagehouse offers an excellent opportunity to develop and utilize the room as a venue hosting natural acoustic performances, amplified performances, or some combination of the two.
- Historically, the theater has a reputation for its excellent natural acoustics, which is not surprising given its intimate volume and good sightlines.

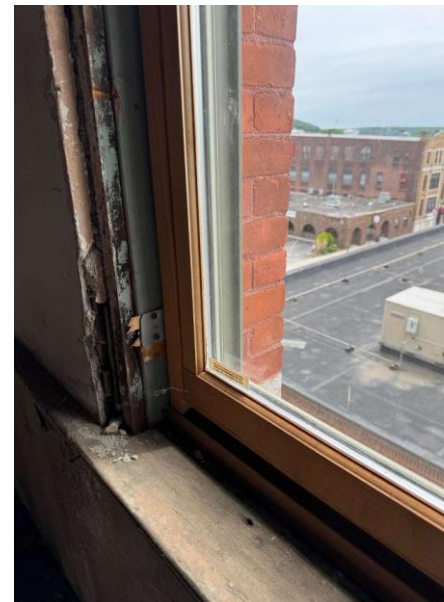
Fig. 3

From the standpoint of sound isolation, the existing theater structure appears to have at least one solid layer of masonry/stucco between the interior and exterior (Fig. 3). This provides a good foundation for sound isolation from exterior noise, given the relatively low levels of traffic noise outside the theater. Even with the extensive quantity of glazed surfaces open to the auditorium (Fig. 4), relatively little traffic was noticeable during our visit, with the exception of a couple louder motorcycles.

We do, however, have concerns that any highly amplified events would be clearly audible outside the building and potentially disturbing to neighbors unless there are significant enhancements made to the windows and possibly the attic/roof assembly. Double or triple-glazed windows (if acceptable from a historic preservation viewpoint) would help contain most intelligible sound from amplified performances, though a series of acoustic shutters may be required within the auditorium to more fully contain bass frequencies. The attic zone would need to be sealed (or baffled if used as a plenum) to sufficiently isolate amplified performance sound levels.

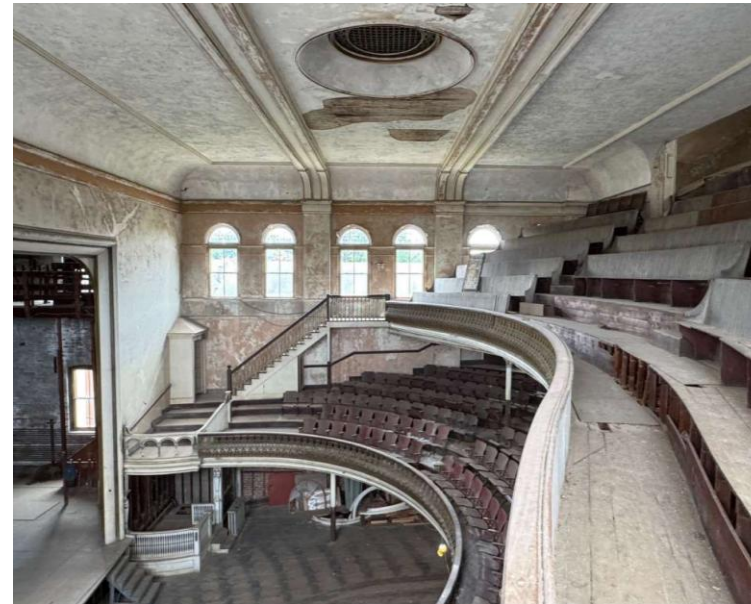
Fig. 6

The building does not appear to have any forced air ventilation. We assume that the heating was provided by steam or hot water, based on the presence of radiators within occupied areas (Fig. 5). Natural ventilation through windows and the attic void (Fig. 6) appears to be the traditional approach for cooling, and was likely satisfactory to audiences of the past century and neighbors who were not subjected to highly amplified performances. Modern comfort standards and the higher sound levels of today's amplified events will most likely lead the team to recommend some form of forced air cooling system with ducted fresh air intake and exhaust. Locating the equipment for these systems - most likely two or more air handlers plus chillers, pumps, and cooling towers - is an acoustical challenge. To the extent possible, these systems are best located in the basement or at grade and mounted on spring and neoprene vibration isolators.

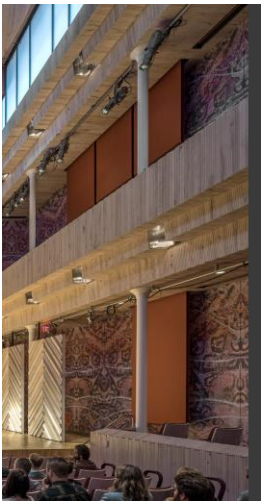
Fig. 7

In a variable acoustic approach, room finishes would be provided similar to those for optimal natural acoustics. Then, most wall surfaces within the room and stagehouse would be equipped with heavyweight draperies (horizontally deployed) or banners (vertically deployed) to cover reflective surfaces when louder amplification is in use. There are challenges to incorporating either banners or curtains within the audience areas, since the room does not have clear locations to "pocket" curtains when not used, and the attic void appears to be too shallow to store banners. While these are solvable problems, there are costs of implementation and ongoing maintenance of variable acoustic systems to consider and weigh against the possibility of expanding program. Figures 7 and 8 illustrate vertically deploying variable acoustic banners in different room settings.

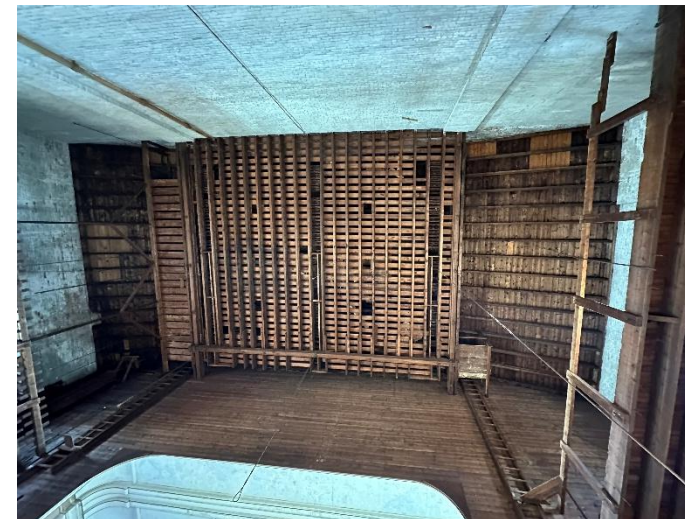
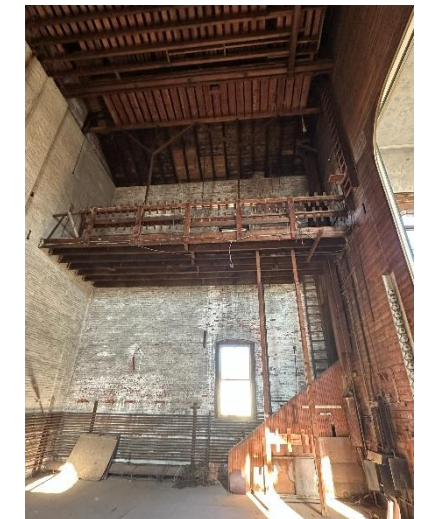
The area below the stage will be similar to the stage, with the 10' deep new interior structure upstage and shortened floor joists spanning from the new bearing wall to the proscenium wall.

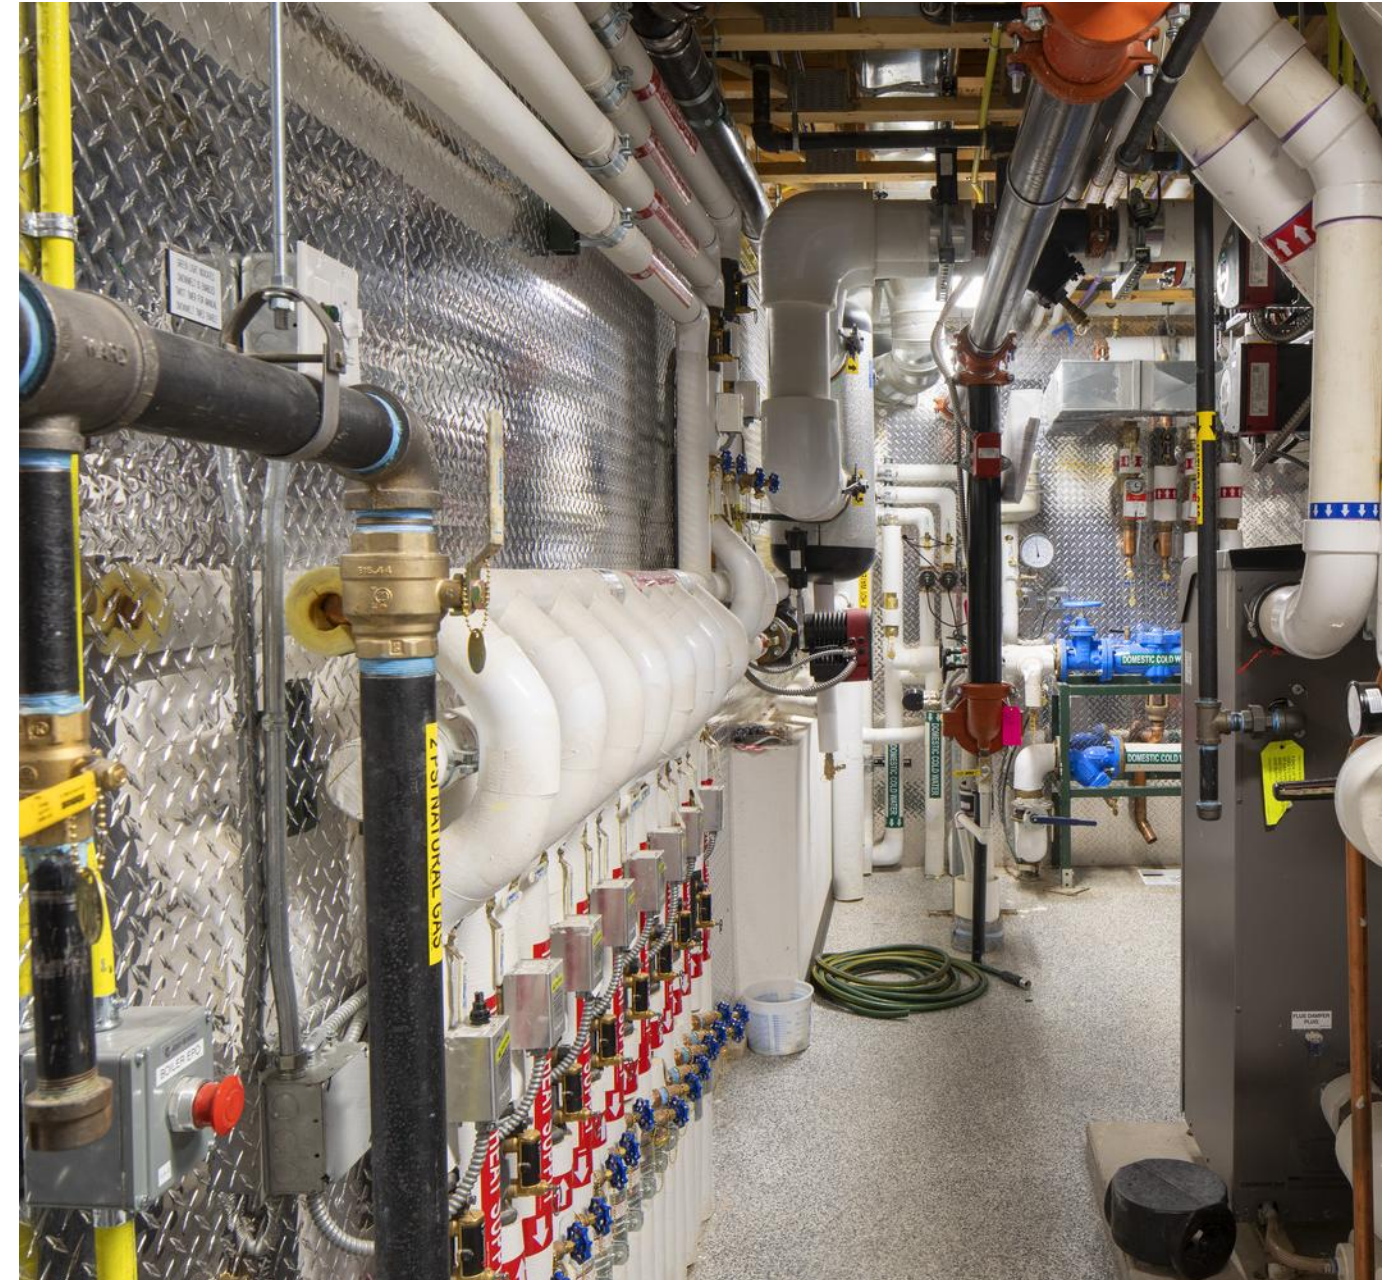
- The existing water service entrance appears to be galvanized steel piping. The existing service entrance and valves likely contain materials with unacceptable lead content and shall be replaced. Service piping should be replaced with new from the existing service main in Elizabeth Street.

- The existing exposed storm piping should be scoped and inspected to confirm conditions and replaced as required. Existing south side storm system will be rerouted as required with the new addition installation.

- All existing sanitary system piping shall be removed and new piping installed as required by the new program. The existing connection at the Elizabeth Street sewer line should be scoped to verify conditions and replaced with new as required.

- All existing plumbing fixtures shall be removed and new fixtures installed as required by the new program.
- Interior vent piping should be scoped and inspected to confirm conditions and replaced as required. Existing vent piping through roof to be reused.
