**APPENDIX F**

**RESULTS OF STABILITY ANALYSIS**

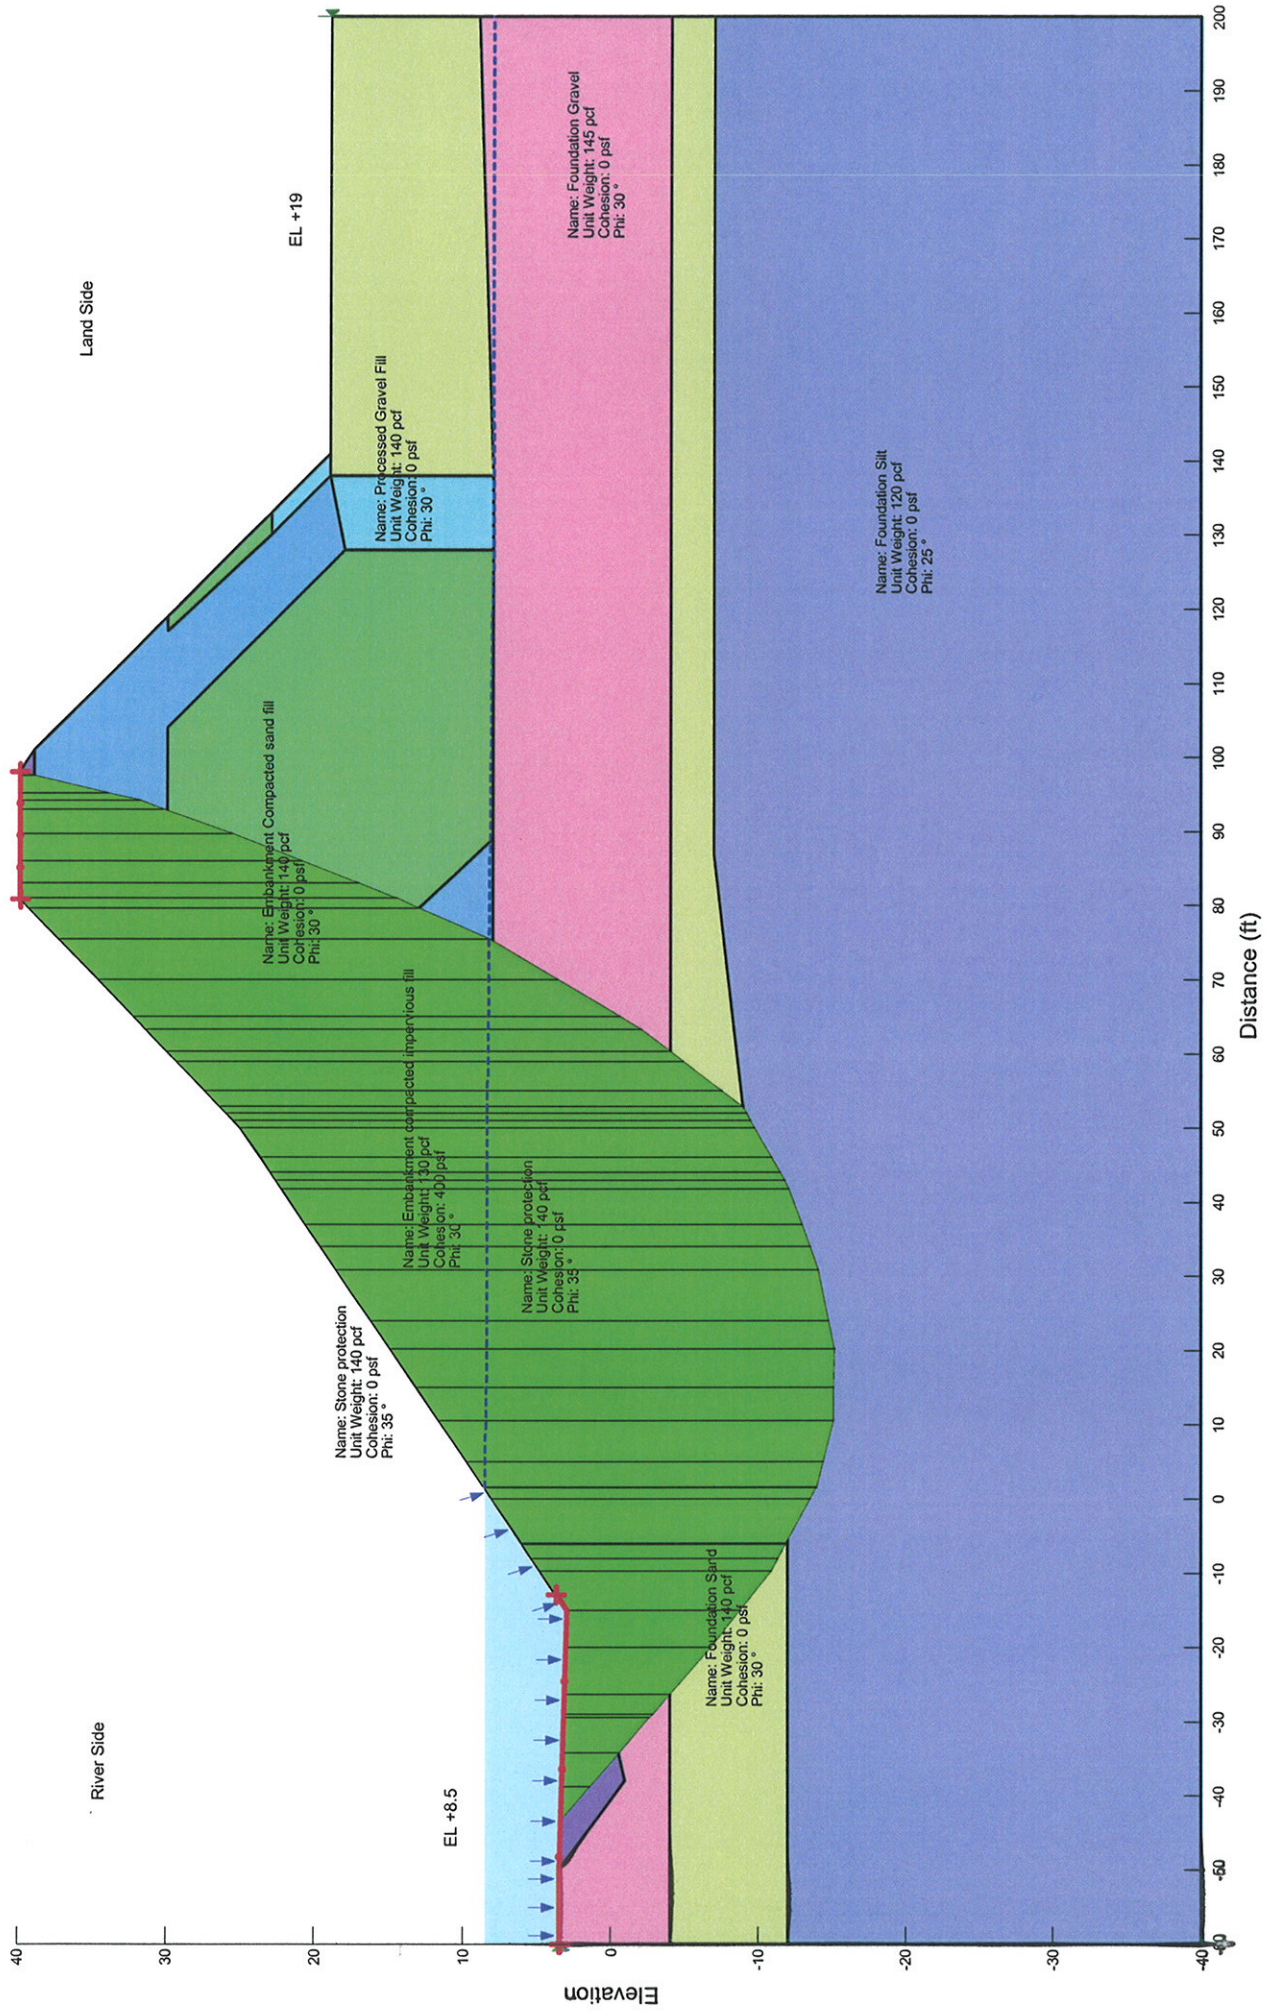
# Slope/W Analysis at Section PSS-2 Steady State Condition (River Side)

1.81

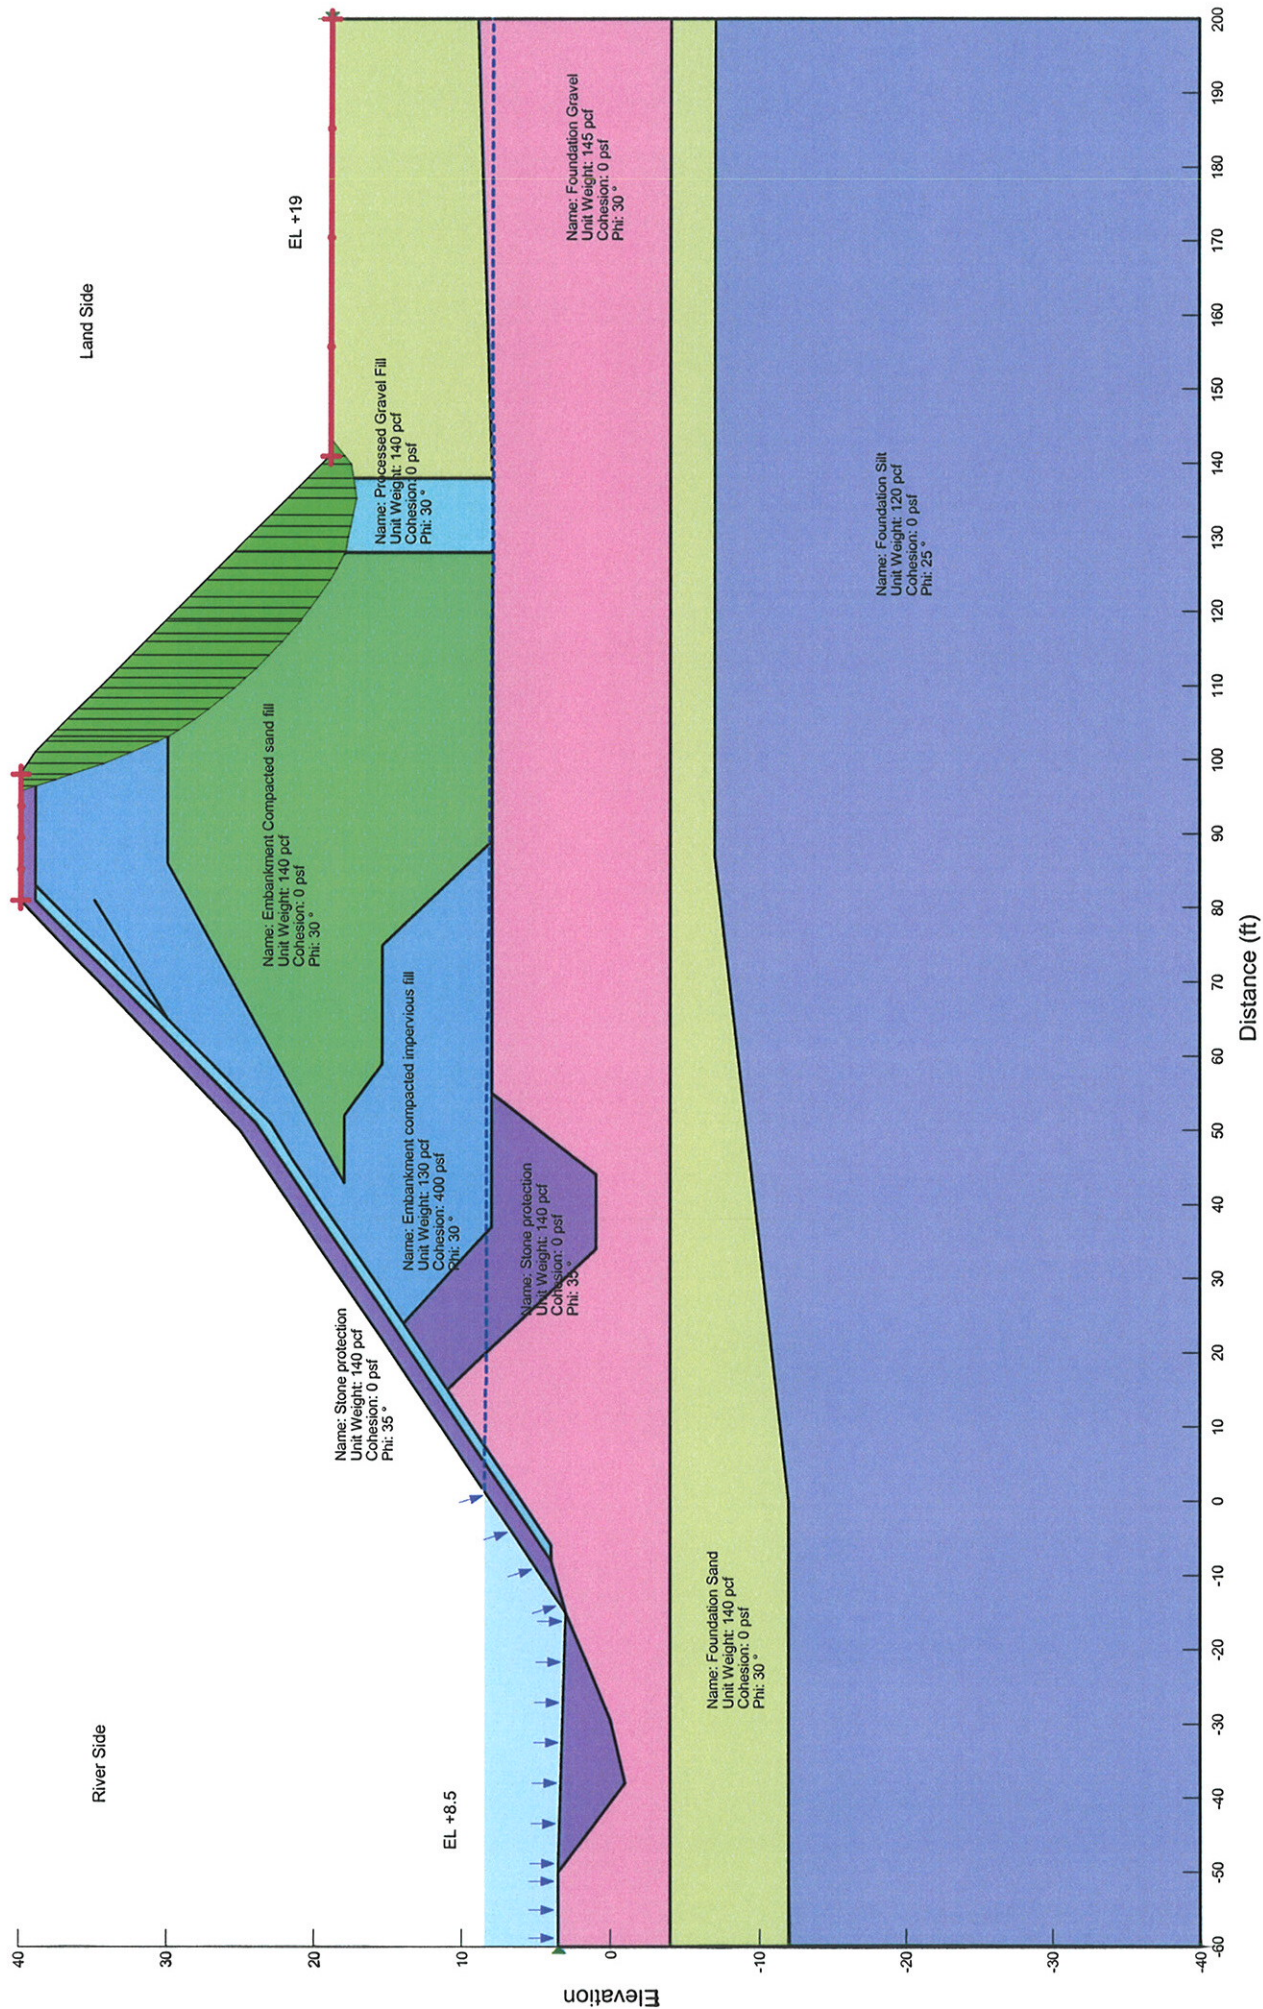
# **SLOPEW ANALYSIS SECTION AT PSS-2** **Steady State Condition (Land Side)**

1.74

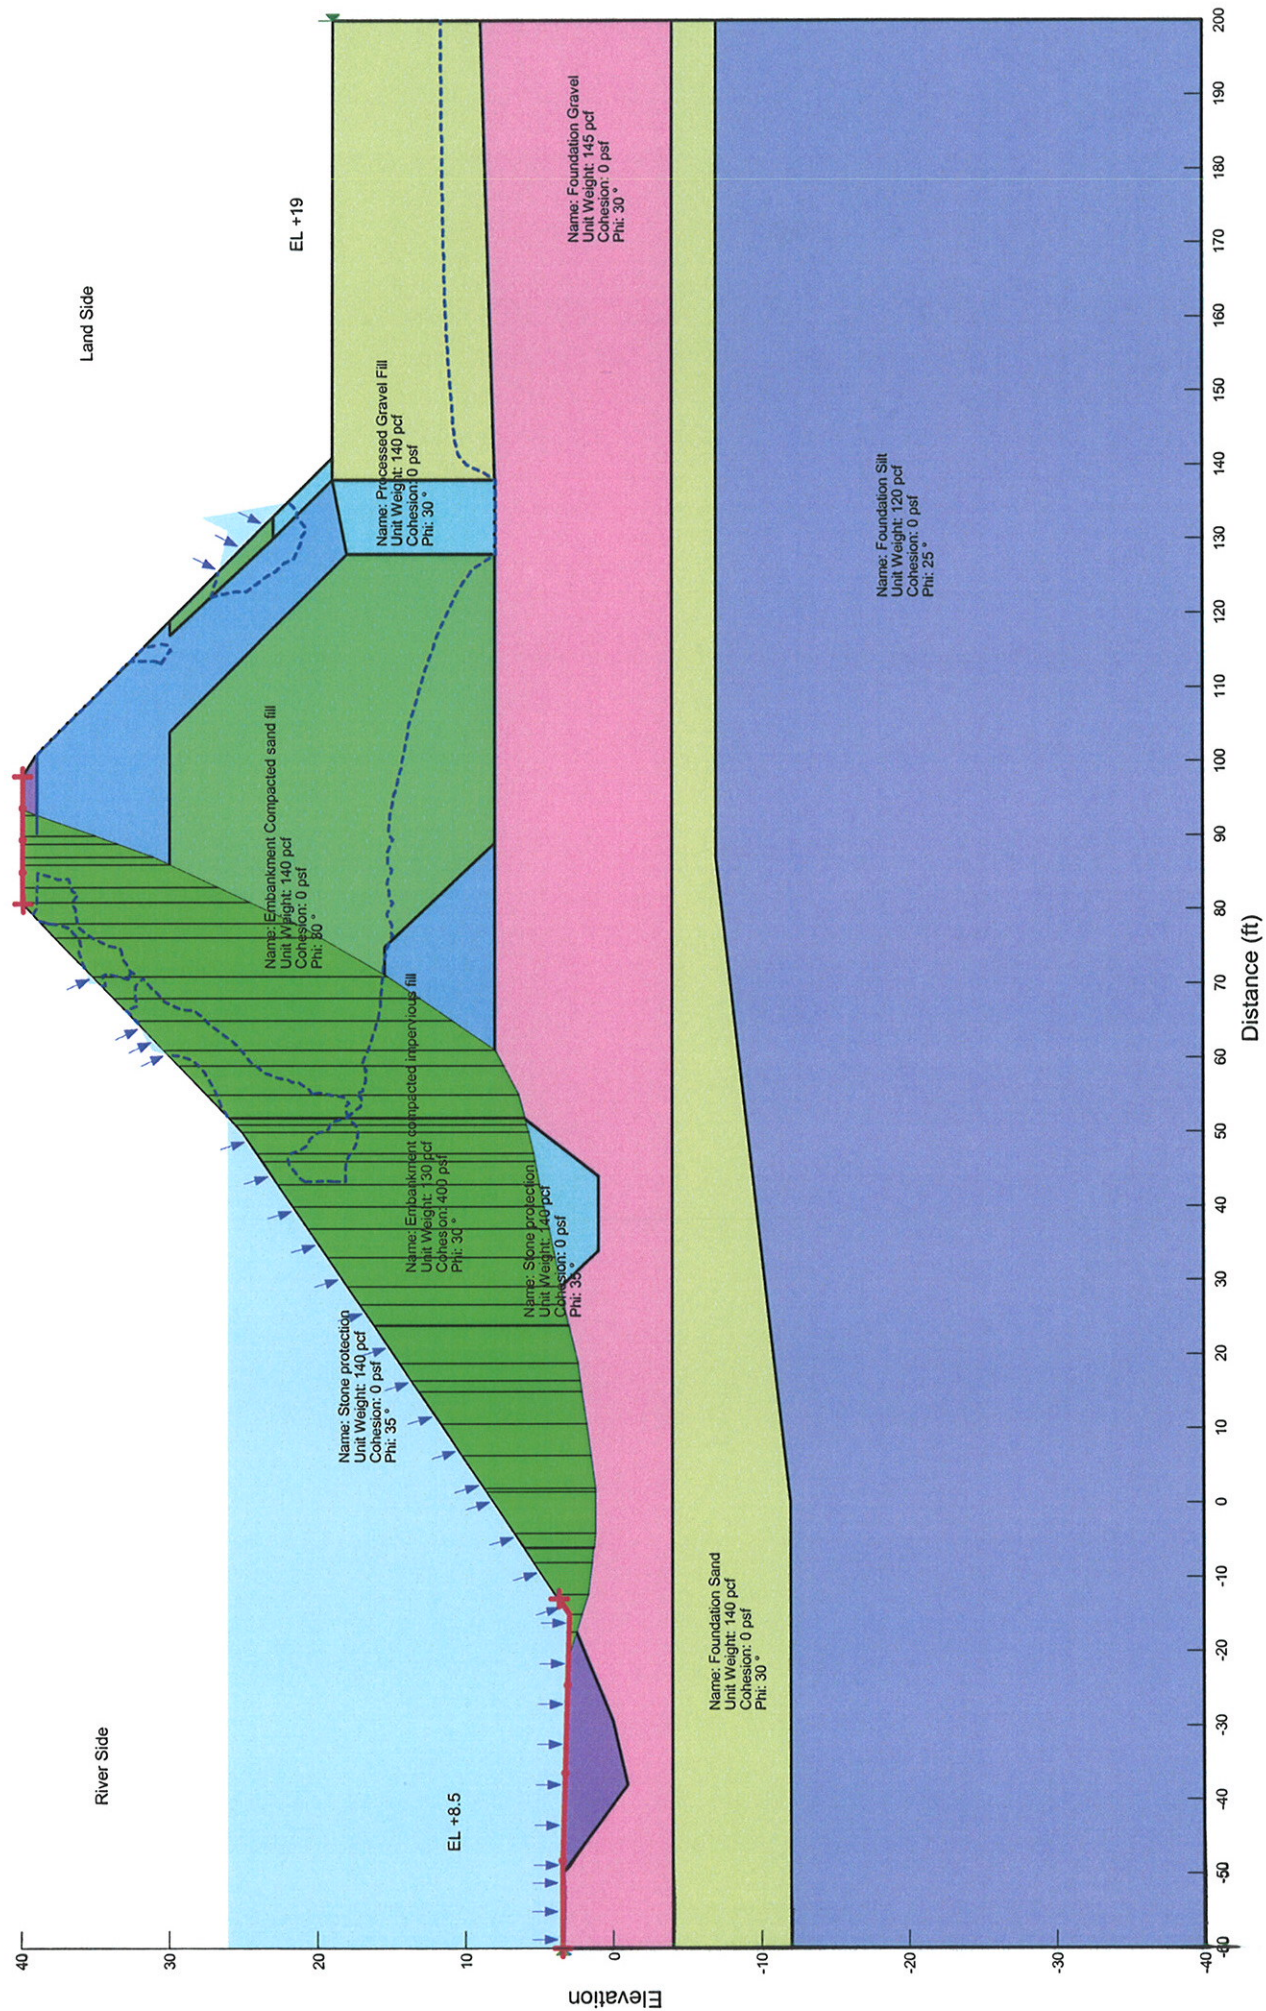
# SLOPE/W ANALYSIS SECTION AT PSS-2 High Flood Condition (River Side)

1.93

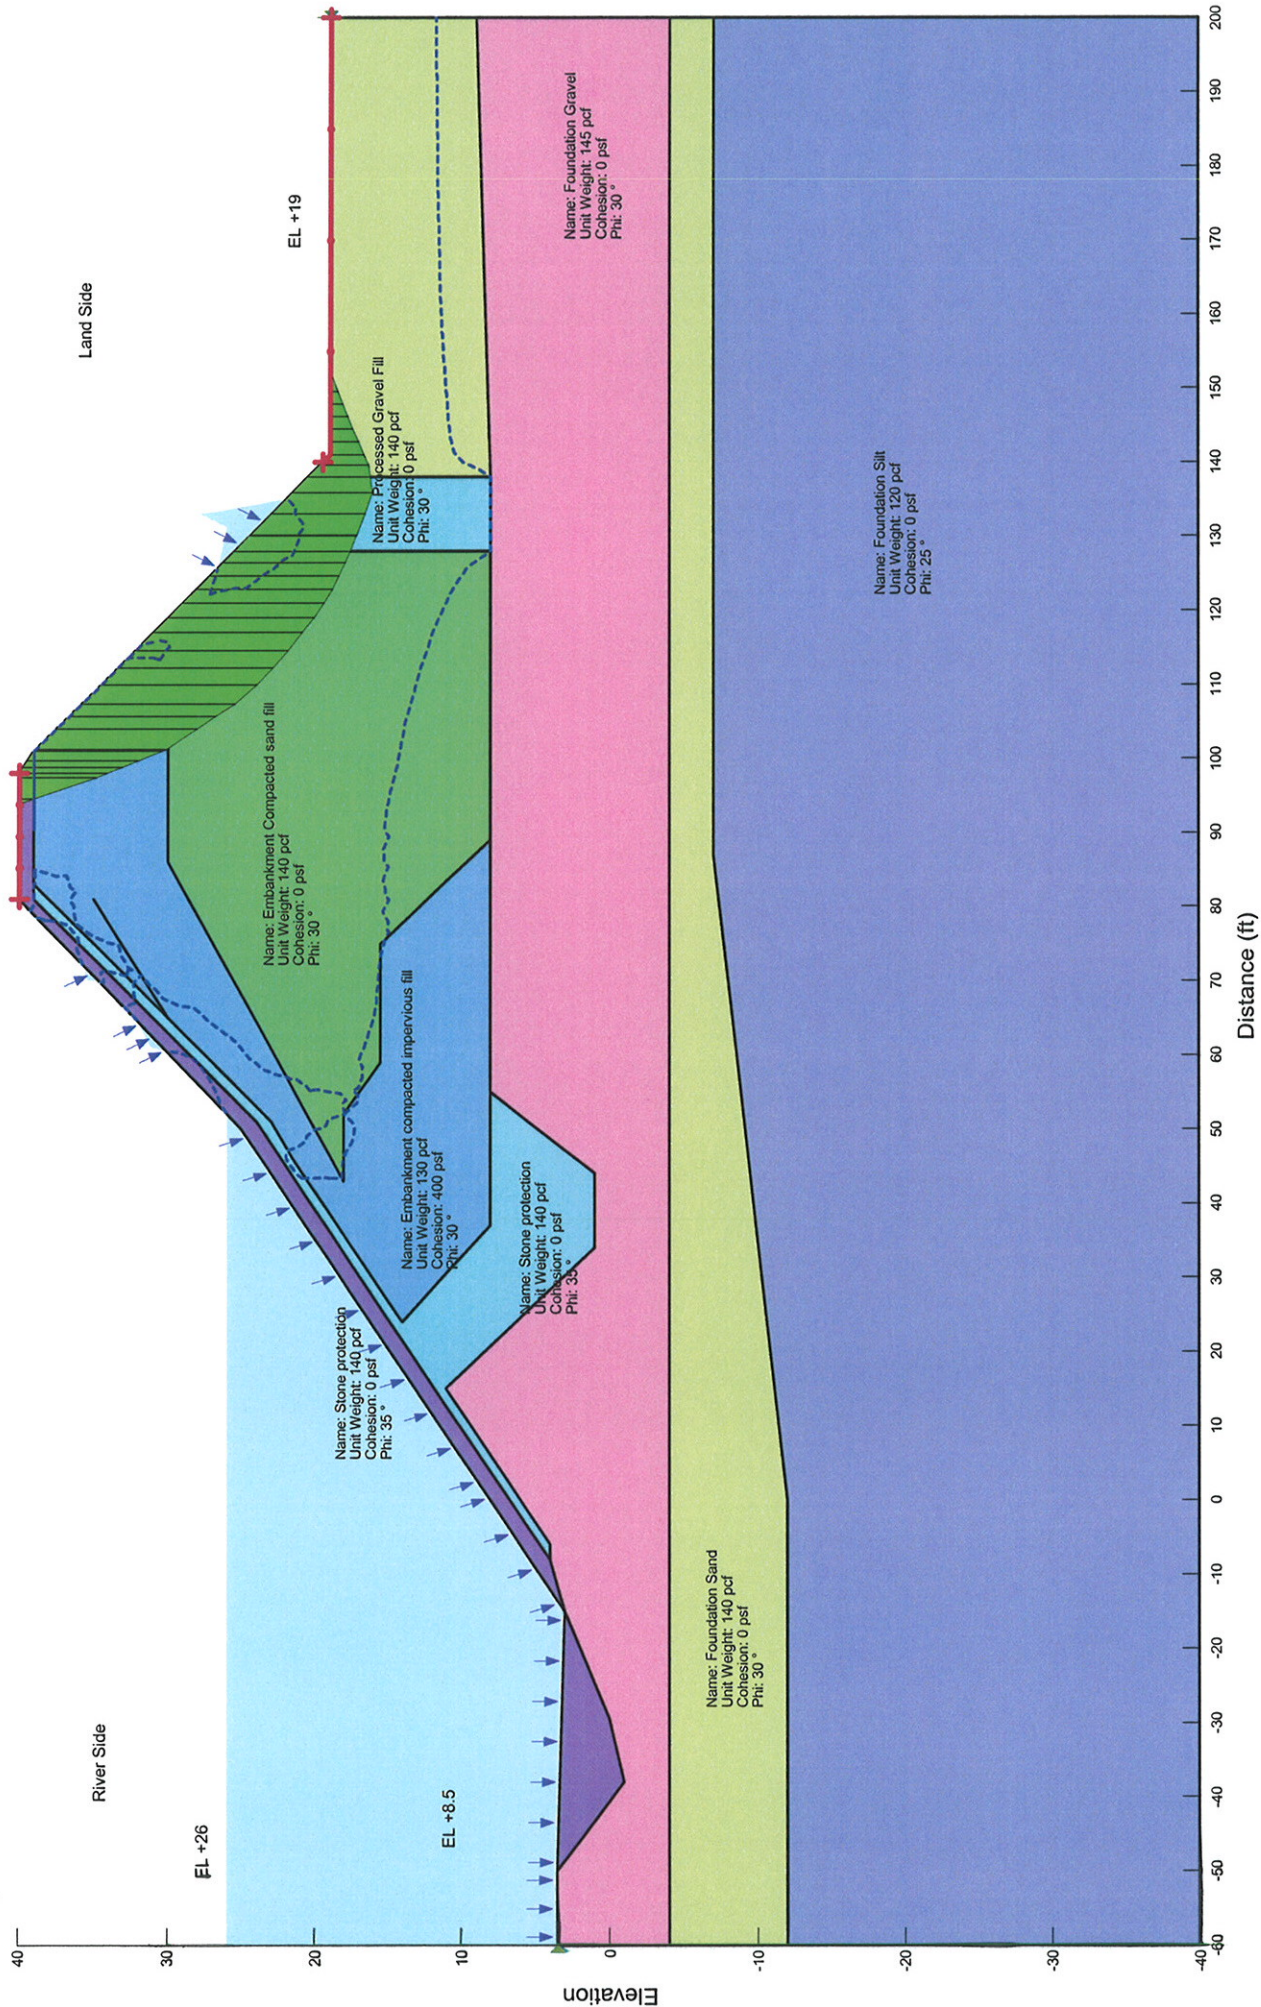
# **SLOPE/W ANALYSIS SECTION AT PSS-2** **High Flood Condition (Land Side)**

1.84

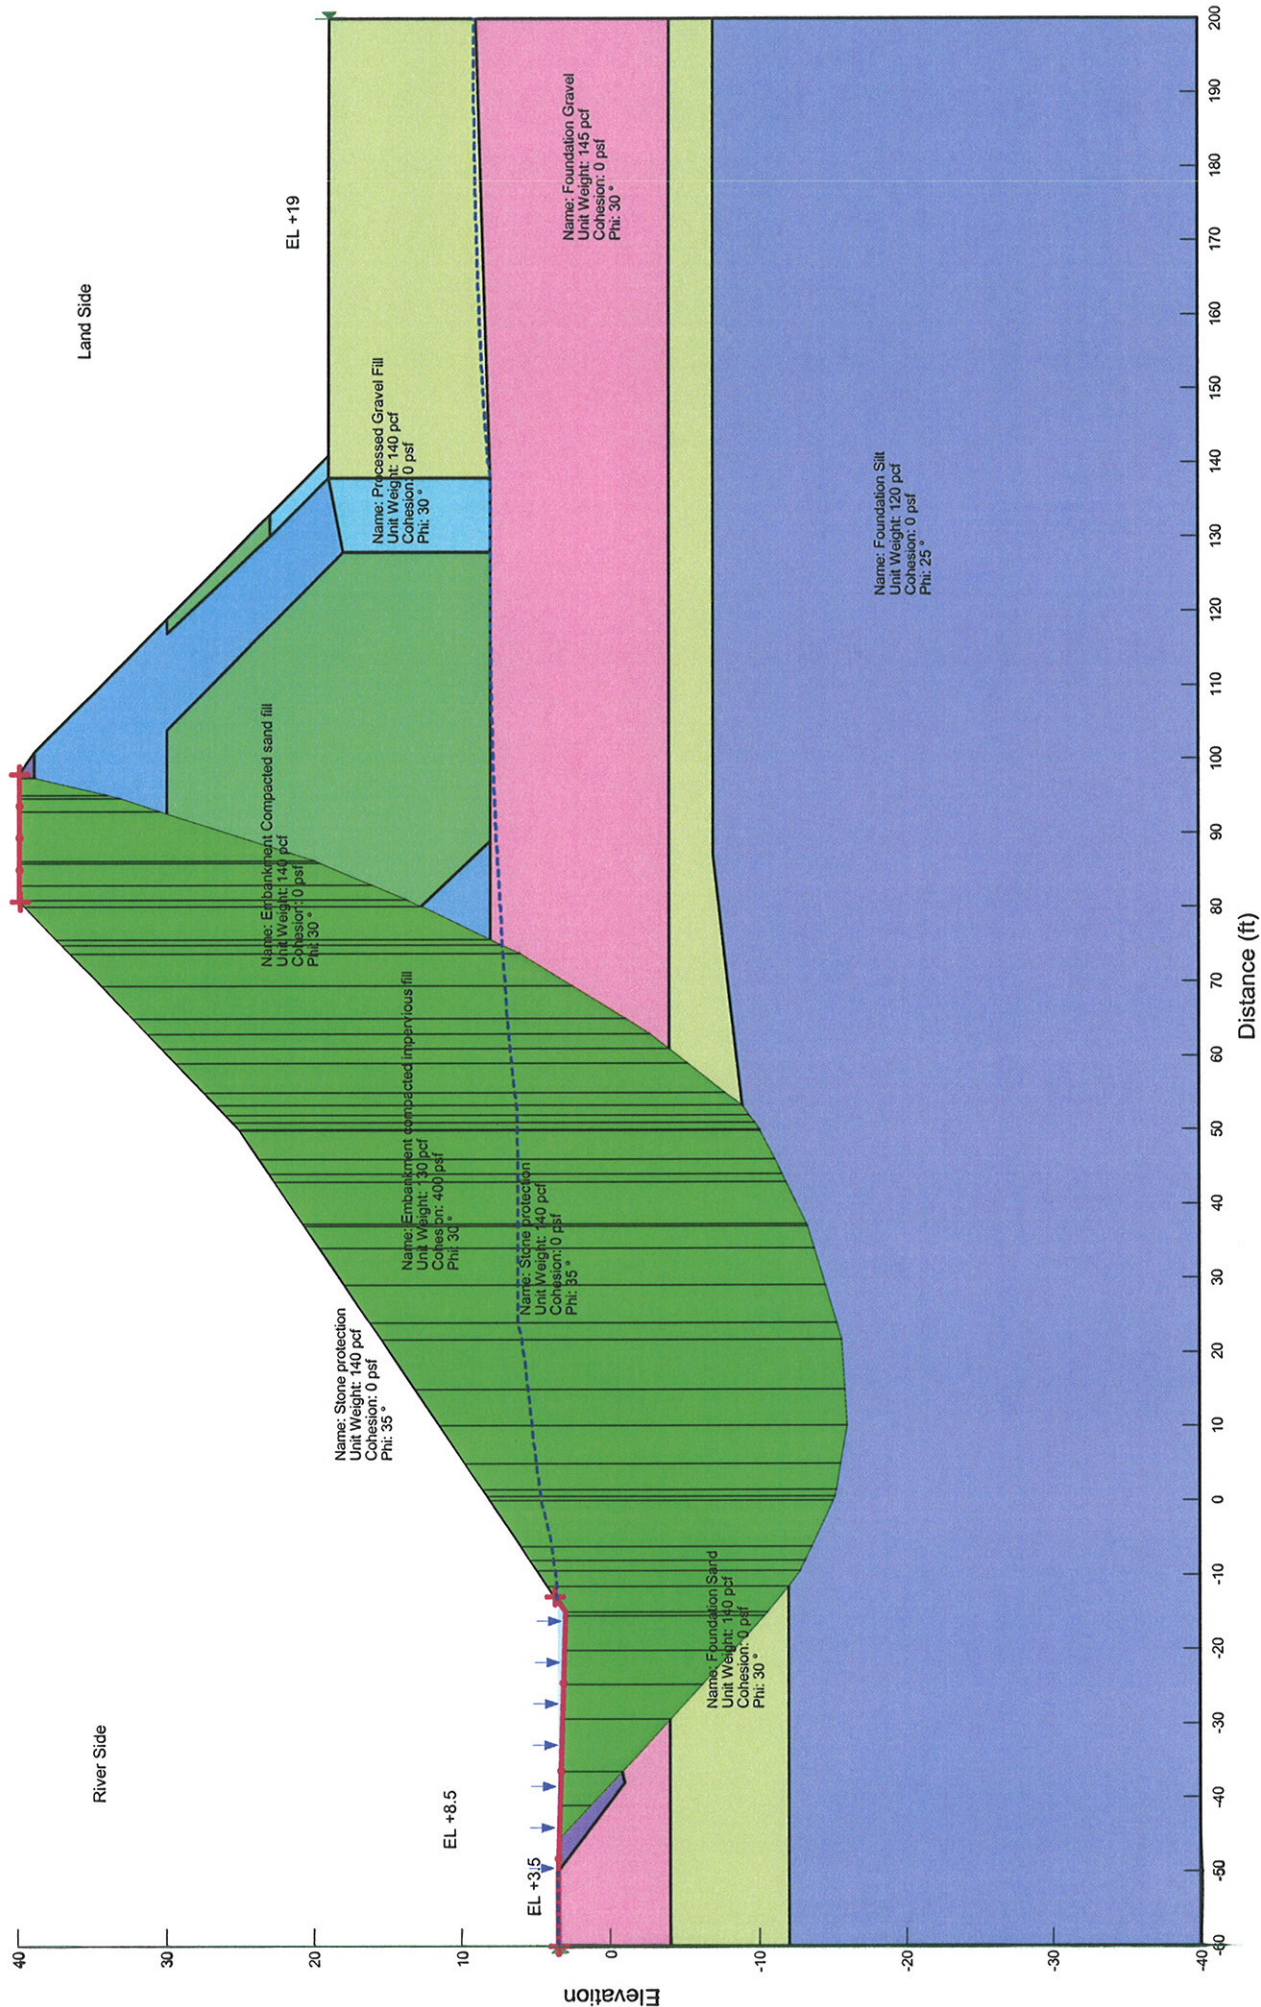
# **SLOPE/W ANALYSIS SECTION AT PSS-2** **Sudden Drawdown Condition (River Side)**

1.78

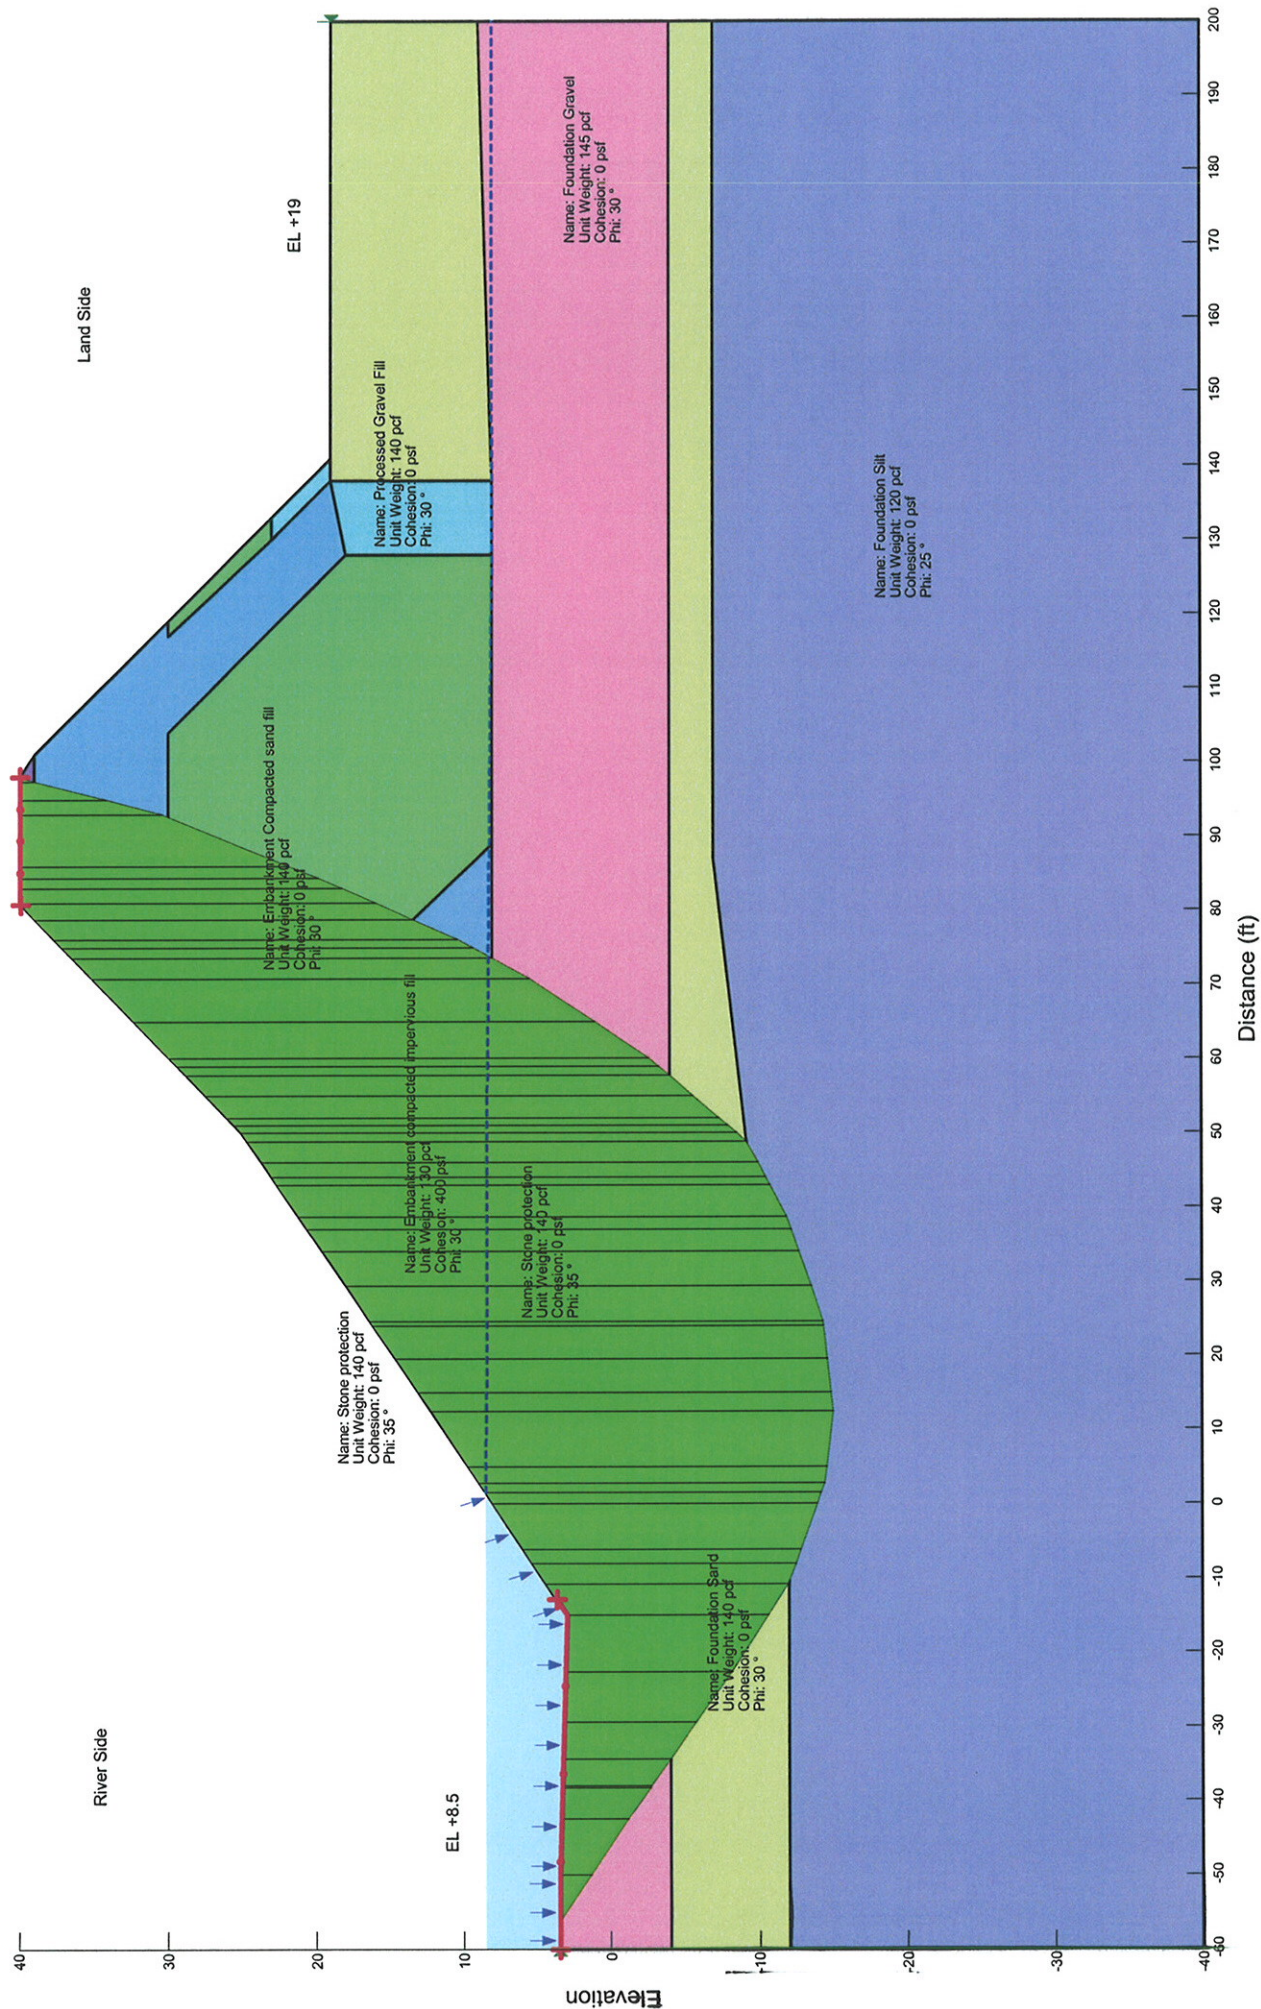
# SLOPE/W ANALYSIS SECTION AT PSS-2 Pseudo Static Condition (River Side)

1.39

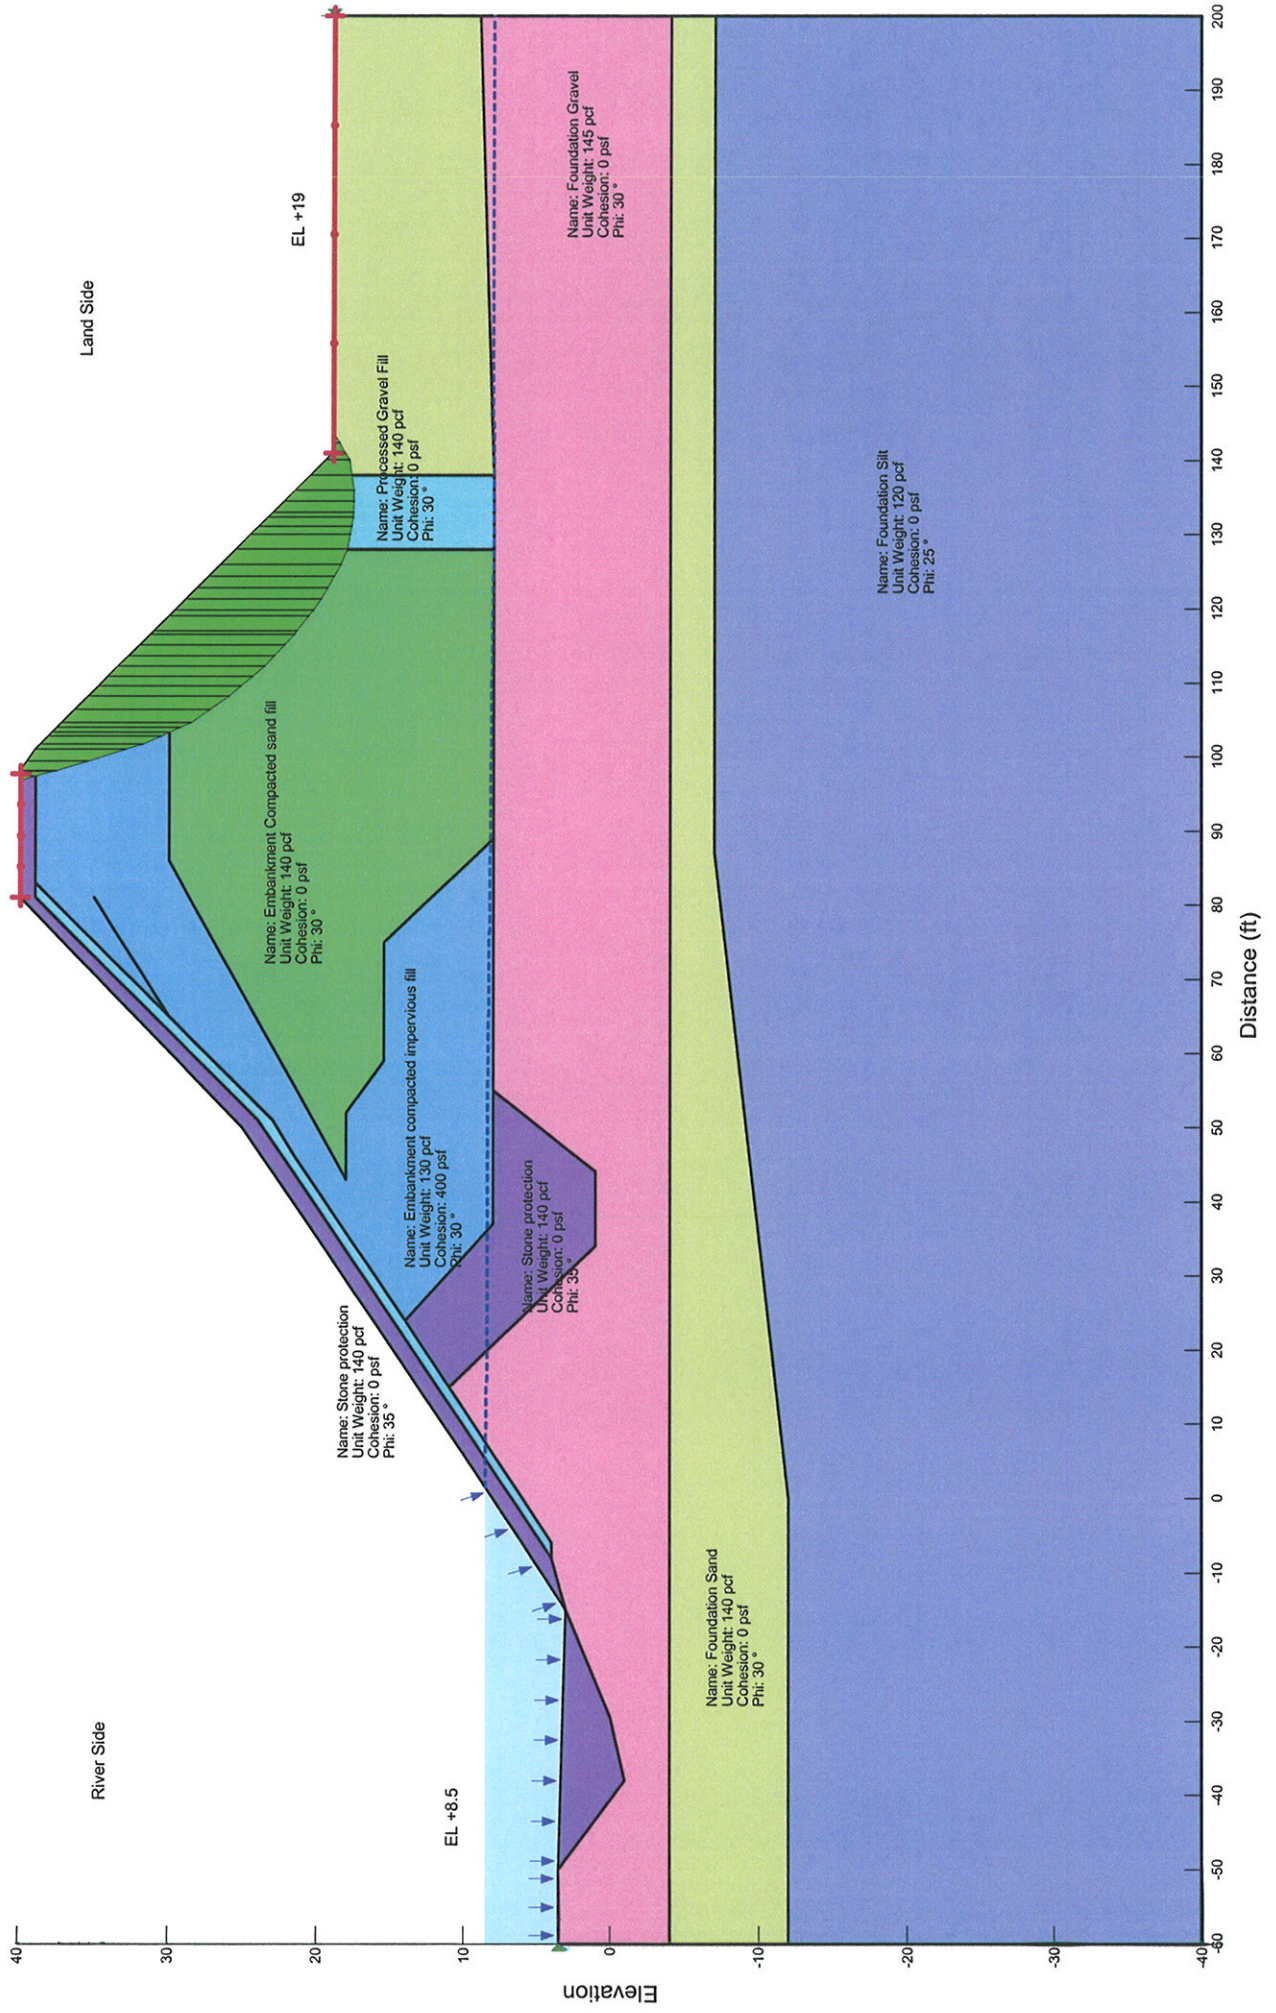
# SLOPEW ANALYSIS SECTION AT PSS-2 Pseudo Static Condition (Land Side)

1.45

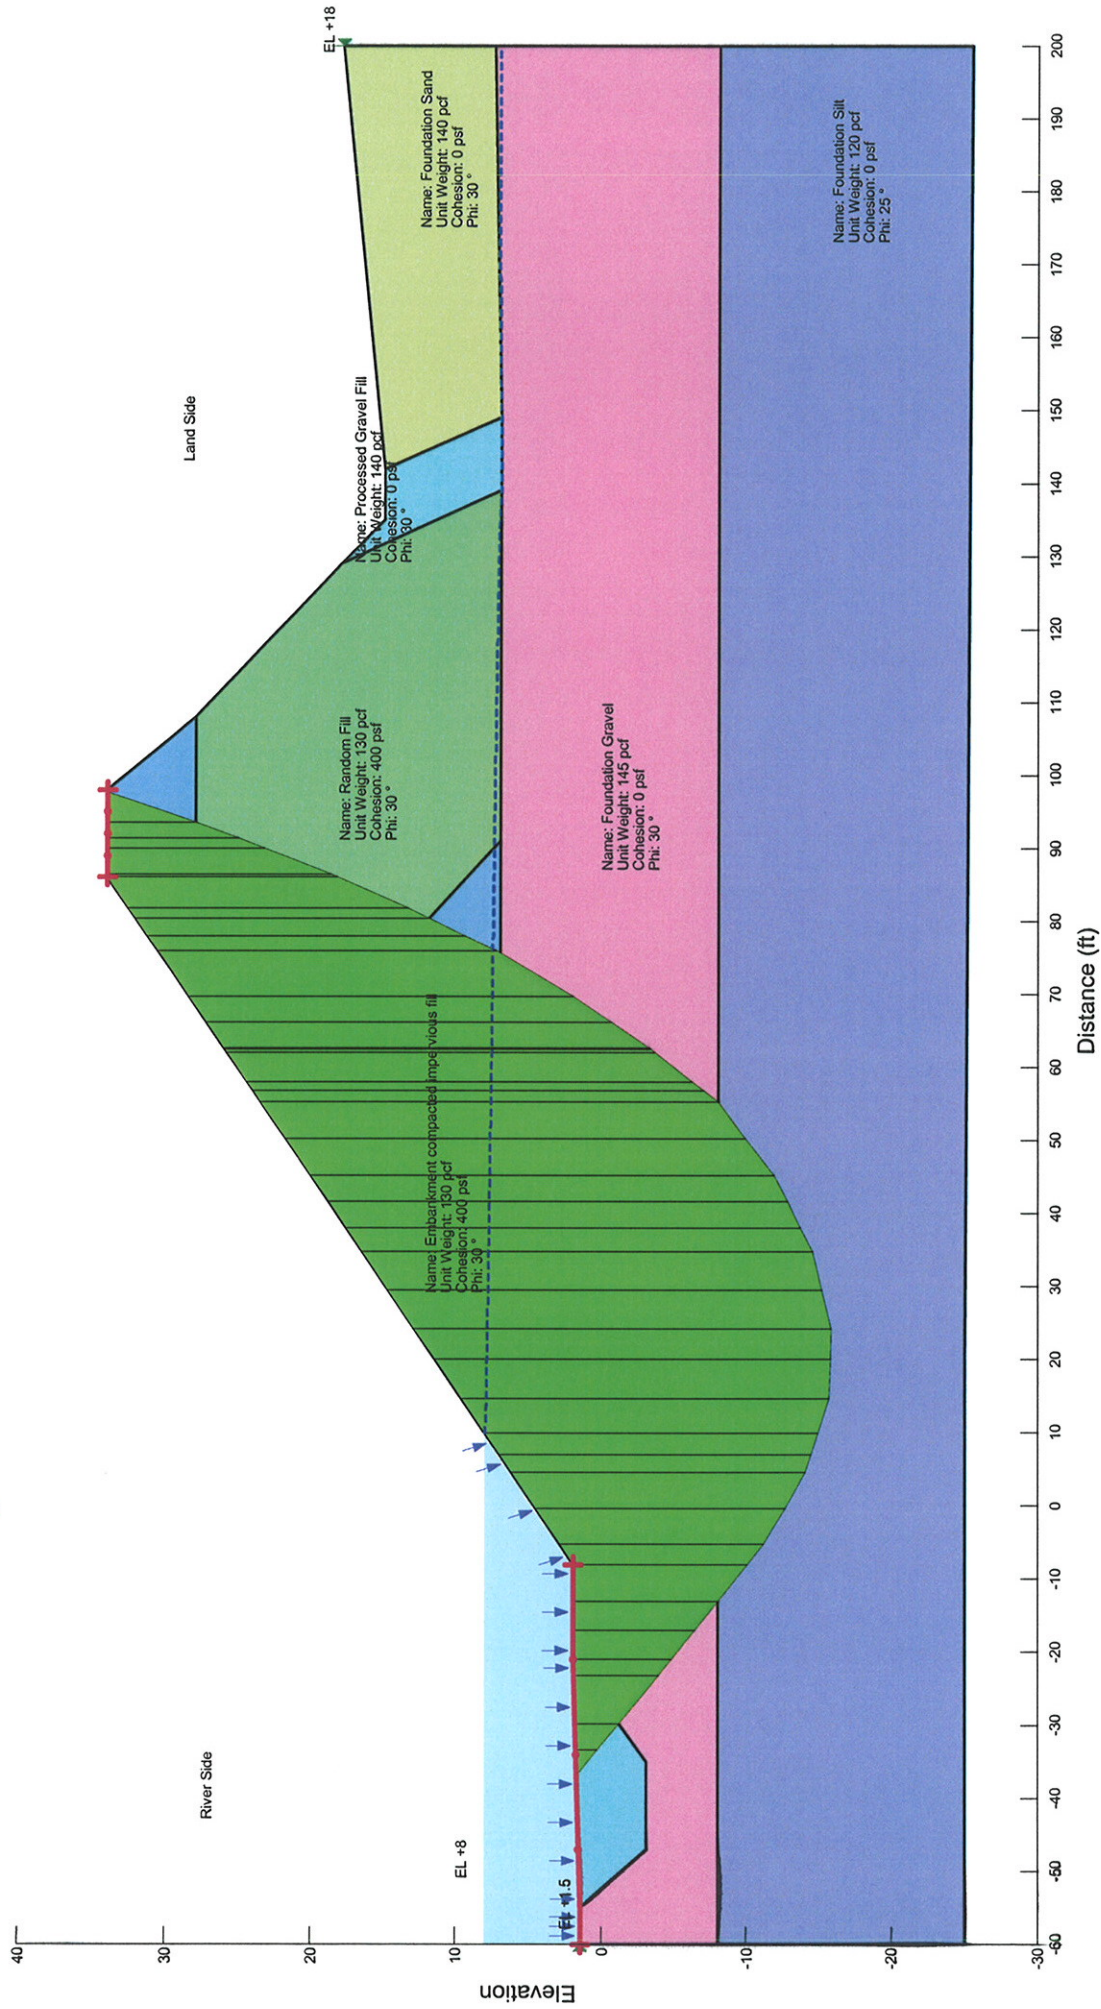
# **SLOPE/W ANALYSIS SECTION AT PSS-4** **Steady State Condition (River Side)**

1.99

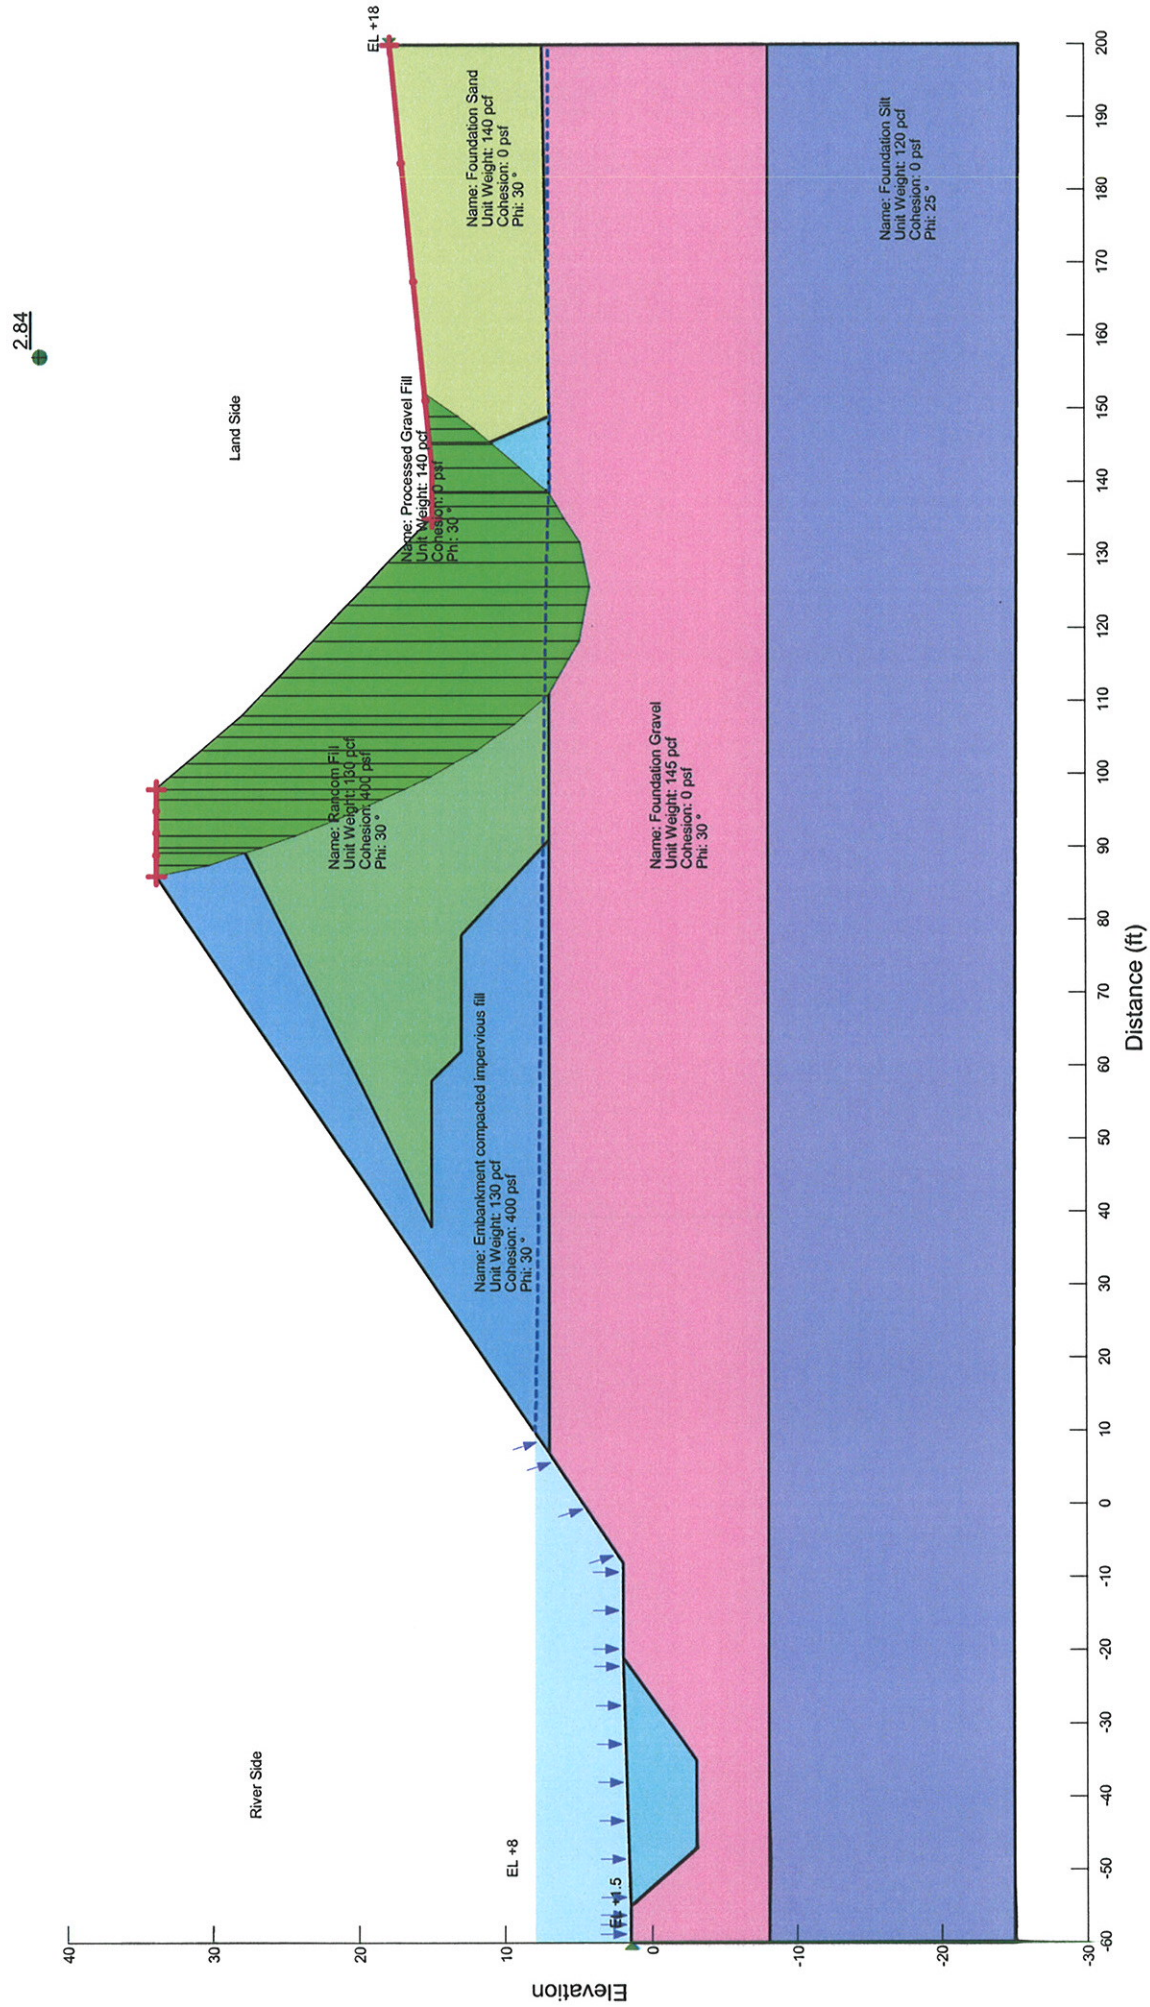
# **SLOPE/W ANALYSIS SECTION AT PSS-4** **Steady State Condition (Land Side)**
