**APPENDIX F**

**RESULTS OF STABILITY ANALYSIS**

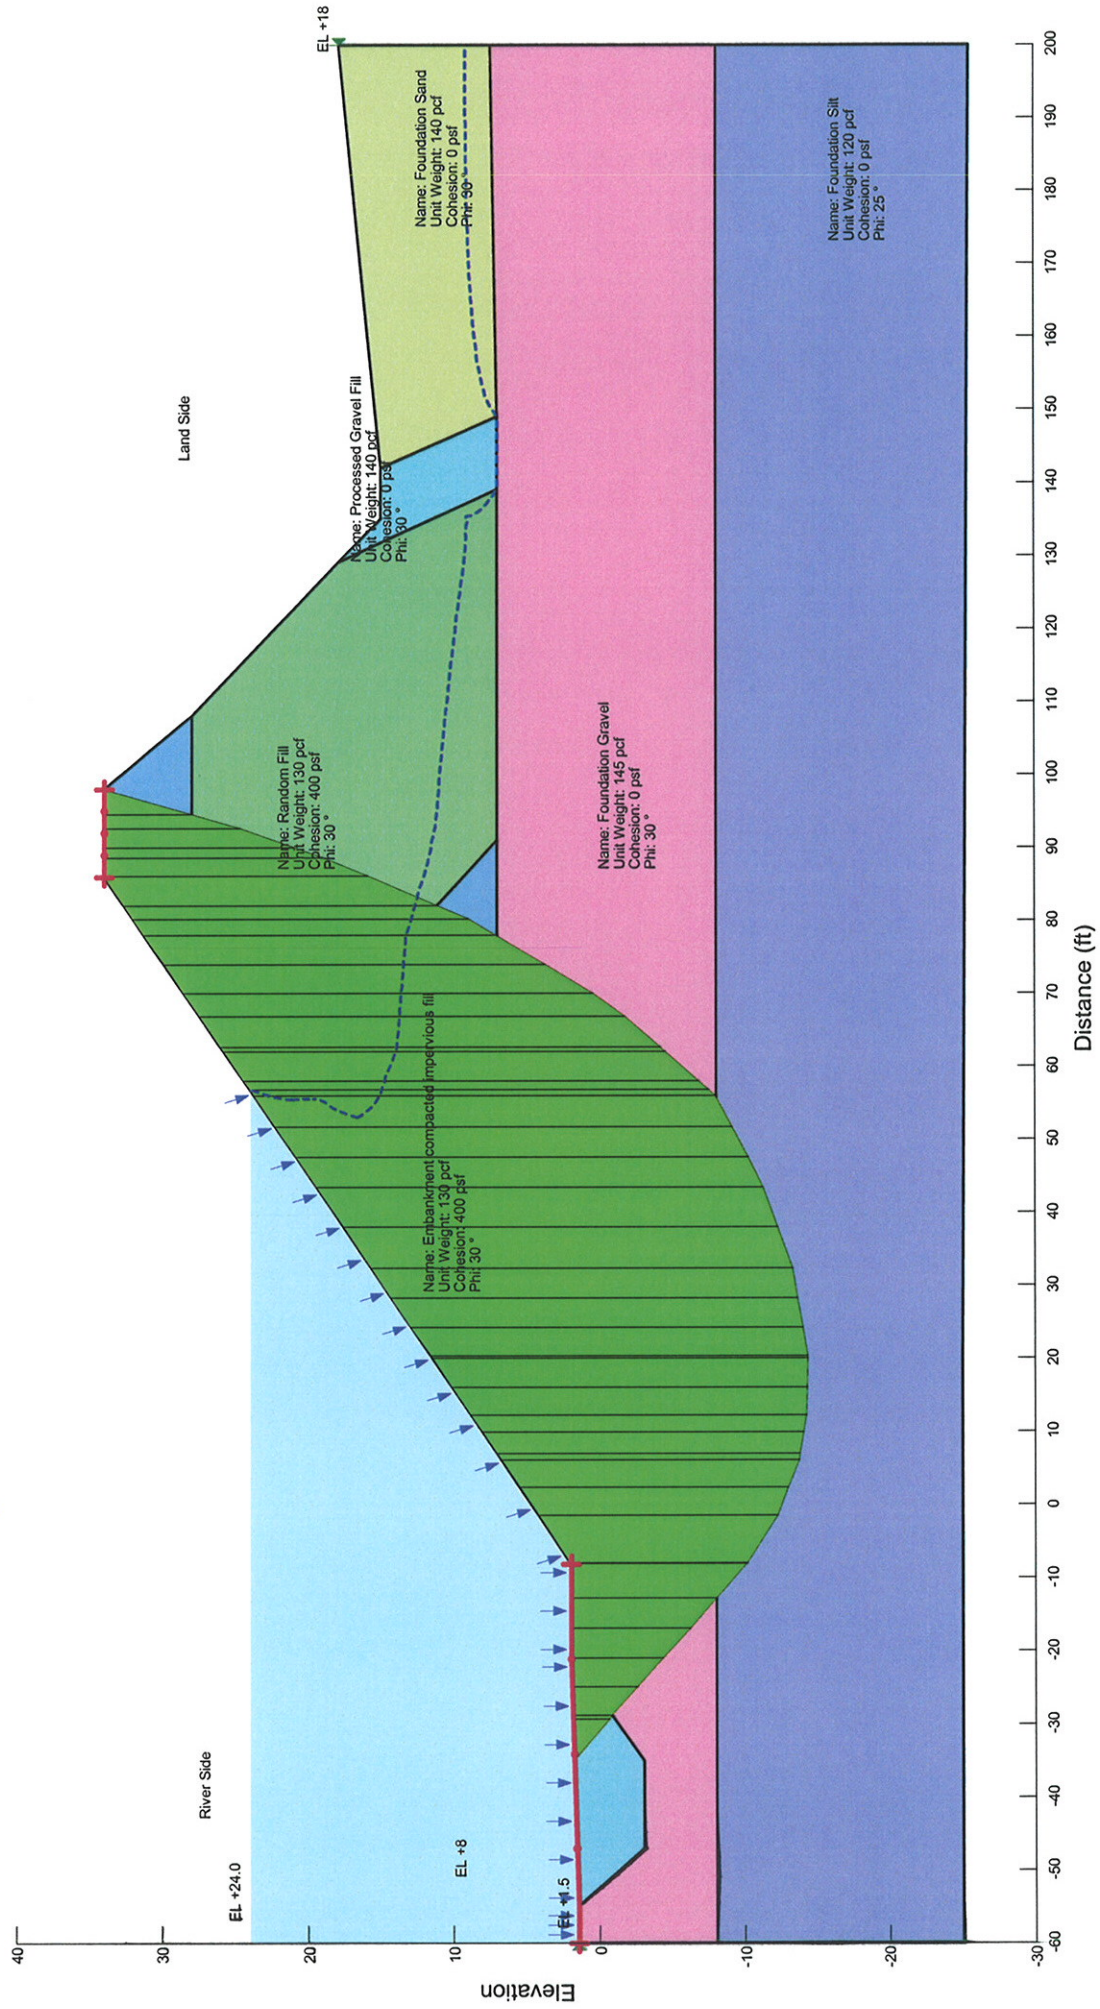
# **SLOPE/W ANALYSIS SECTION AT PSS-4** **High Flood Condition (River Side)**

2.68

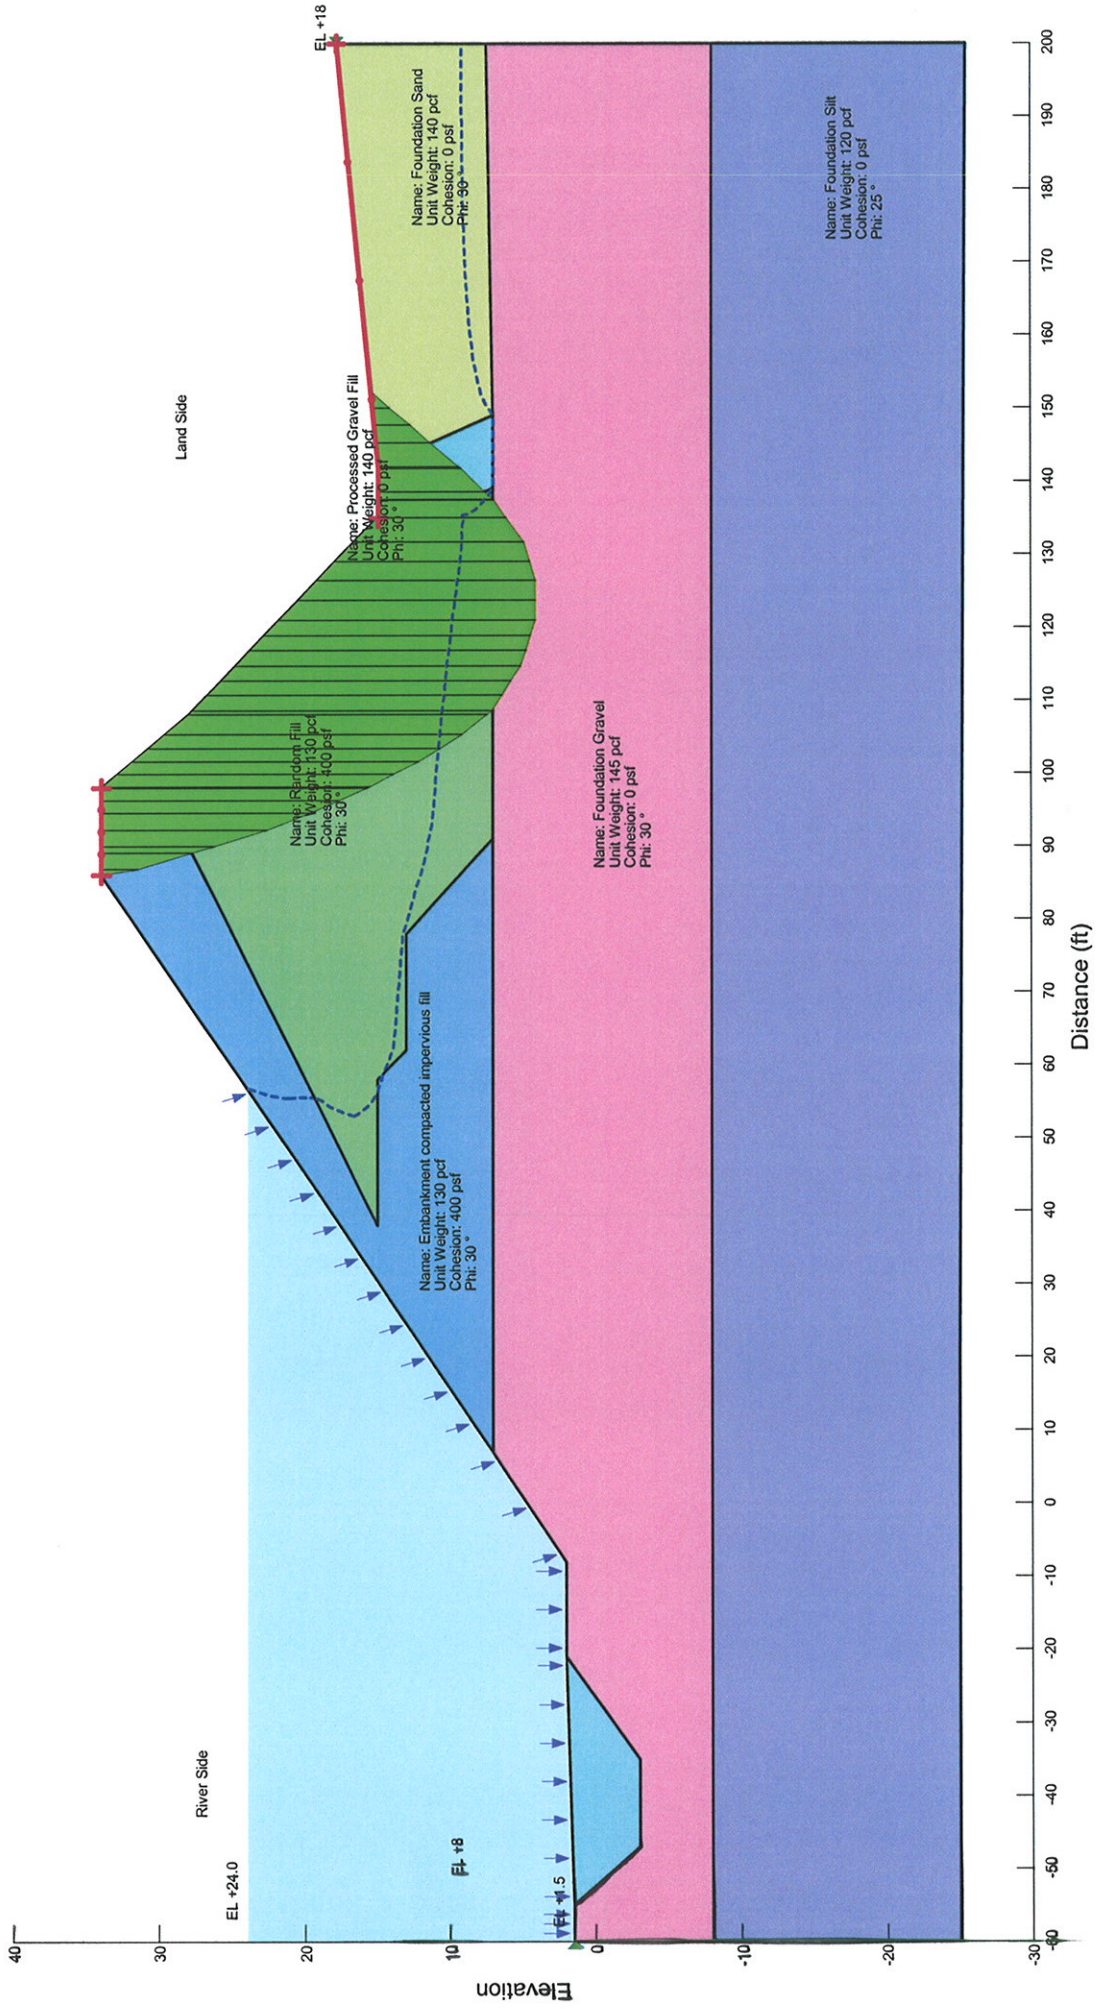
# **SLOPE/W ANALYSIS SECTION AT PSS-4** **High Flood Condition (Land Side)**

2.67

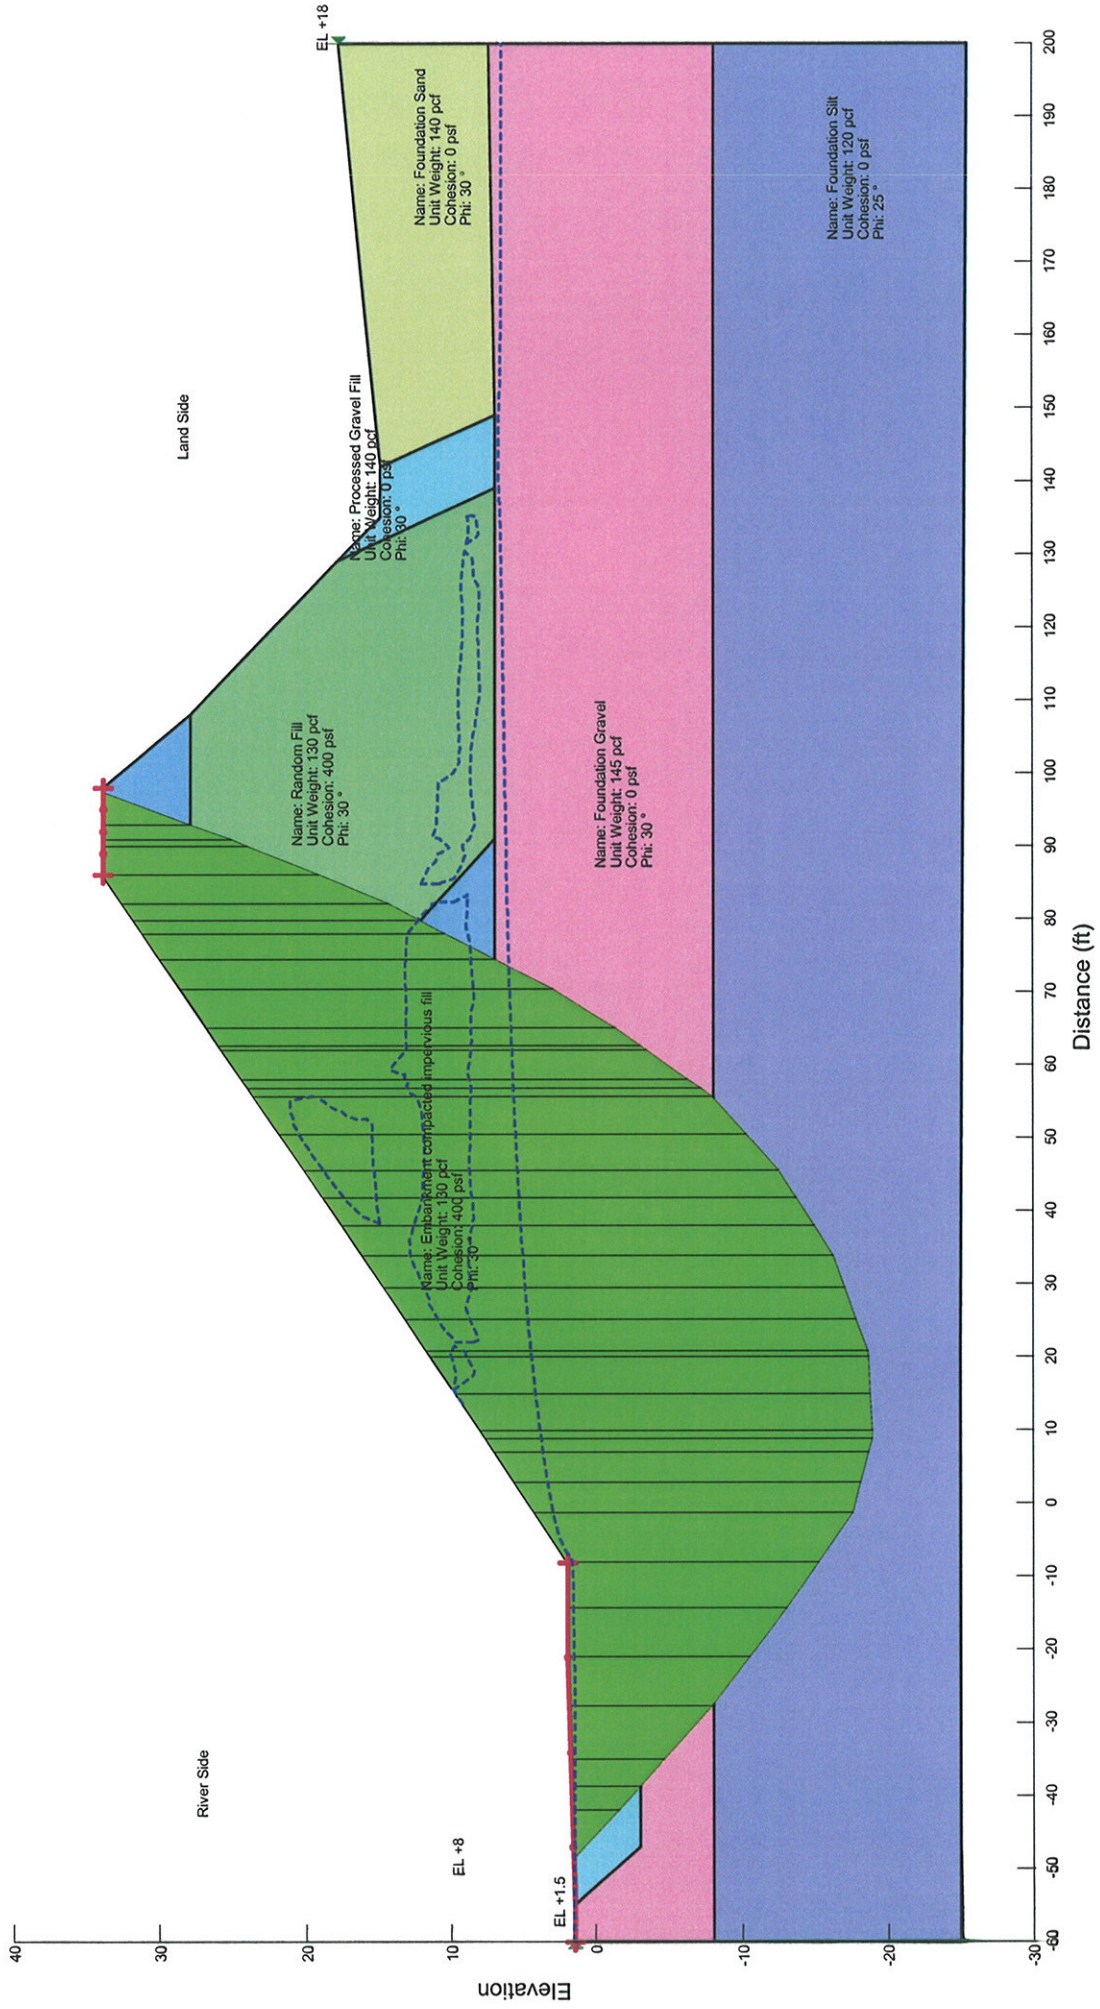
# **SLOPEW ANALYSIS SECTION AT PSS-4** **Sudden Drawdown Condition (River Side)**

1.91

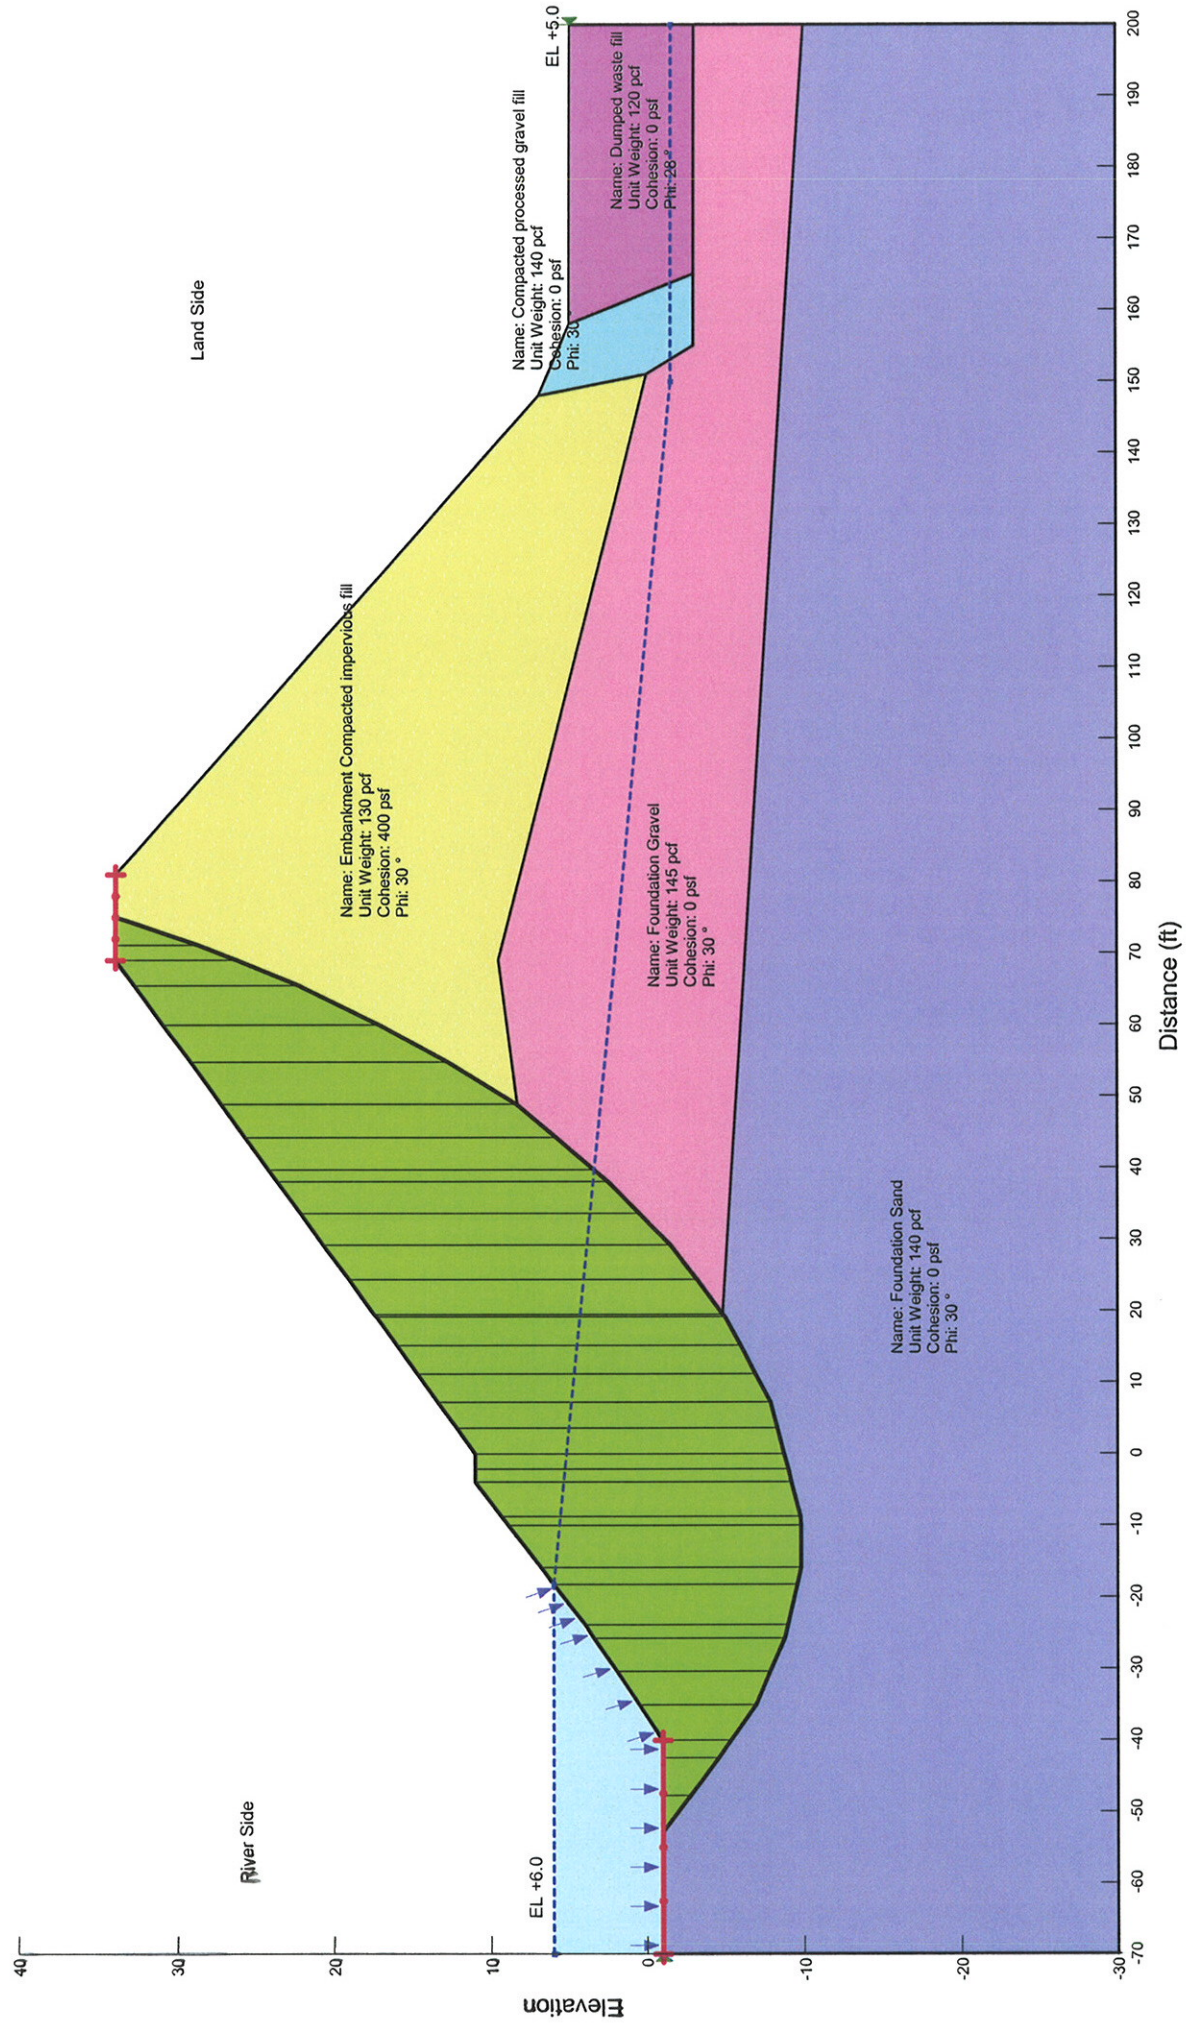
# **SLOPE STABILITY ANALYSIS SECTION AT PSS-6** **Steady State Condition (River Side)**

2.14

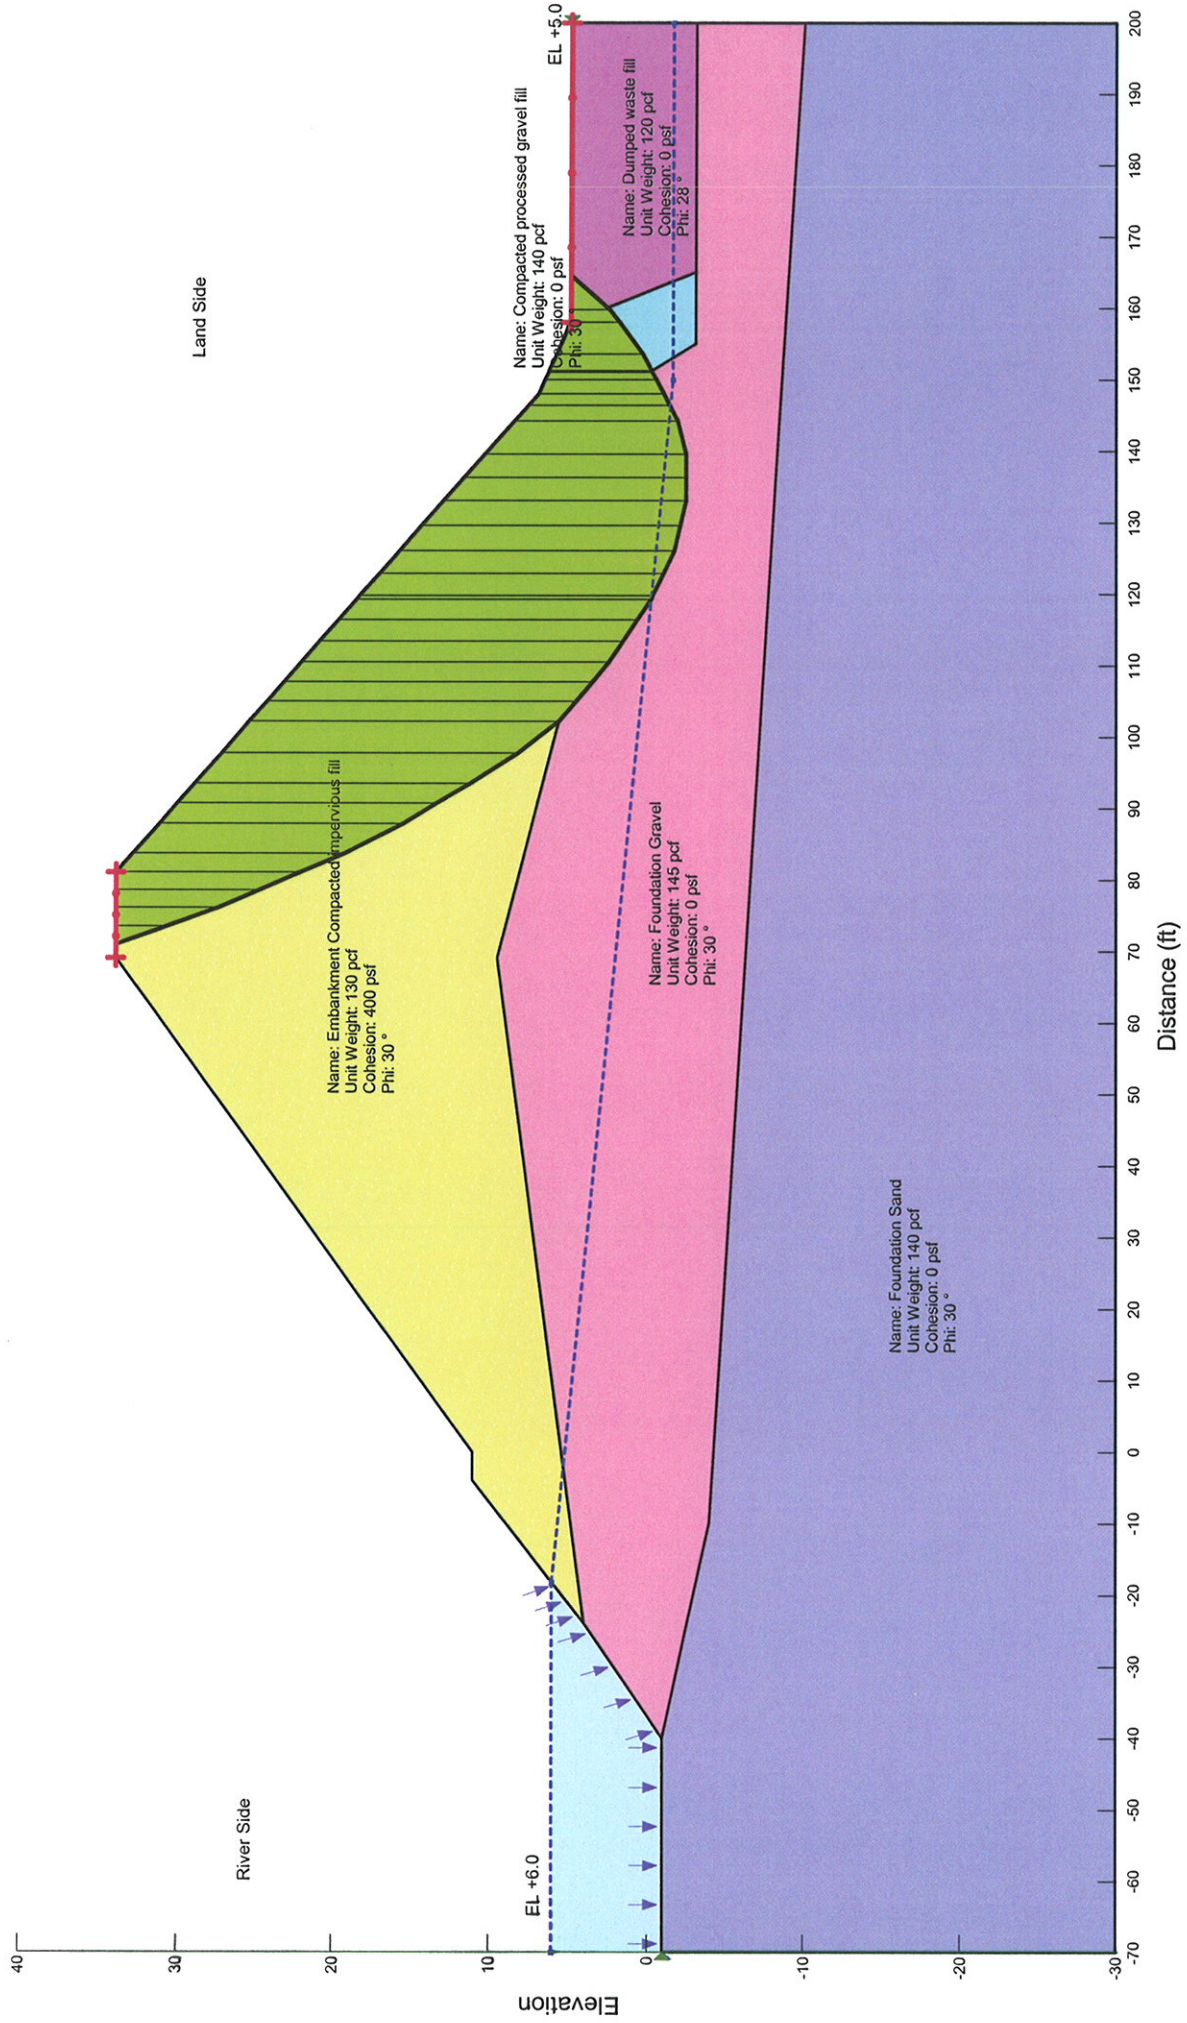
# **SLOPE STABILITY ANALYSIS SECTION AT PSS-6** **Steady State Condition (Land Side)**

2.28

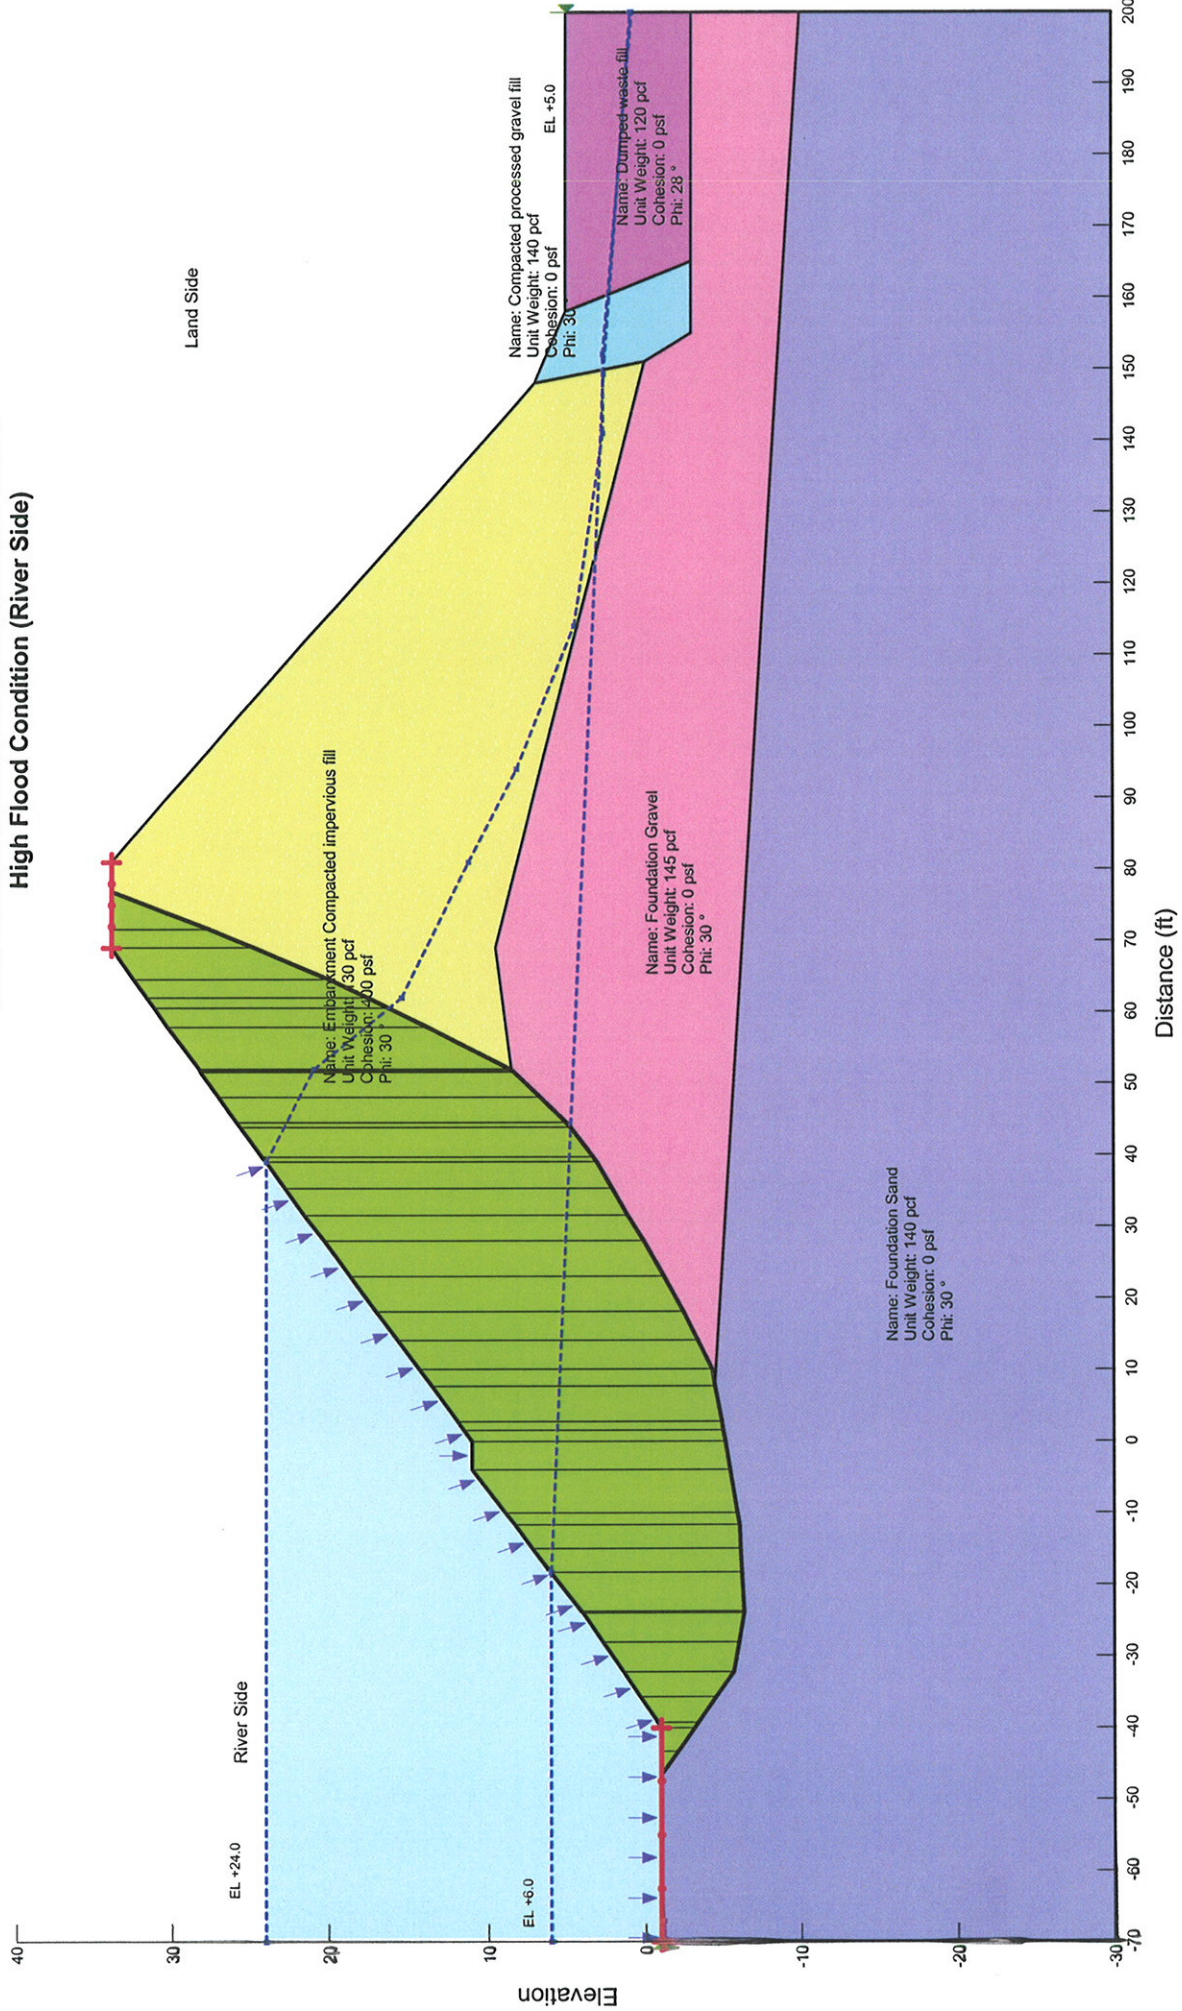
# SLOPE STABILITY ANALYSIS SECTION AT PSS-6 High Flood Condition (River Side)

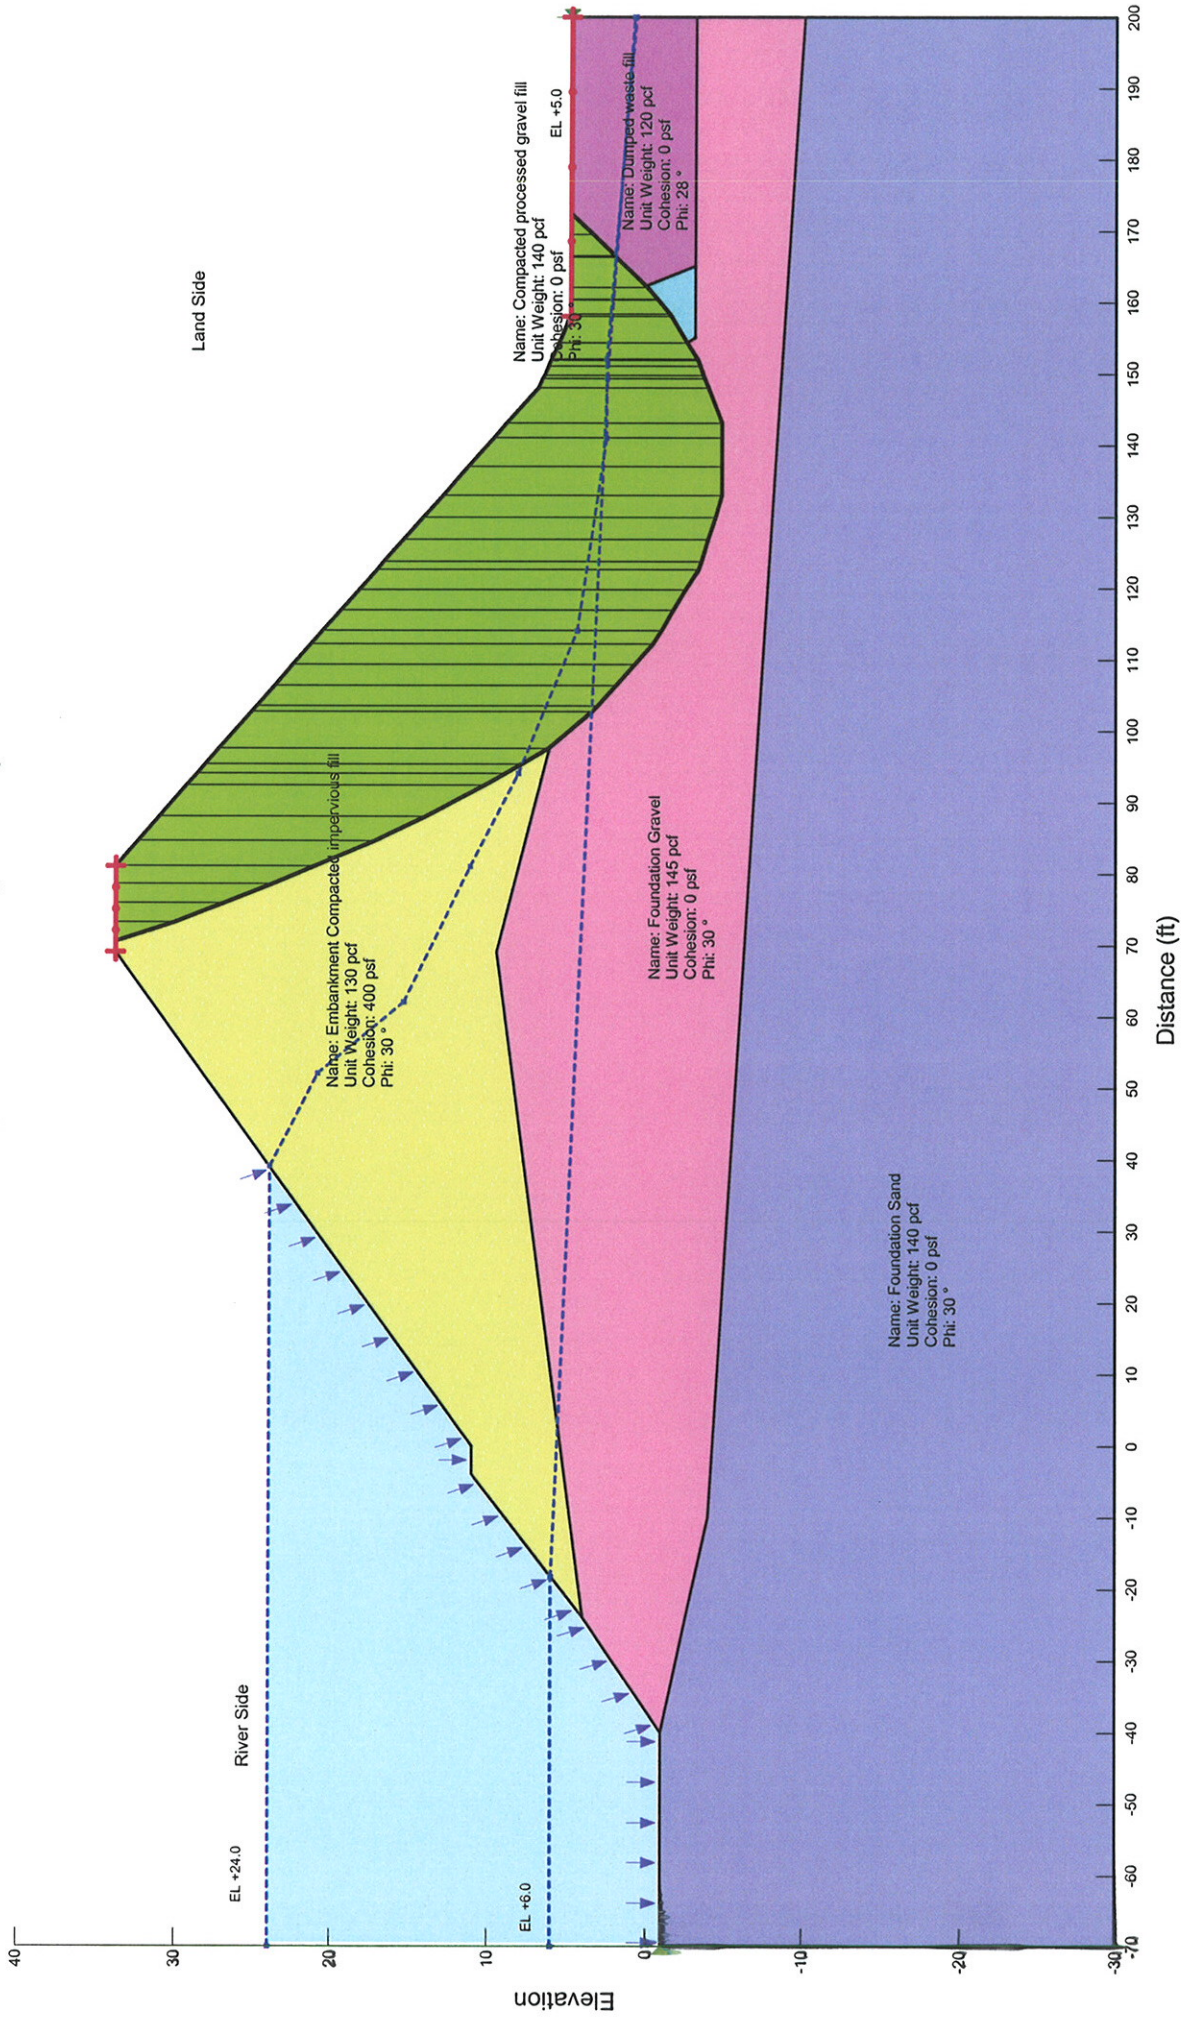
# **SLOPE STABILITY ANALYSIS SECTION AT PSS-6** **High Flood Condition (Land Side)**

2.09

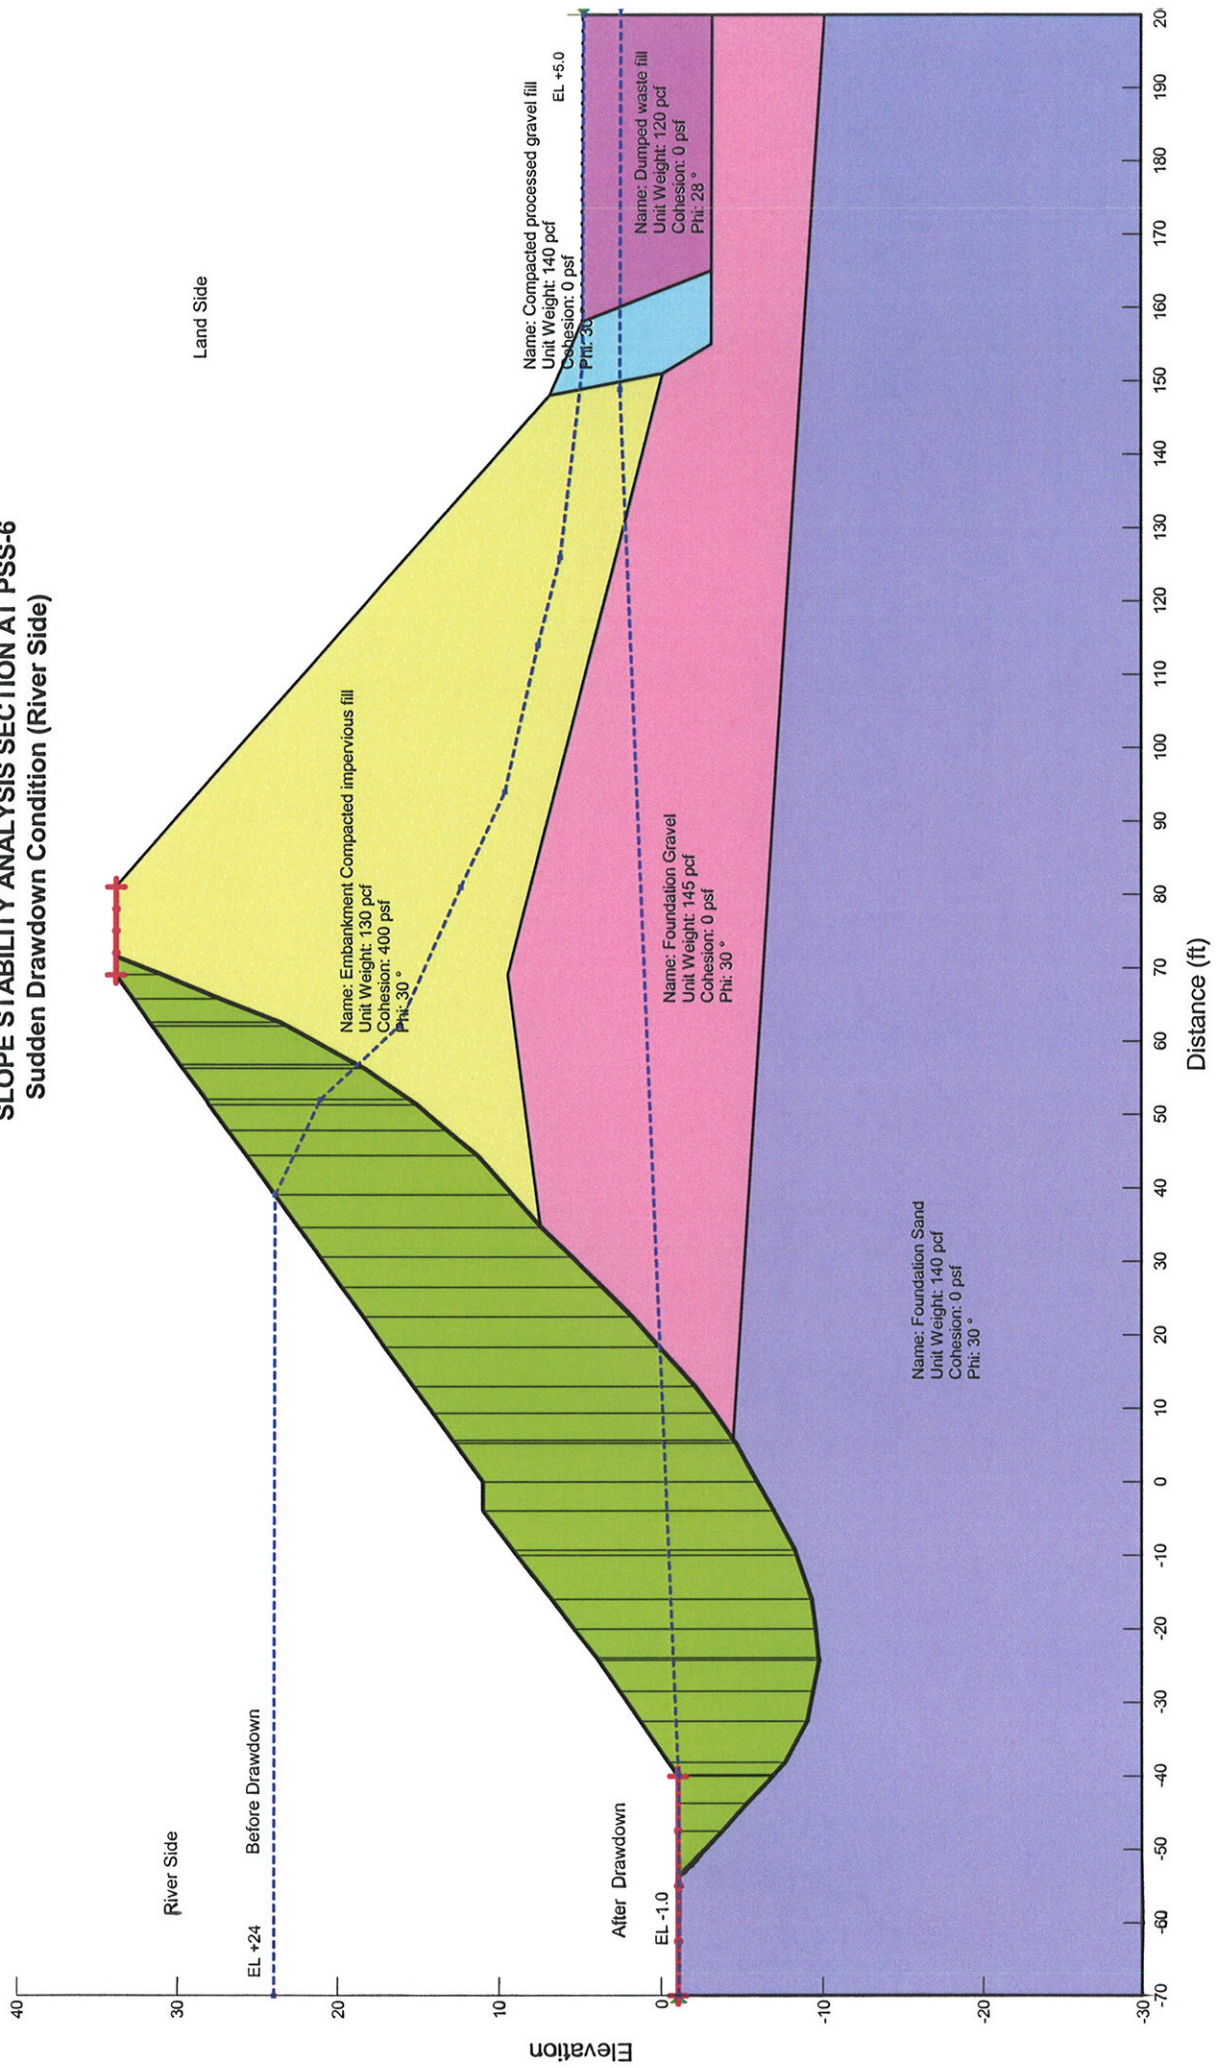
2.09

# SLOPE STABILITY ANALYSIS SECTION AT PSS-6 Sudden Drawdown Condition (River Side)

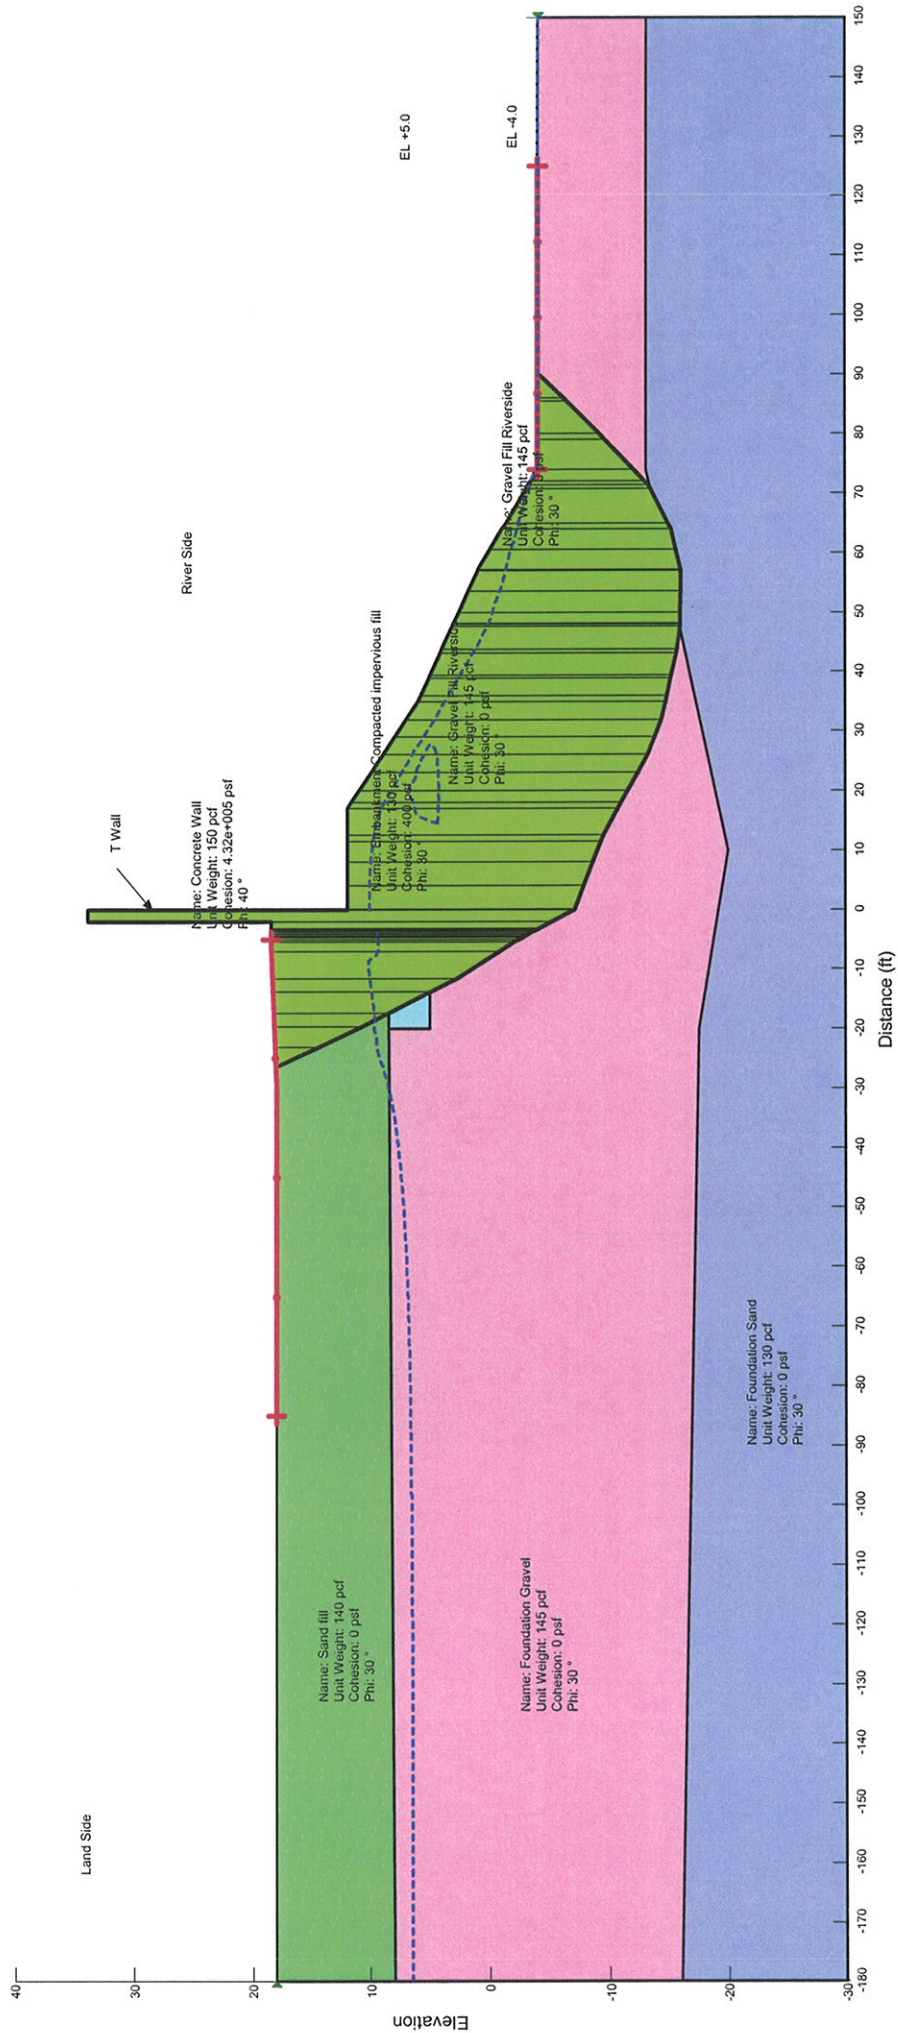
# SLOPEW ANALYSIS SECTION AT PSS-7 ("T" Wall) Sudden Drawdown Condition (River Side)

2.02

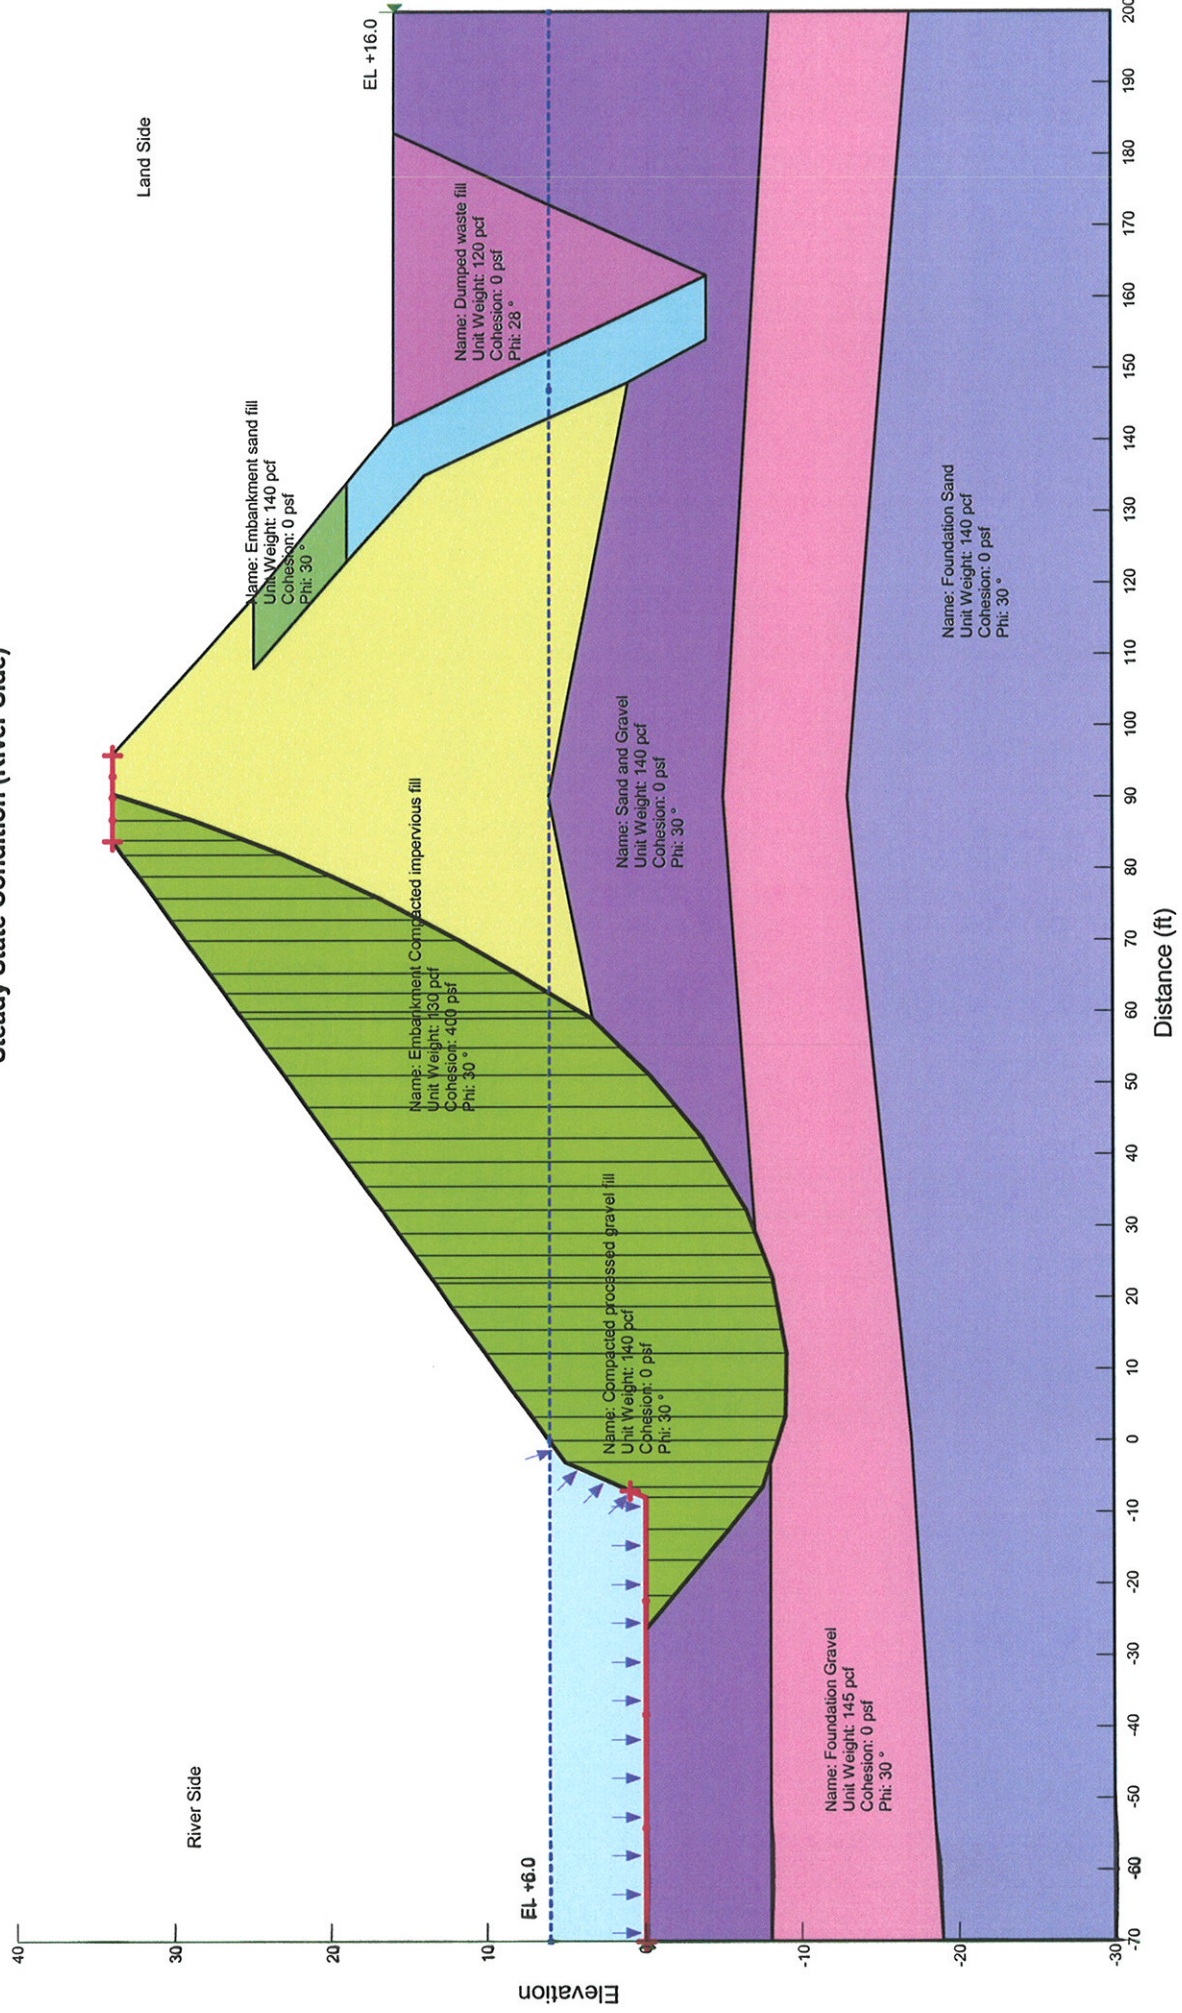
2.06

# SLOPEW ANALYSIS SECTION AT PSS-8 Steady State Condition (River Side)
