**APPENDIX F**

**RESULTS OF STABILITY ANALYSIS**

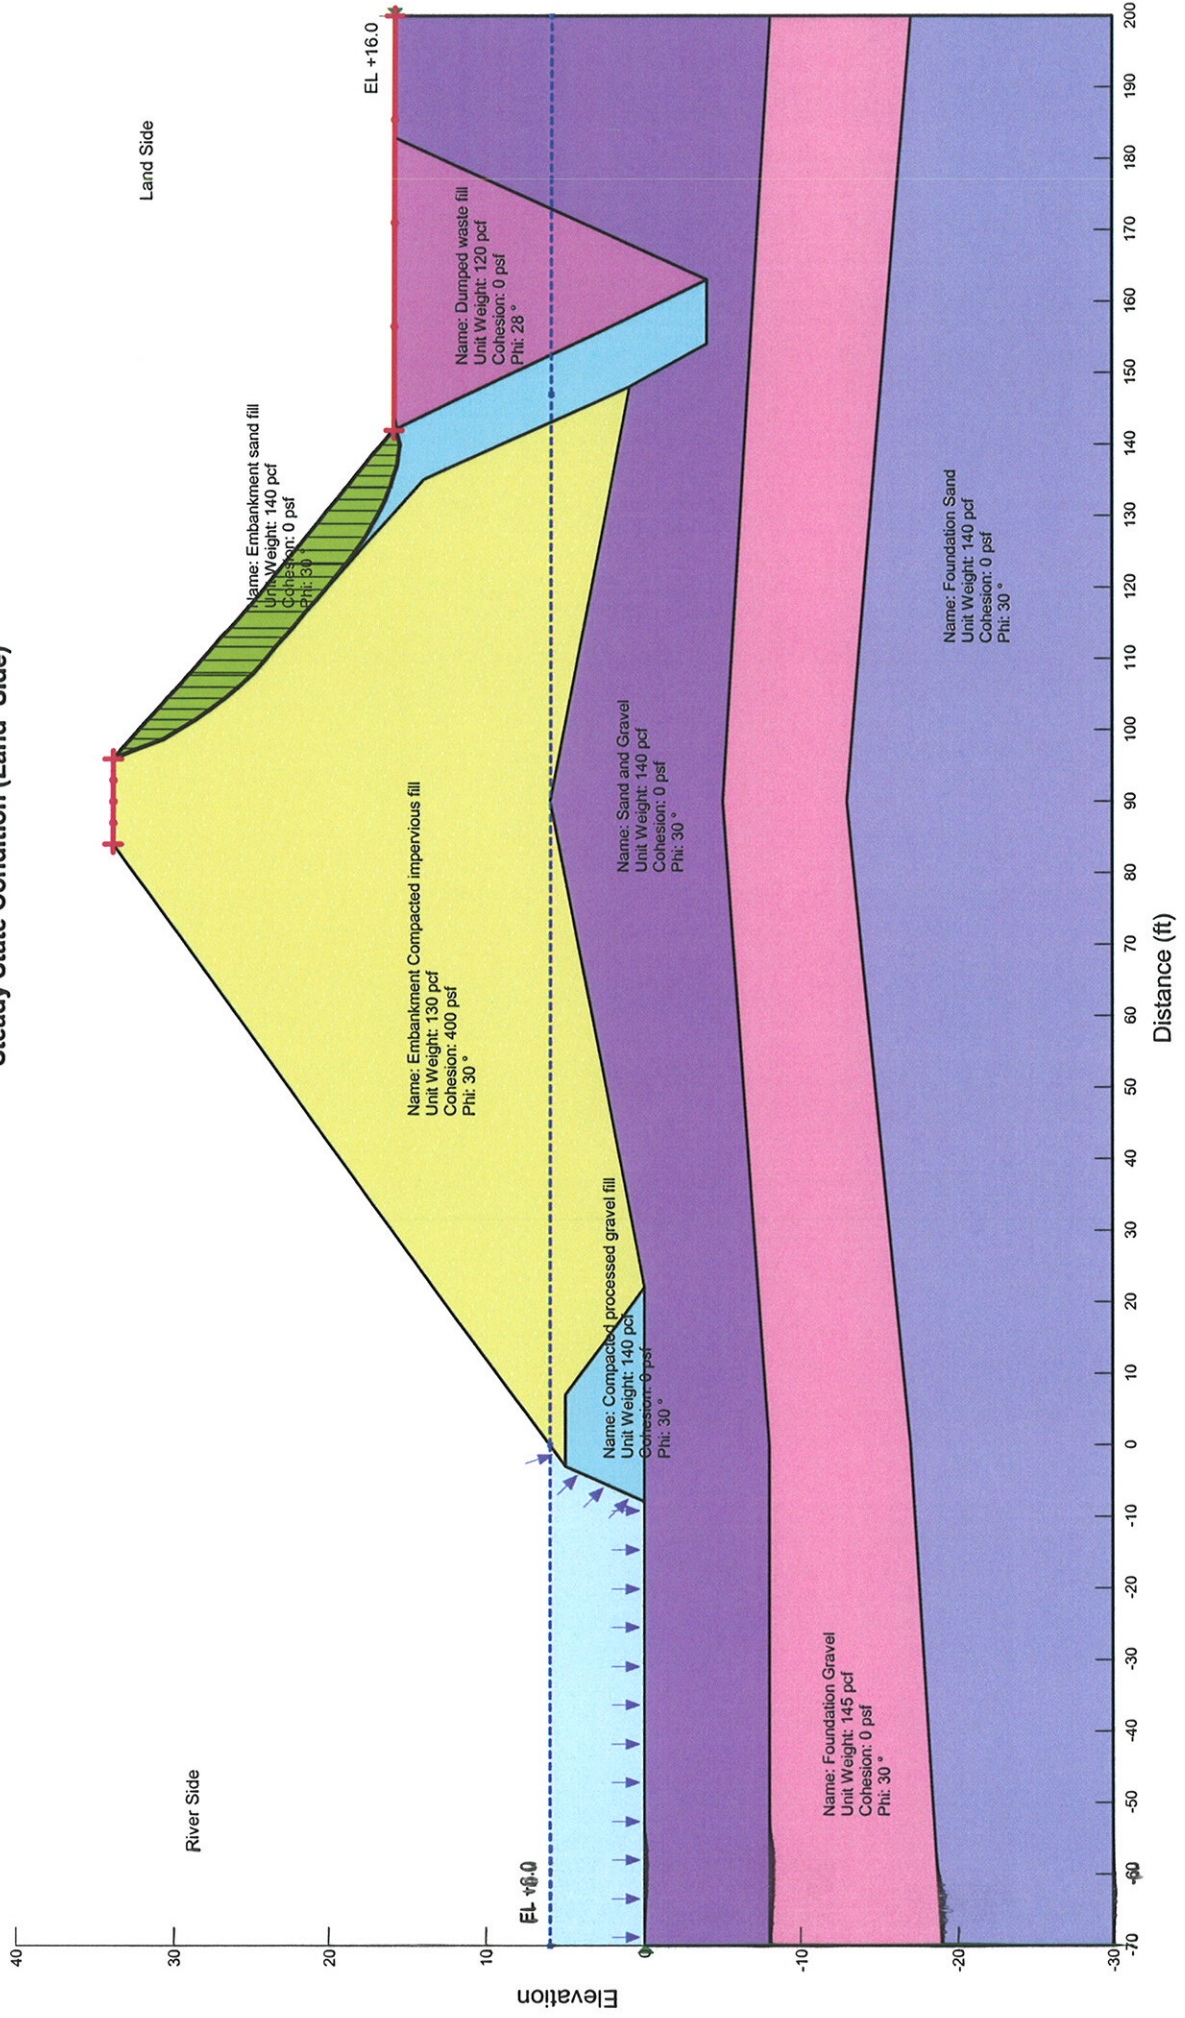
# **SLOPE/W ANALYSIS SECTION AT PSS-8** **Steady State Condition (Land Side)**

2.40

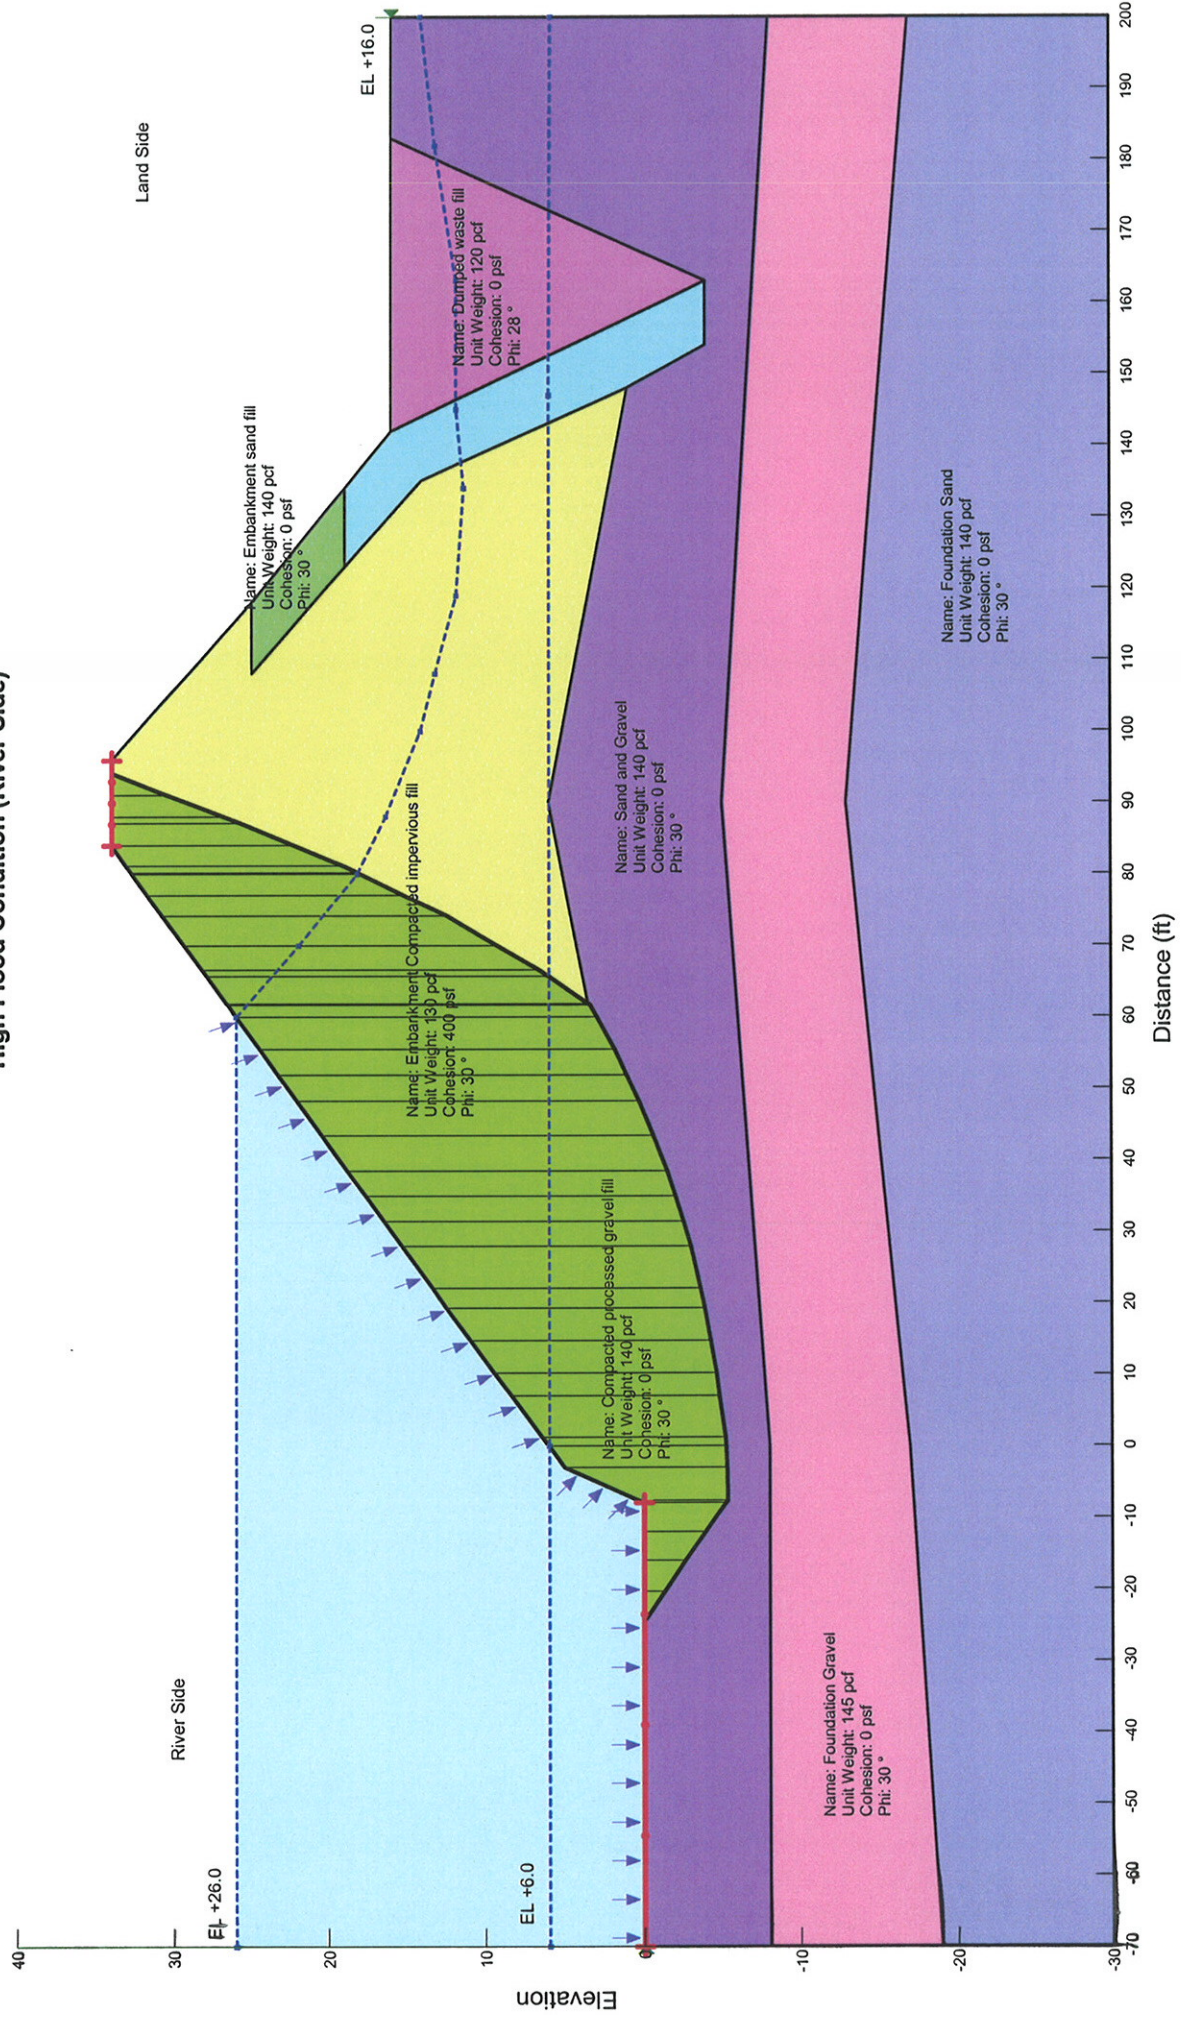
2.47

# SLOPE/W ANALYSIS SECTION AT PSS-8 High Flood Condition (River Side)

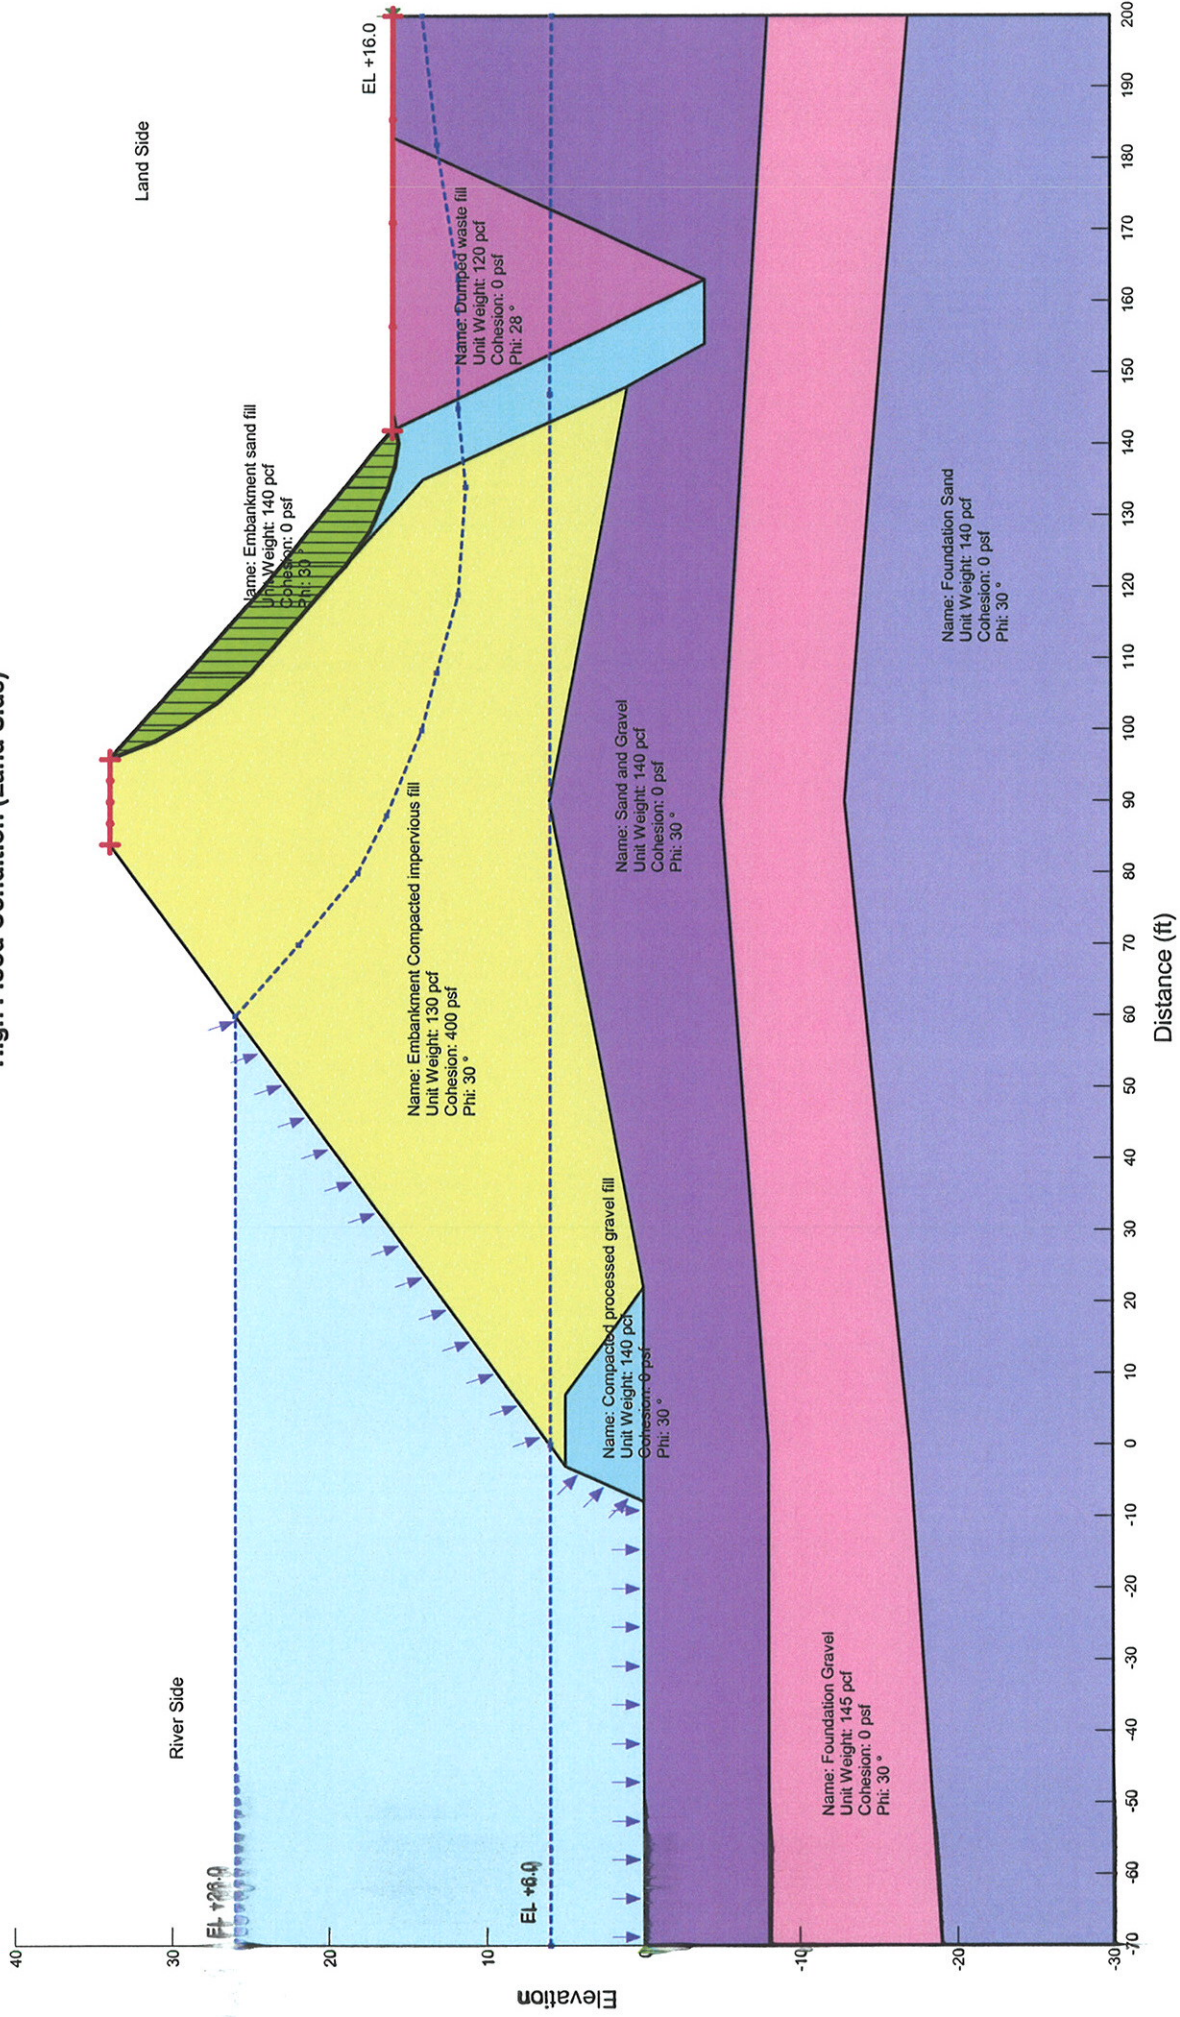
# **SLOPE/W ANALYSIS SECTION AT PSS-8** **High Flood Condition (Land Side)**

2.40

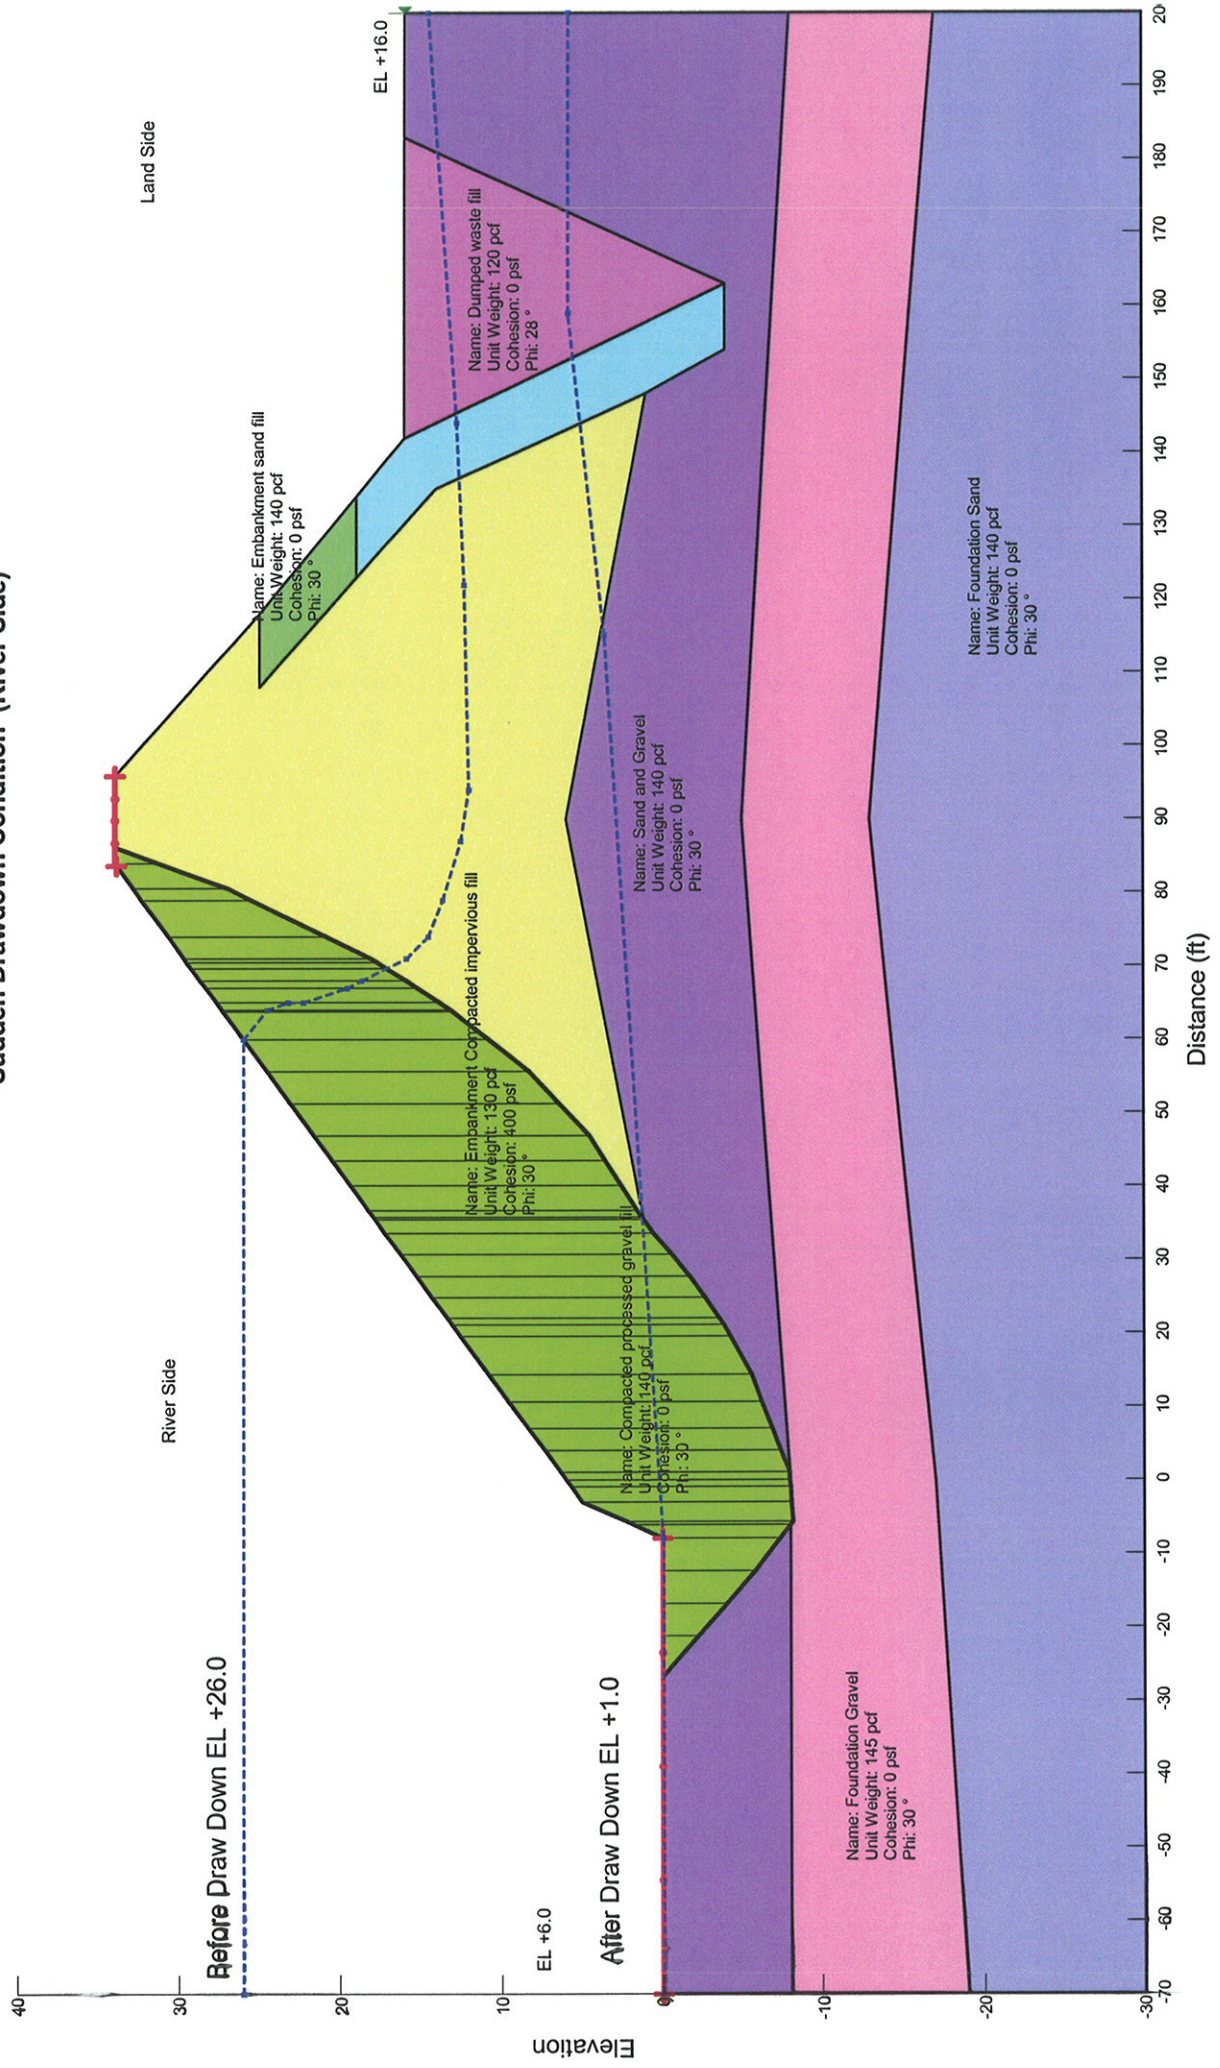
1.89

# SLOPE/W ANALYSIS SECTION AT PSS-8 Sudden Drawdown Condition (River Side)

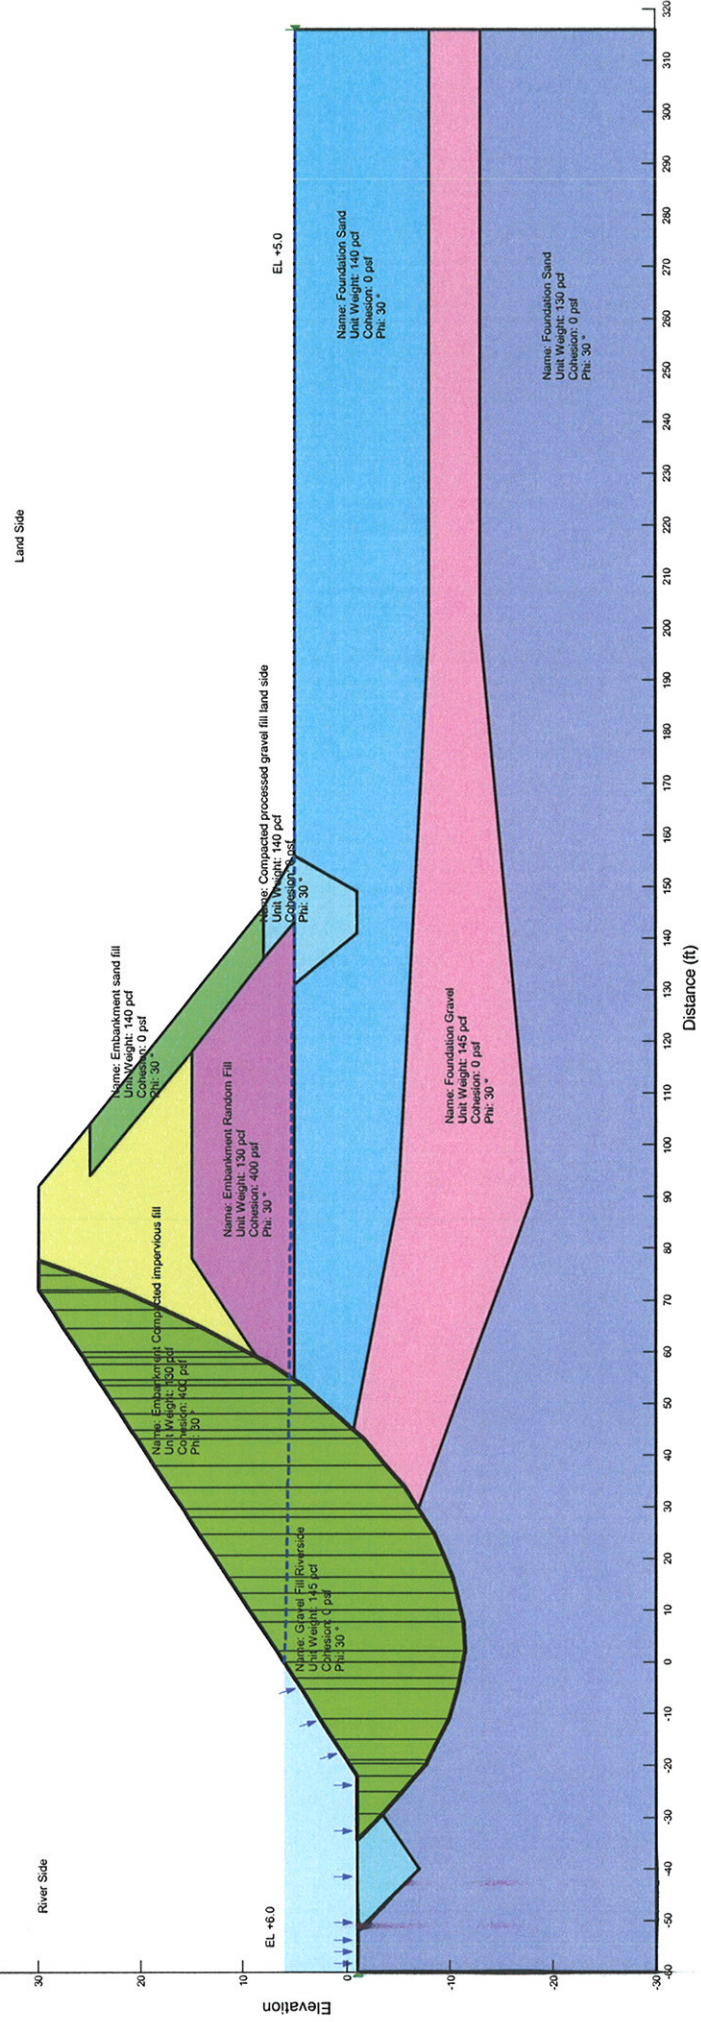
# **SLOPE/W ANALYSIS SECTION AT PSS-9** **Steady State Condition (River Side)**

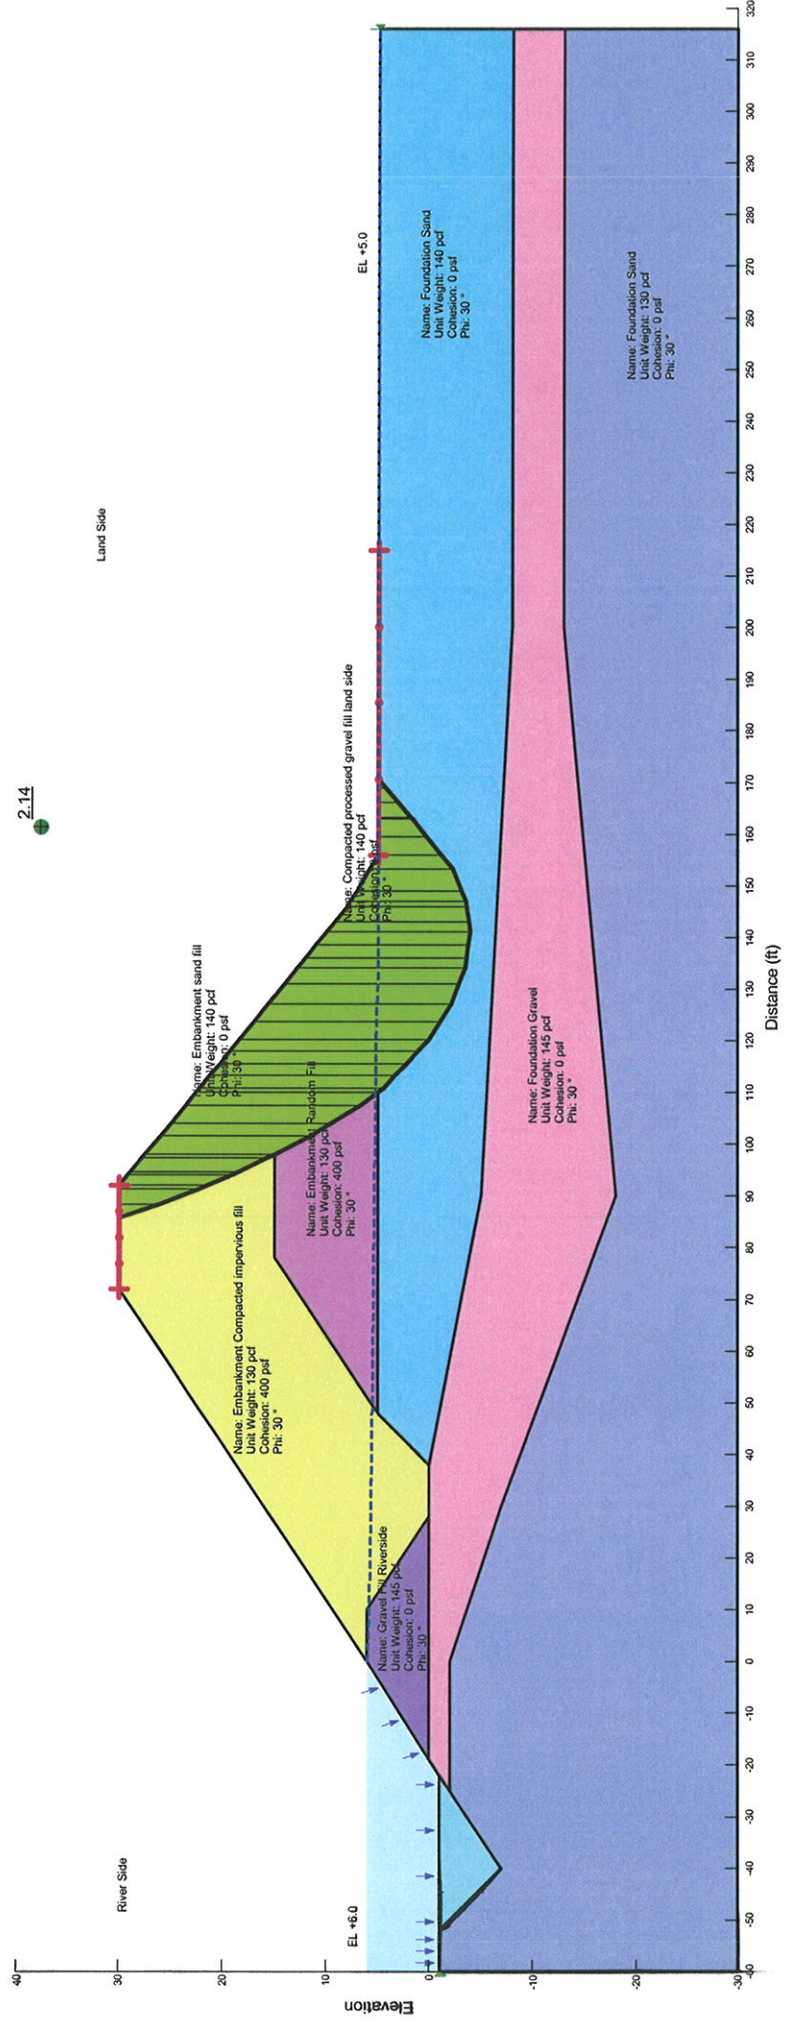
# SLOPEW ANALYSIS SECTION AT PSS-9 Steady State Condition (Land Side)

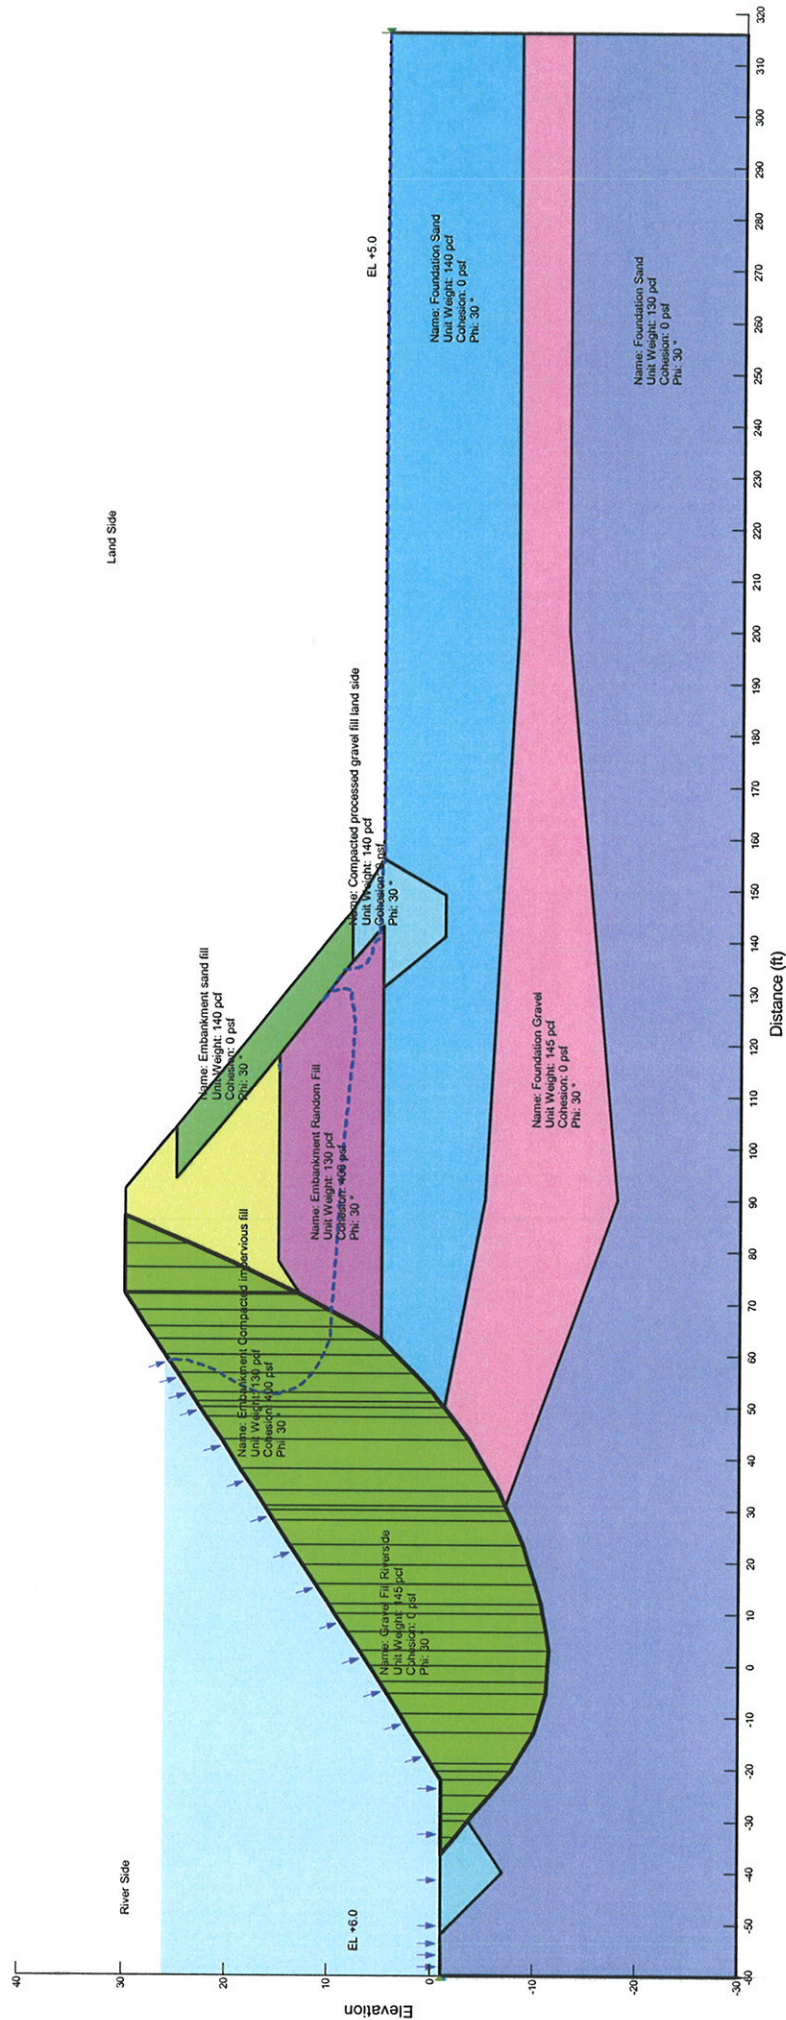
SLOPEW ANALYSIS SECTION AT PSS-9  
High Flood Condition (River Side)

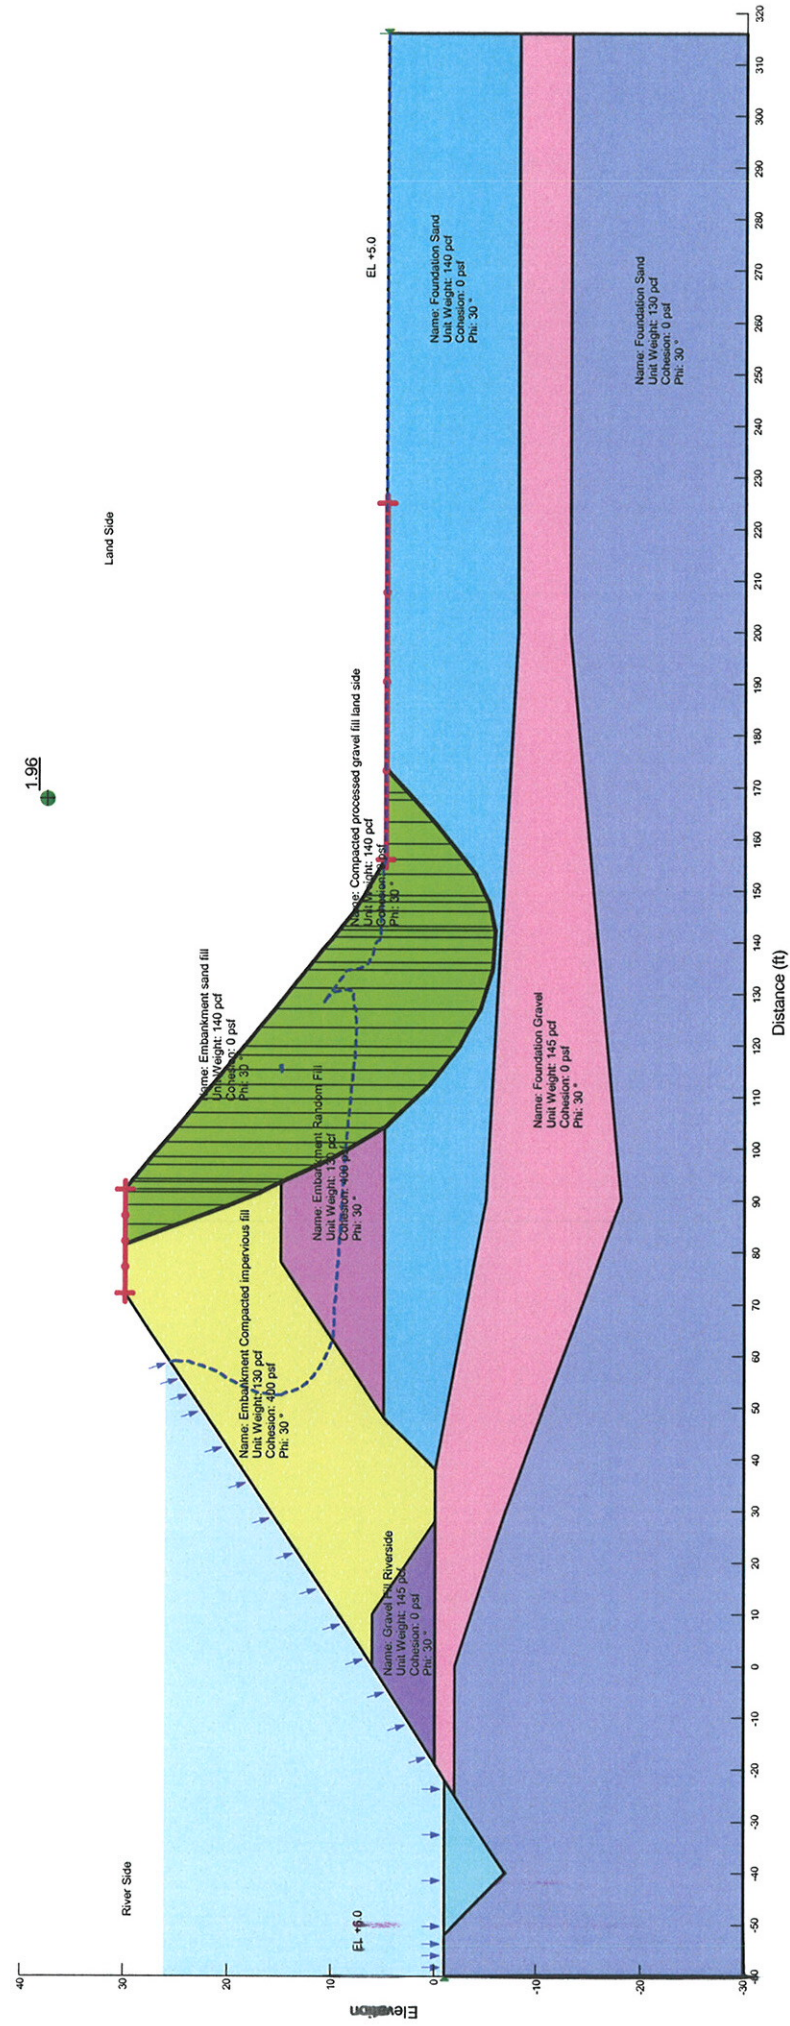
**SLOPE/W ANALYSIS SECTION AT PSS-9**  
**High Flood Condition (Land Side)**

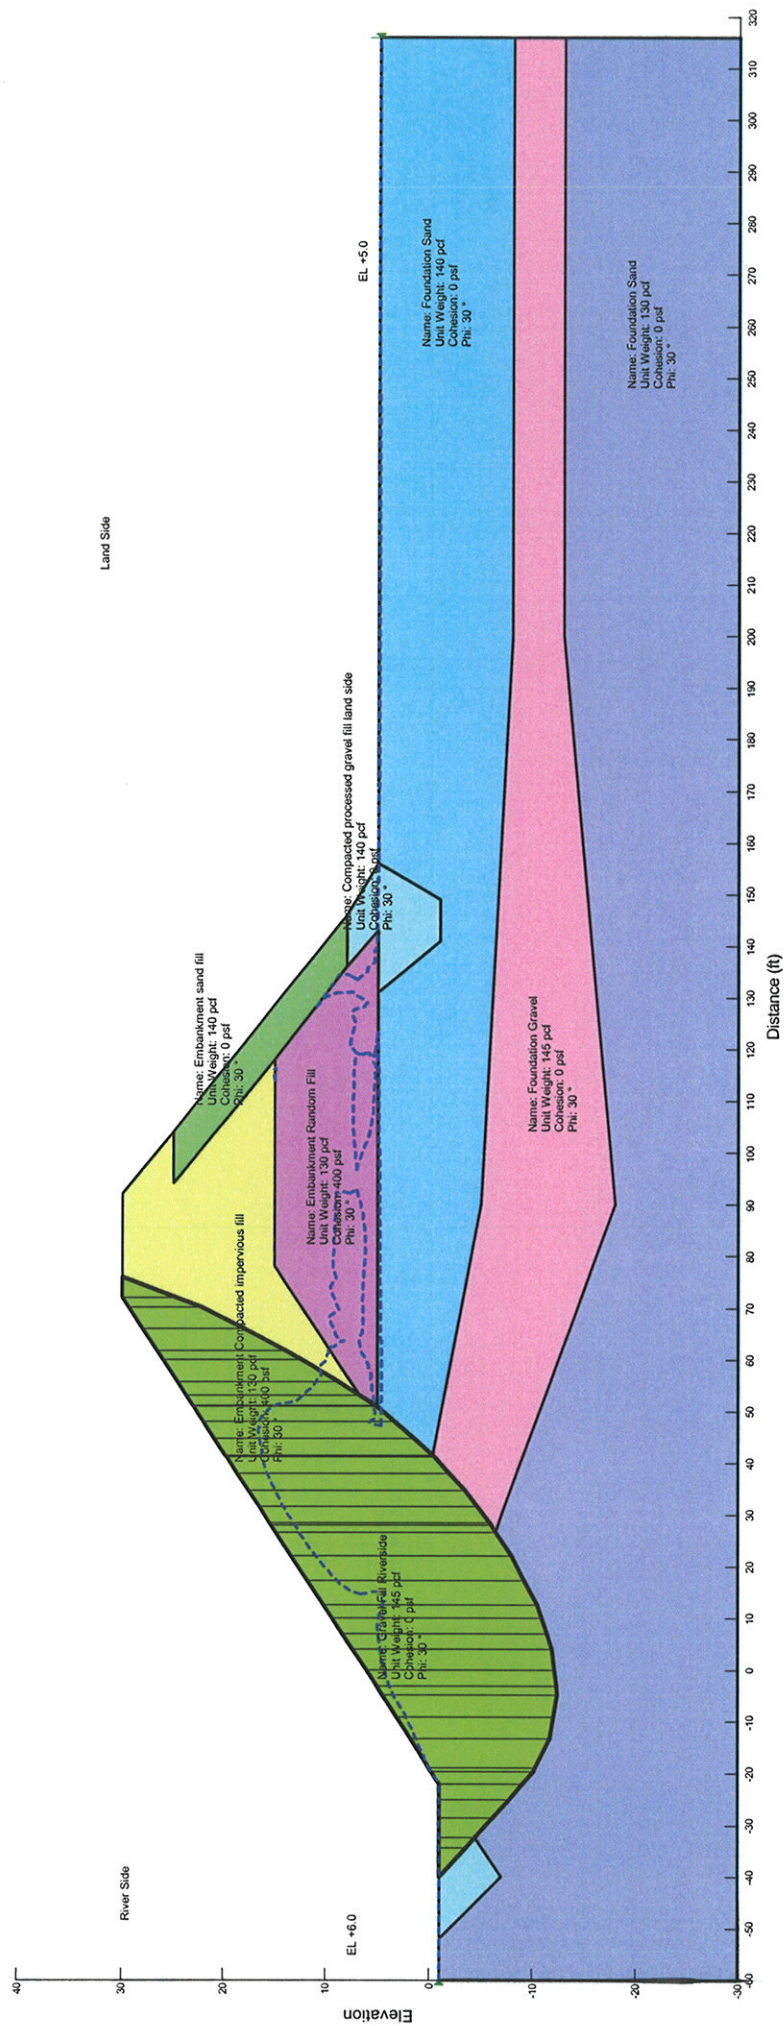
SLOPE/W ANALYSIS SECTION AT PSS-9  
Sudden Drawdown Condition (River Side)

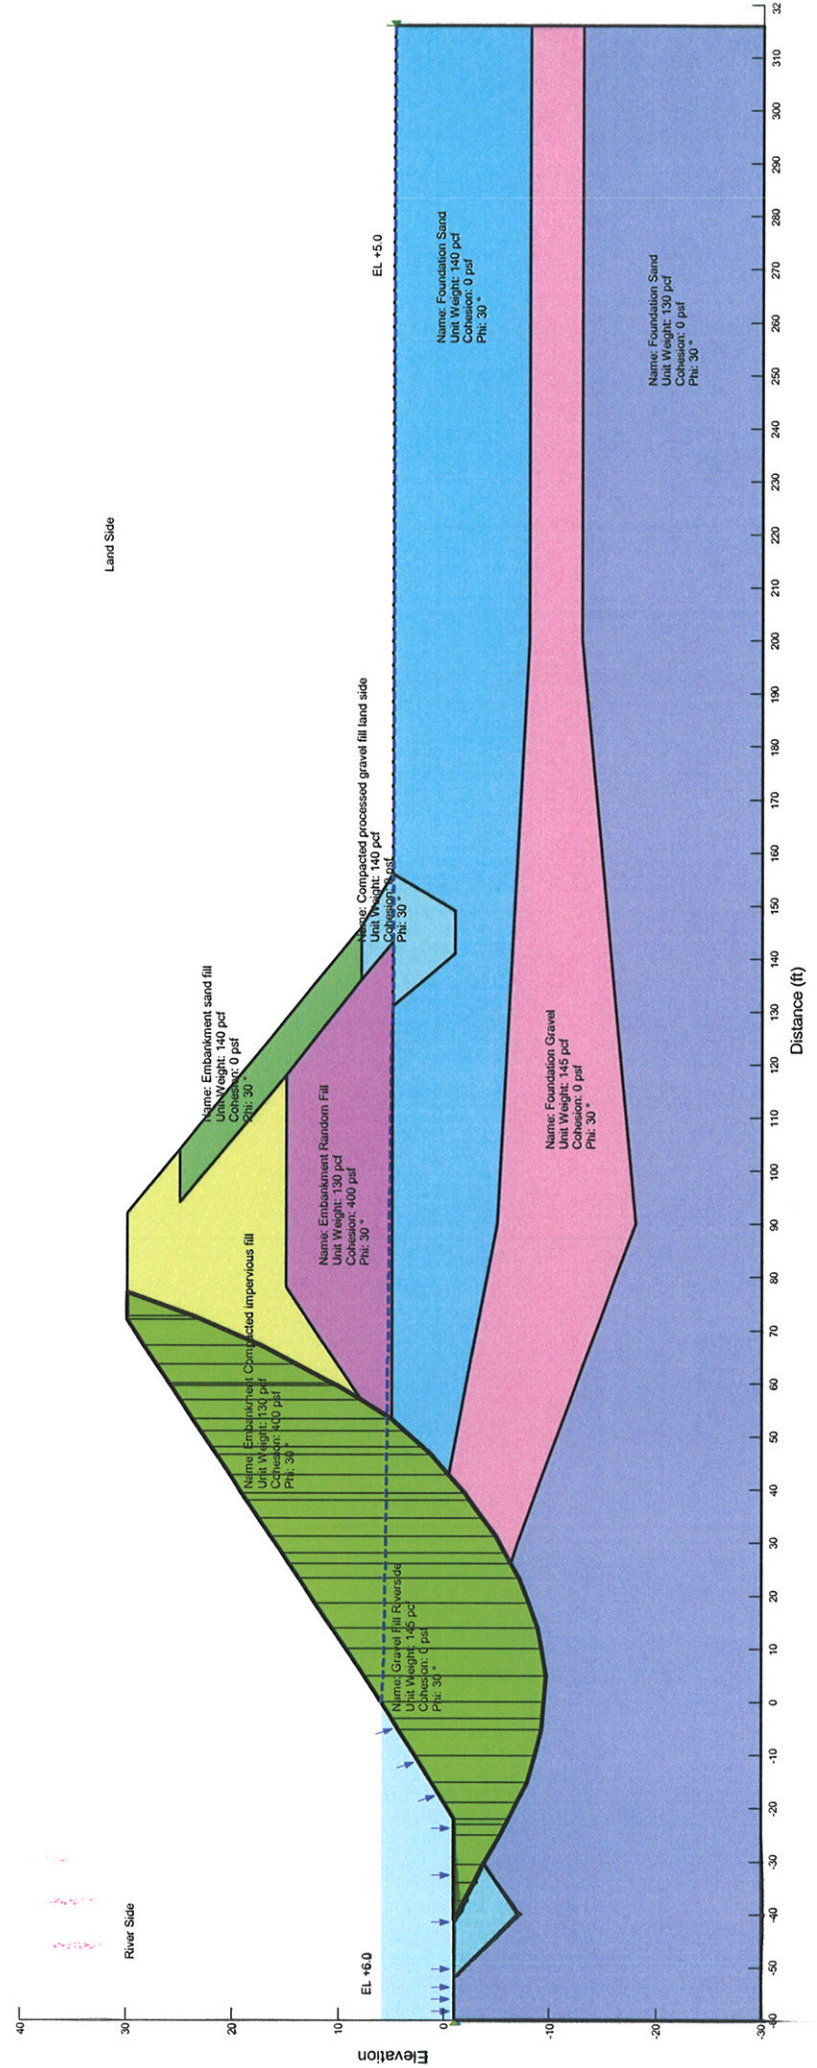
SLOPE ANALYSIS SECTION AT PSS-9  
Pseudo Static Condition (River Side)

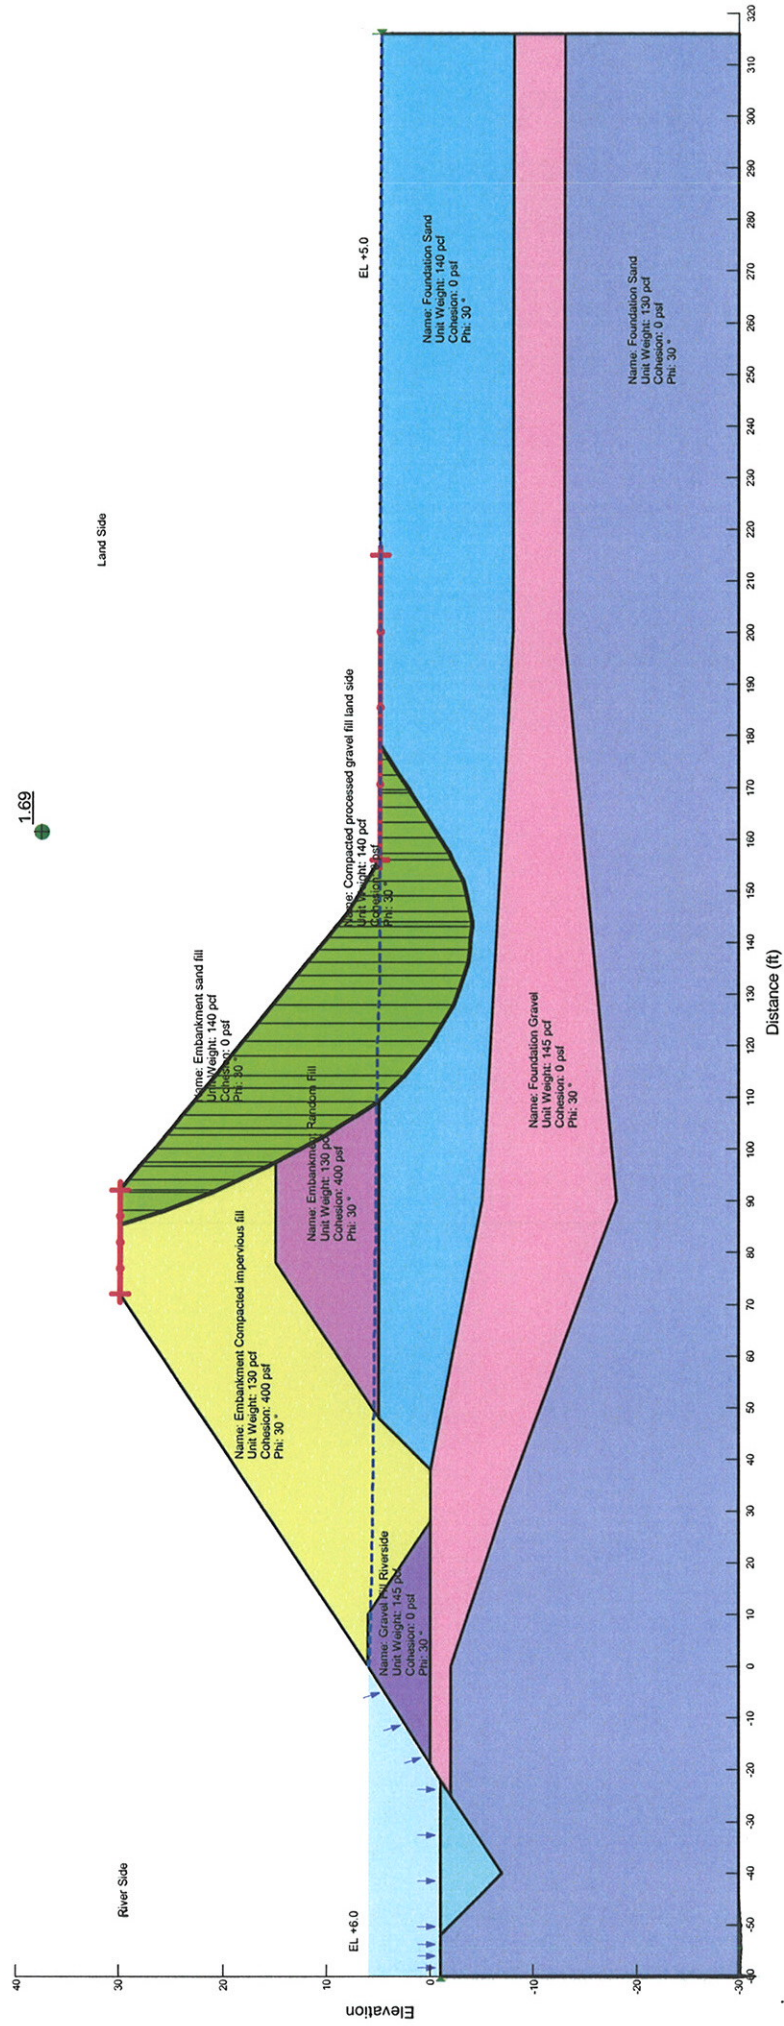
# **SLOPEW ANALYSIS SECTION AT PSS-9** **Pseudo Static Condition (Land Side)**

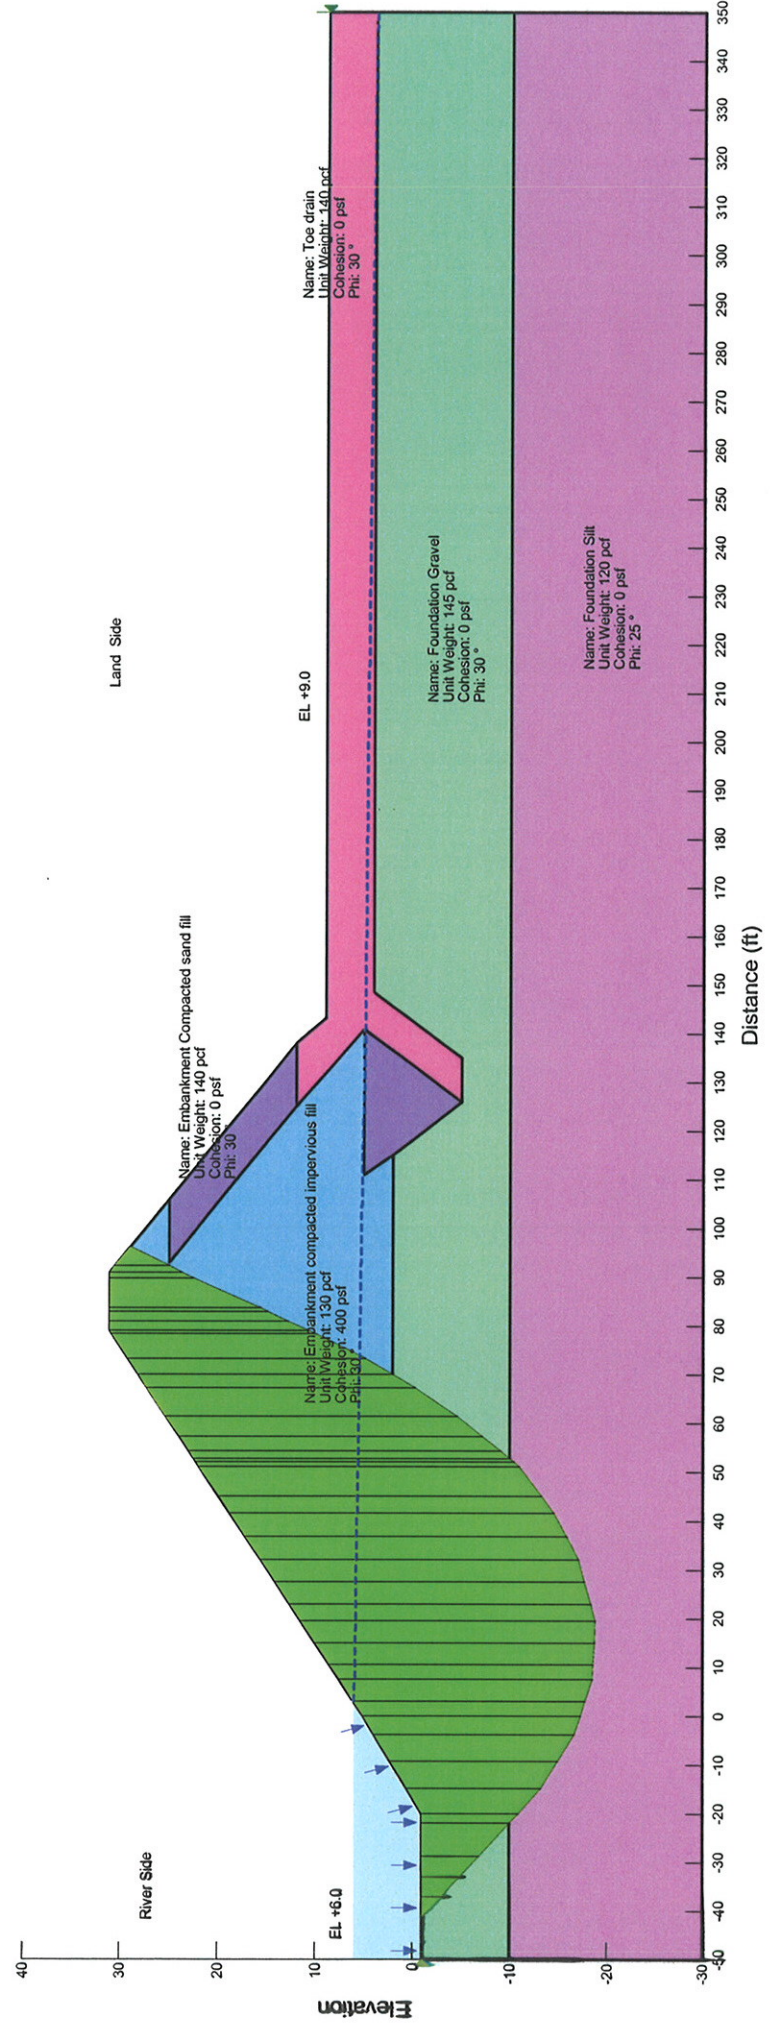
# **SLOPE/W ANALYSIS SECTION AT PSS-10** **Steady State Condition (River Side)**
