**APPENDIX F**

**RESULTS OF STABILITY ANALYSIS**

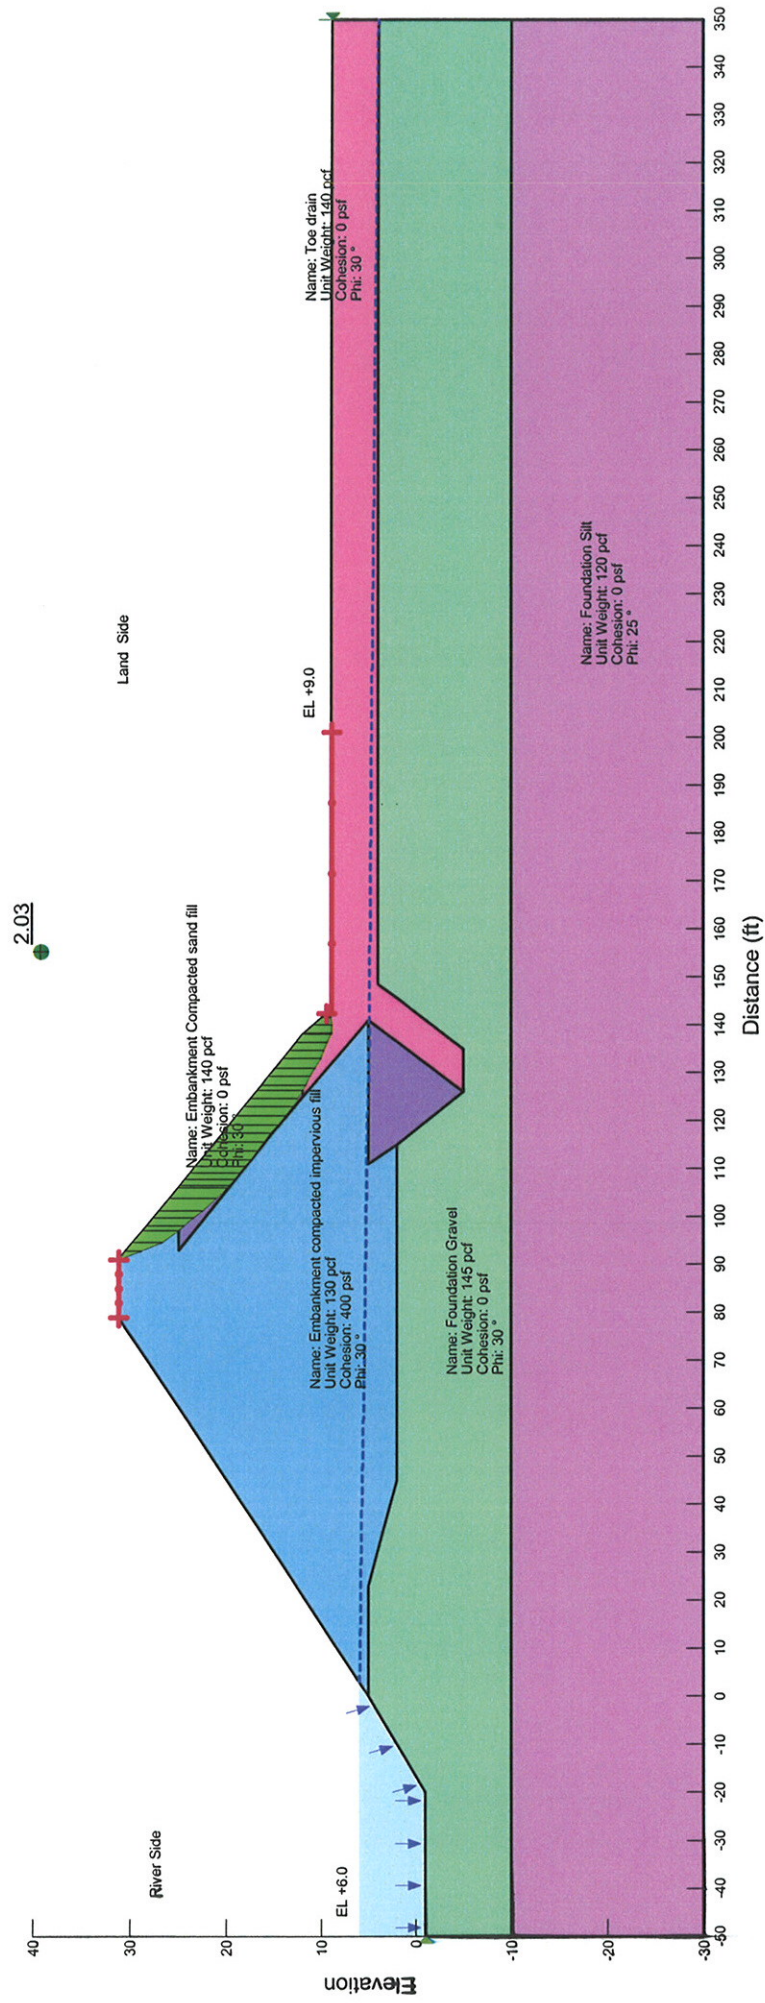
# SLOPEW ANALYSIS SECTION AT PSS-10 Steady State Condition (Land Side)

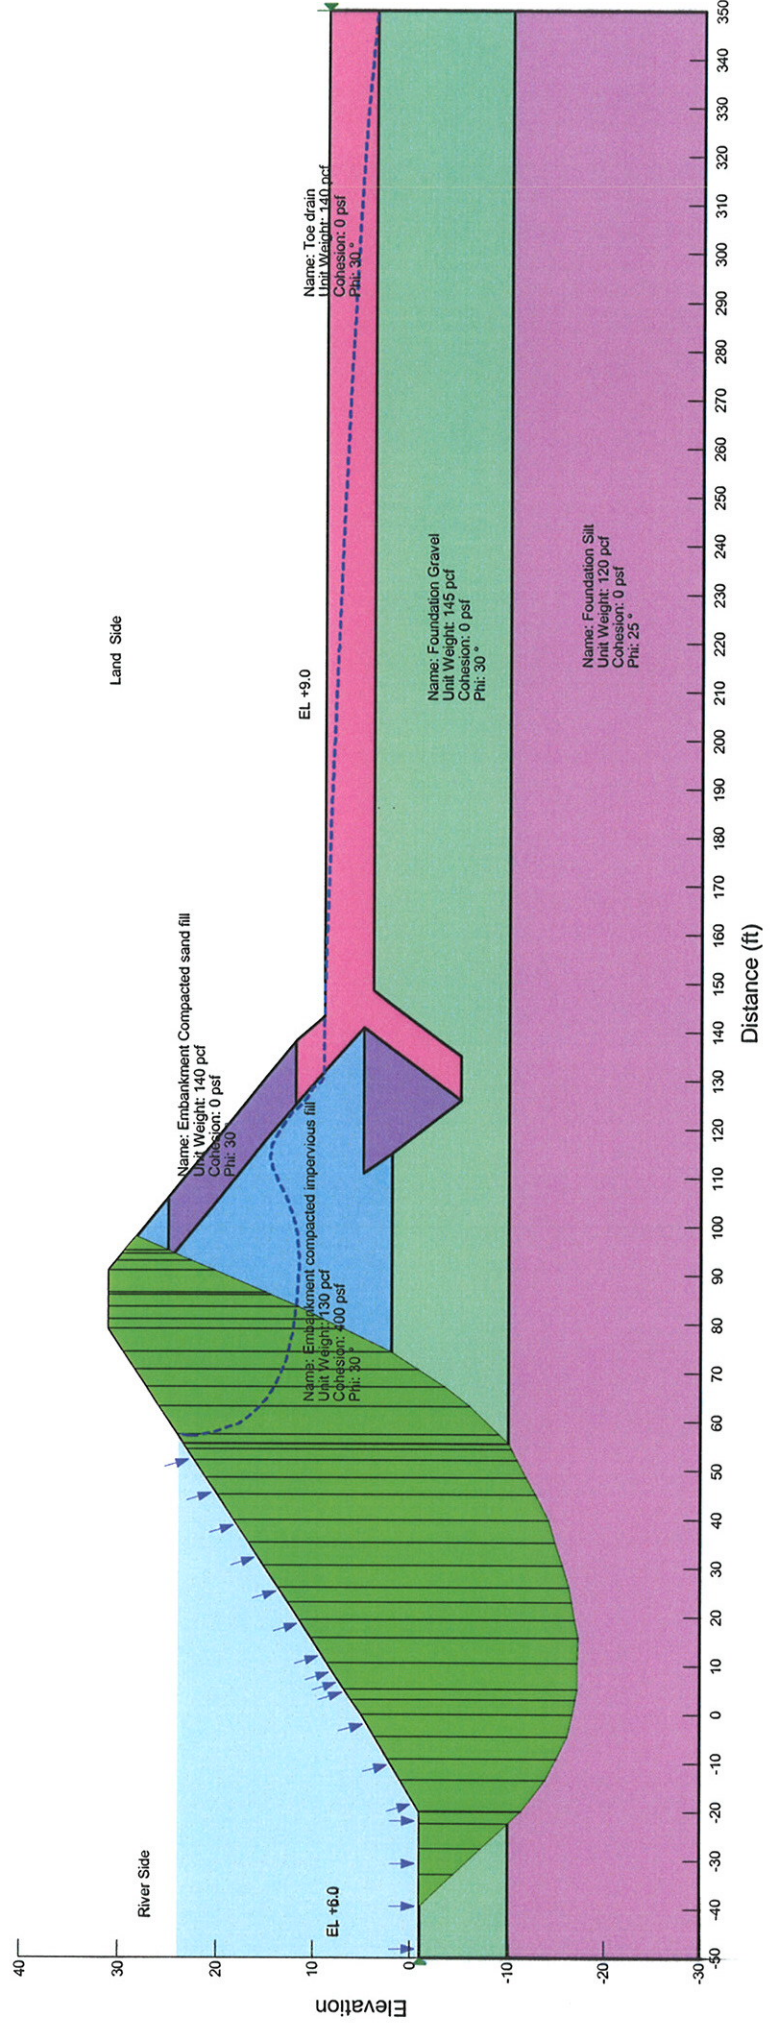
# **SLOPE/W ANALYSIS SECTION AT PSS-10** **High Flood Condition (River Side)**

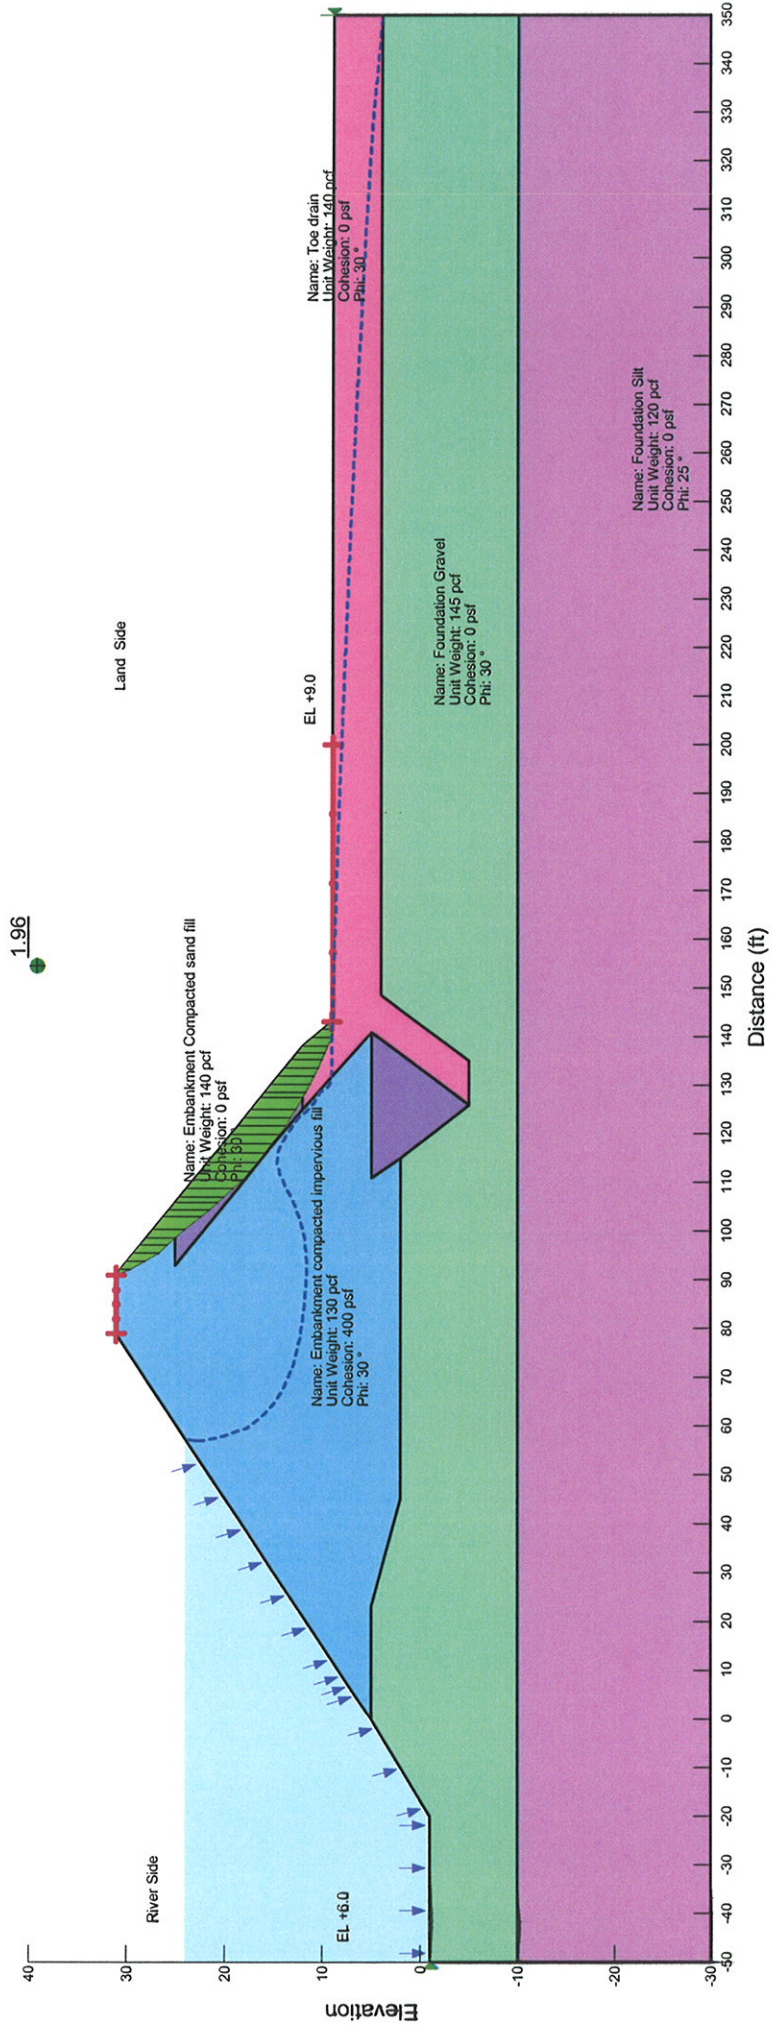
# **SLOPE/W ANALYSIS SECTION AT PSS-10** **High Flood Condition (Land Side)**

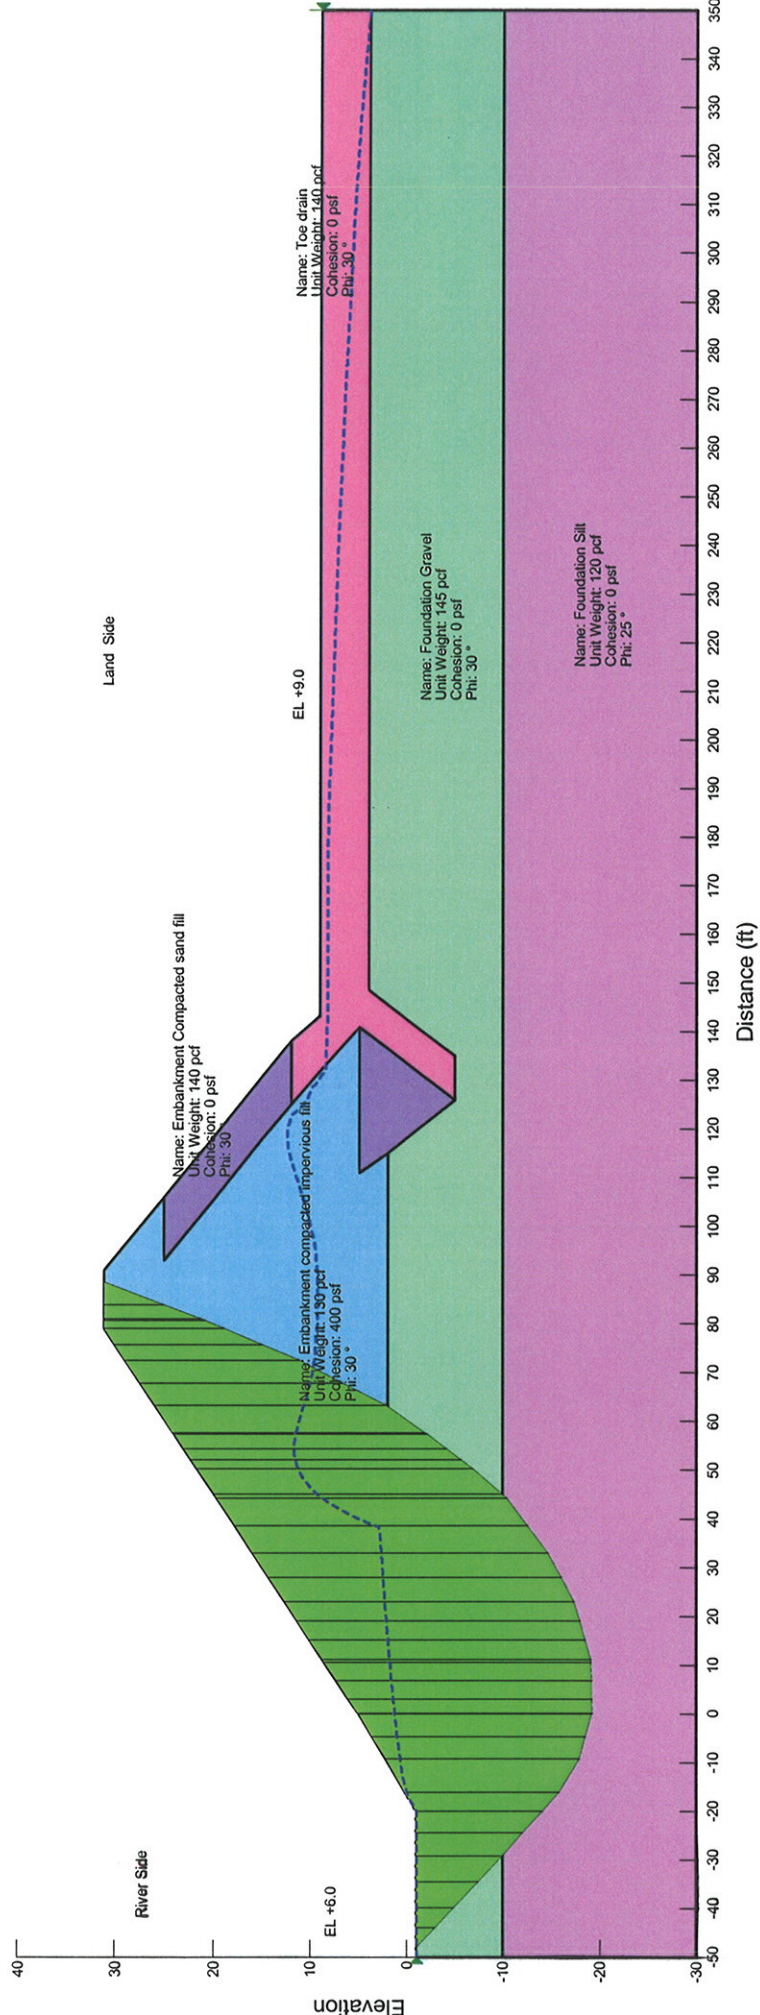
# SLOPE/W ANALYSIS SECTION AT PSS-10 Sudden Drawdown Condition (River Side)
